Defect Listing

Pipe Segment Refere... A8-25_A8-24	City Oliver Springs	Street Walden Rd	Material Concrete Pipe (non-...	Location C... Light High...	Sewer Use Sanitary
Upstream MH A8-25	Total Length 155.6	Year Laid	Shape Circular	Location Details	
DS Manhole A8-24	Length surveyed 155.6	Year Renewed	Height 8	Width 8	Pipe Joint... 4

SPR N/A	MPR N/A	PO Number 4397-03	Customer GRW
SPRI N/A	MPRI N/A	Work Order 4397-02	Purpose Pre-Rehabilitation Survey
QSR N/A	QMR N/A		
OPR N/A	Surveyed By Barry Rogers	Direction Downstream	Date 20150730
OPRI N/A	Certificate Number U-1012-16405	Pre-Cleaning Jetting	Time 07:40
	Date Cleaned 20150730	End Time 07:52	Weather Dry
			Additional Info

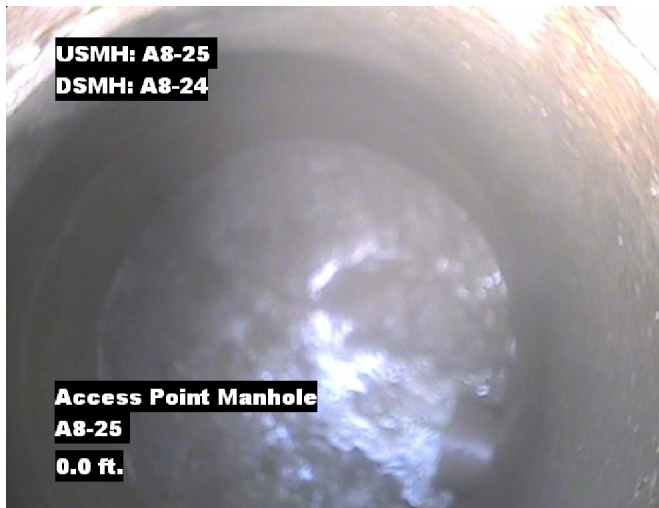
Distance: 0.0 ft. Grade: 0
Condition: Access Point Manhole
Remarks: A8-25

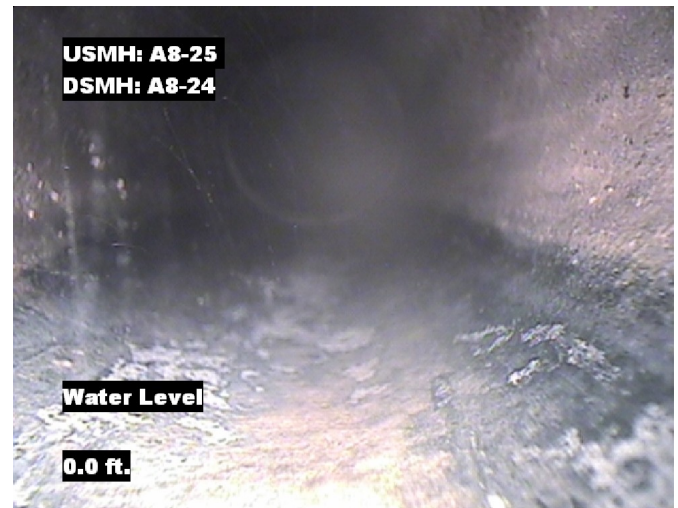
Distance: 0.0 ft. Grade: 0
Condition: Water Level
Remarks: N/A

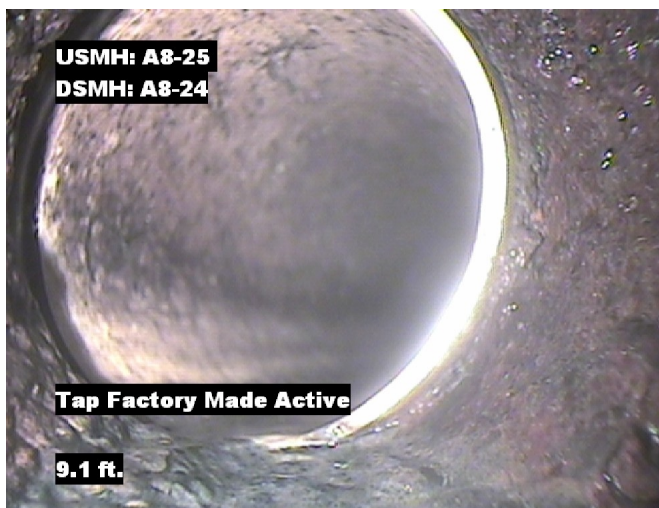
Distance: 9.1 ft. Grade: 0
Condition: Tap Factory Made Active
Remarks: N/A

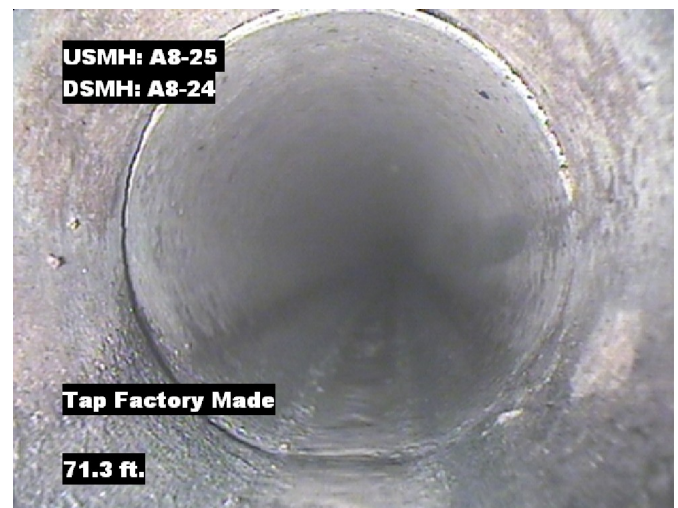
Distance: 71.3 ft. Grade: 0
Condition: Tap Factory Made
Remarks: N/A

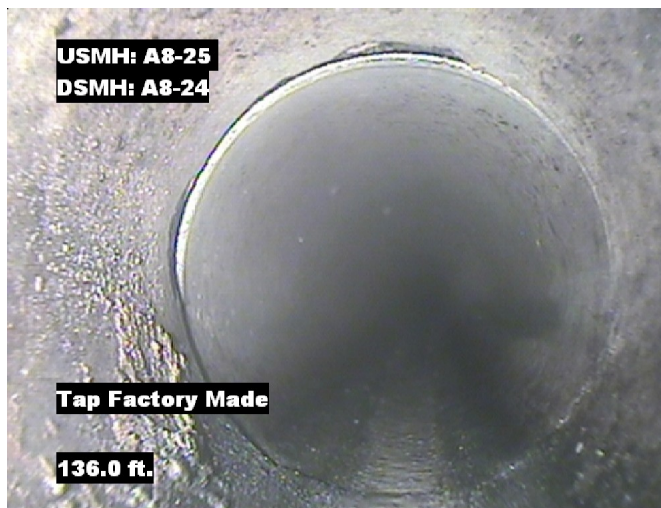
Distance: 136.0 ft. Grade: 0
Condition: Tap Factory Made
Remarks: N/A

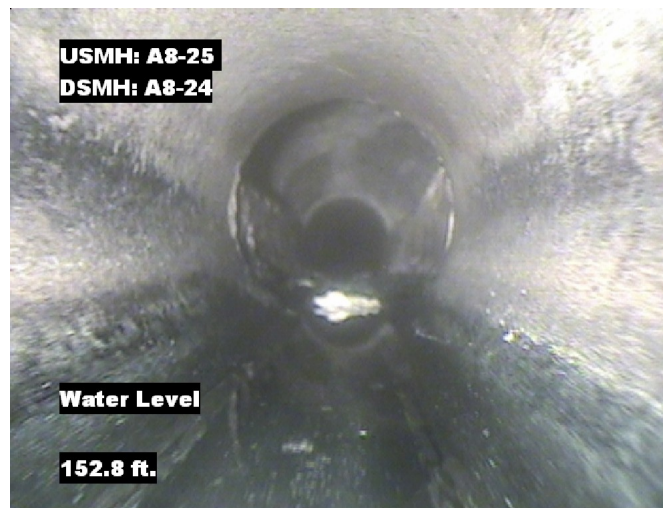
Distance: 152.8 ft. Grade: 0
Condition: Water Level
Remarks: N/A

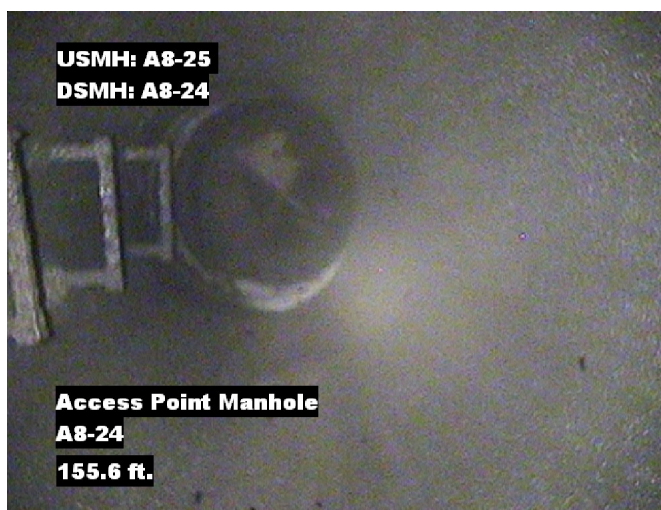
Distance: 155.6 ft. Grade: 0
Condition: Access Point Manhole
Remarks: A8-24
