Defect Listing

Pipe Segment Refere... A8-3_A8-3A	City Oliver Springs	Street Main St	Material Concrete Pipe (non-...	Location C... Light High...	Sewer Use Sanitary
Upstream MH A8-3	Total Length 323.4	Year Laid	Shape Circular	Location Details	
DS Manhole A8-3A	Length surveyed 323.4	Year Renewed	Height 8	Width 8	Pipe Joint... 4

SPR 5	MPR 17	PO Number 4397-03	Customer GRW
SPRI 5	MPRI 2.8	Work Order 4397-02	Purpose Pre-Rehabilitation Survey
QSR 5100	QMR 4133		
OPR 22	Surveyed By Barry Rogers	Direction Downstream	Date 20150814
OPRI 3.1	Certificate Number U-1012-16405	Pre-Cleaning Jetting	Time 09:51
	Date Cleaned 20150814	End Time 10:16	Weather Dry
			Additional Info

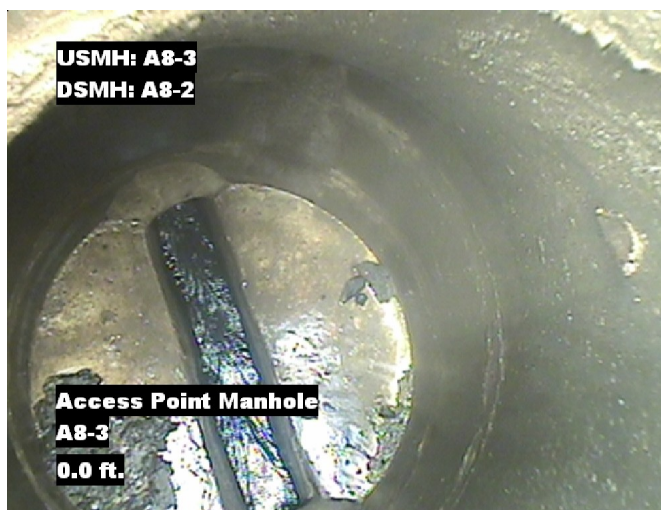
Distance: 0.0 ft. Grade: 0
Condition: Access Point Manhole
Remarks: A8-3

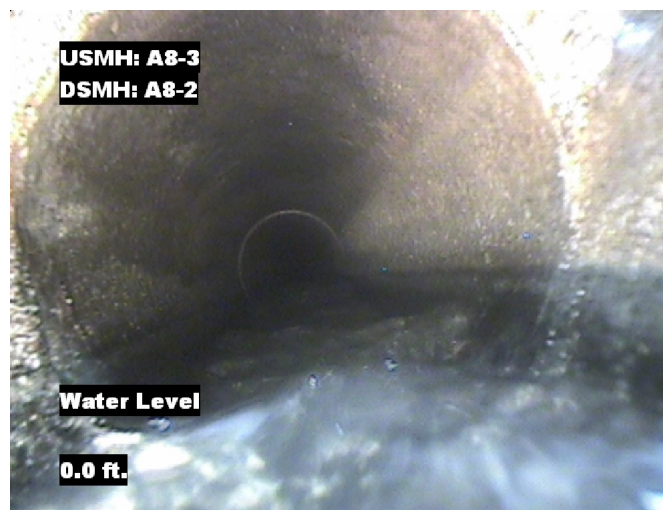
Distance: 0.0 ft. Grade: 0
Condition: Water Level
Remarks: N/A

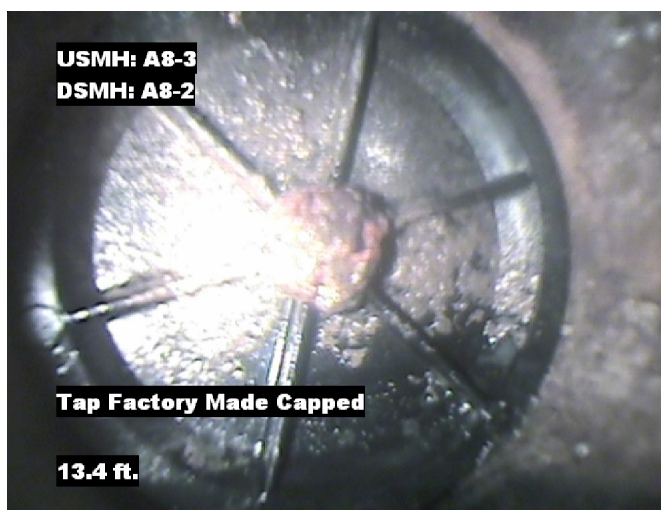
Distance: 13.4 ft. Grade: 0
Condition: Tap Factory Made Capped
Remarks: N/A

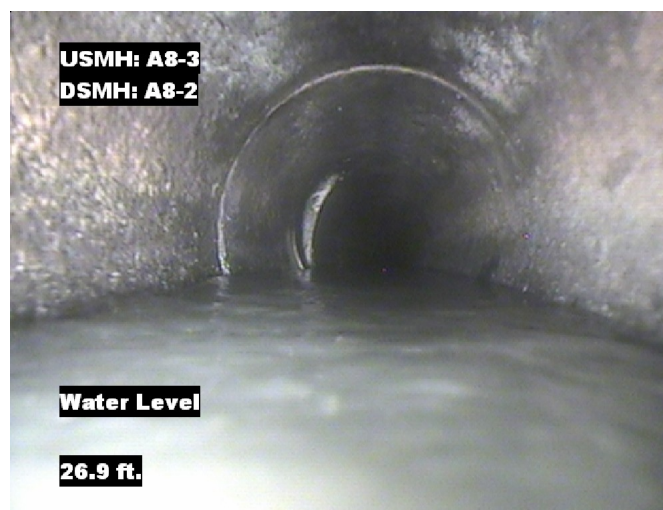
Distance: 26.9 ft. Grade: 0
Condition: Water Level
Remarks: N/A

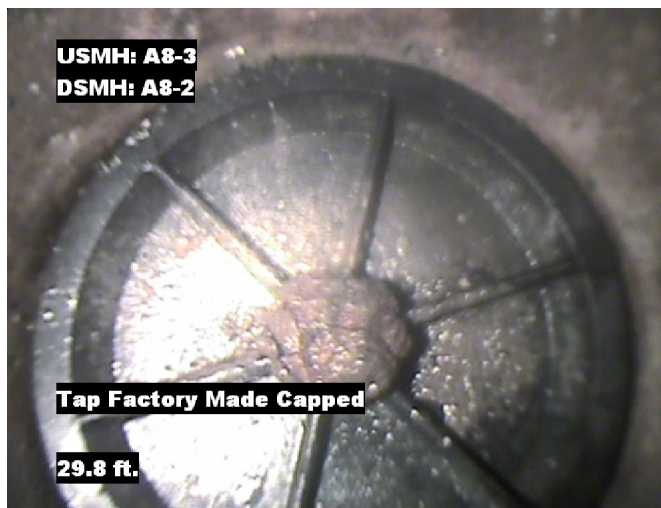
Distance: 29.8 ft. Grade: 0
Condition: Tap Factory Made Capped
Remarks: N/A

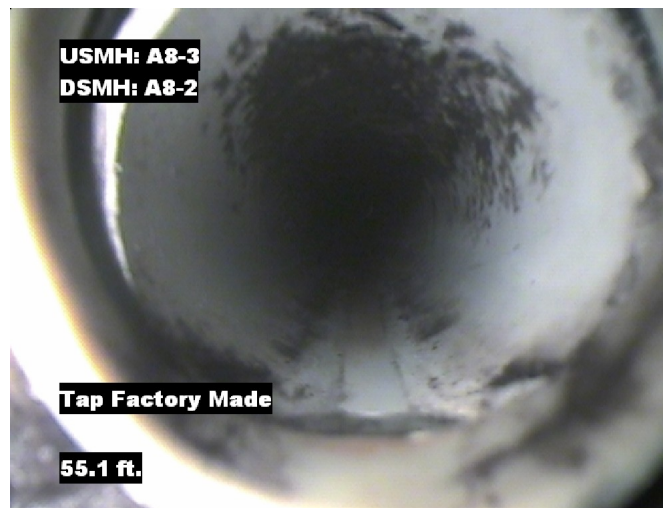
Distance: 55.1 ft. Grade: 0
Condition: Tap Factory Made
Remarks: N/A

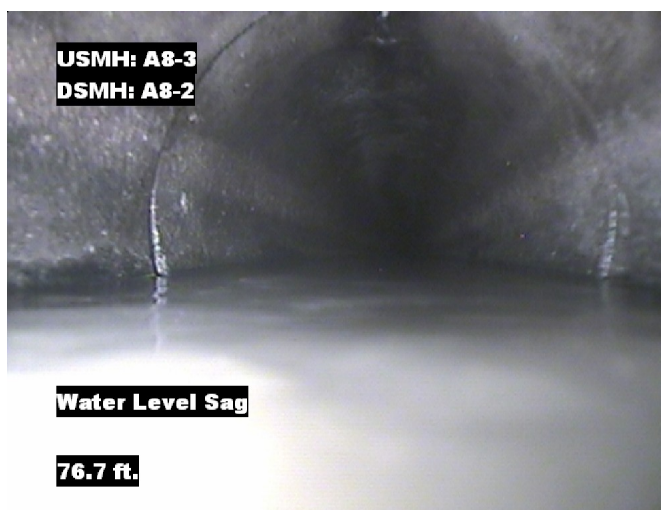
Distance: 76.6 ft. Grade: 3
Condition: Water Level Sag
Remarks: N/A

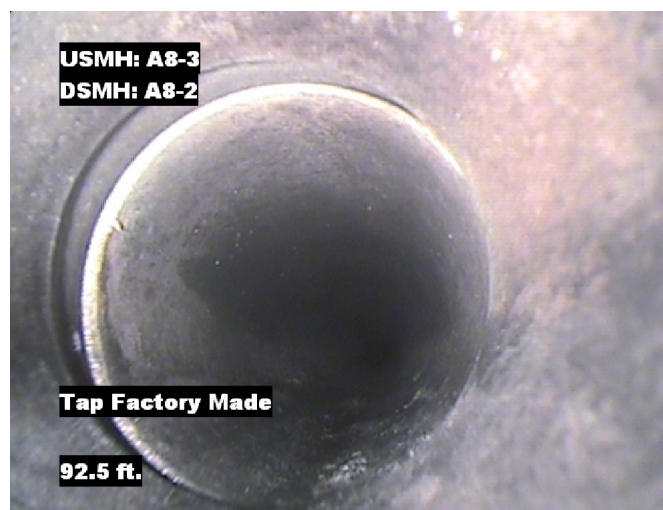
Distance: 92.5 ft. Grade: 0
Condition: Tap Factory Made
Remarks: N/A

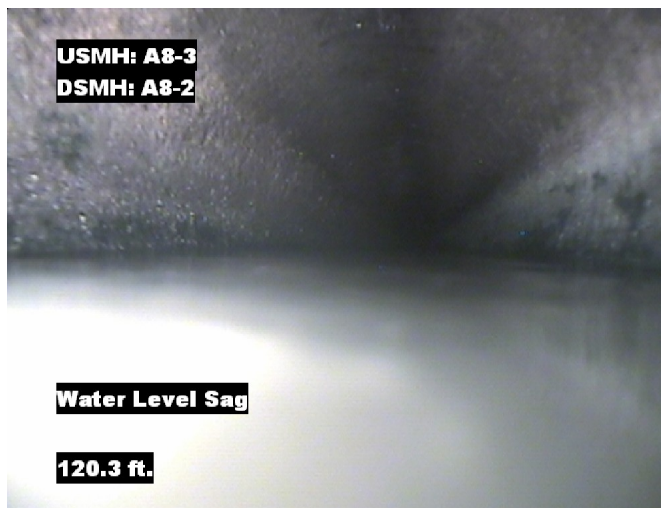
Distance: 120.3 ft. Grade: 3
Condition: Water Level Sag
Remarks: N/A

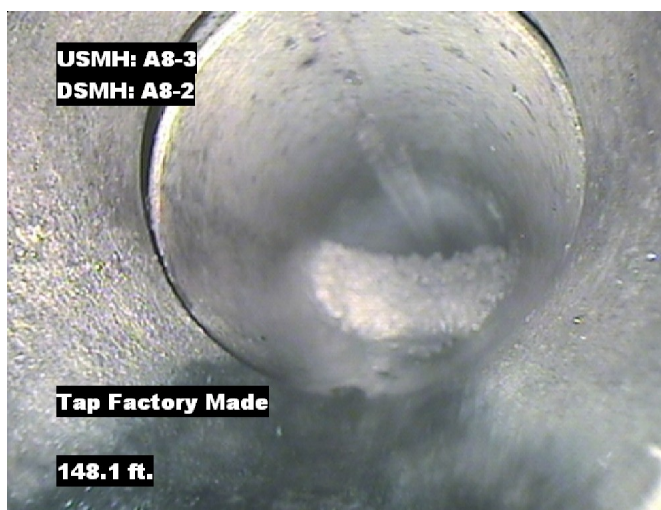
Distance: 148.1 ft. Grade: 0
Condition: Tap Factory Made
Remarks: N/A

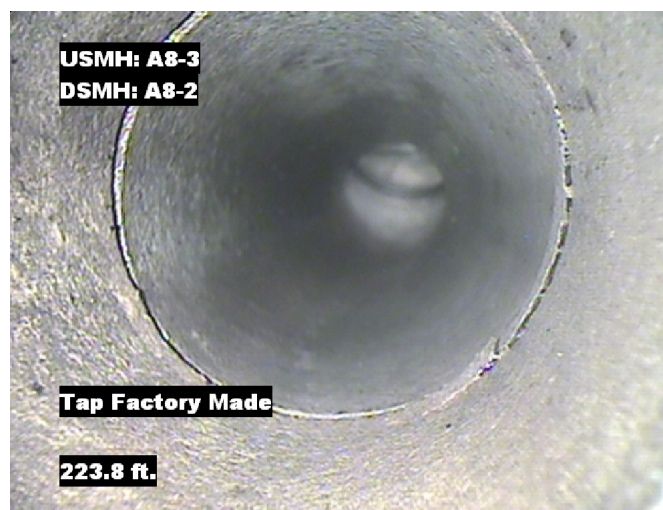
Distance: 223.8 ft. Grade: 0
Condition: Tap Factory Made
Remarks: N/A

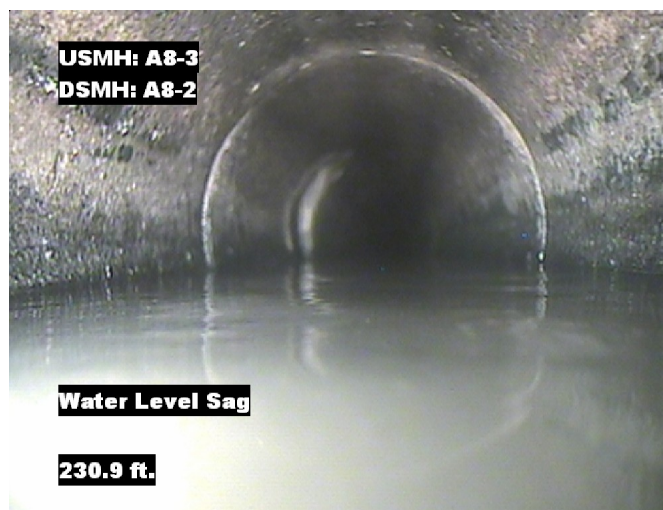
Distance: 230.9 ft. Grade: 3
Condition: Water Level Sag
Remarks: N/A

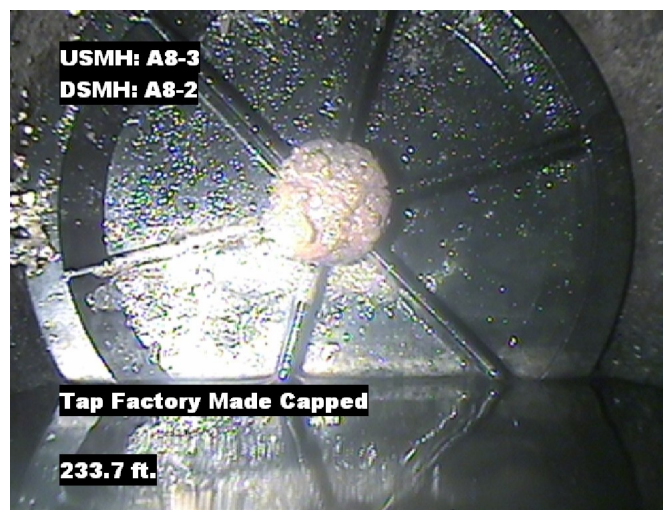
Distance: 233.7 ft. Grade: 0
Condition: Tap Factory Made Capped
Remarks: N/A

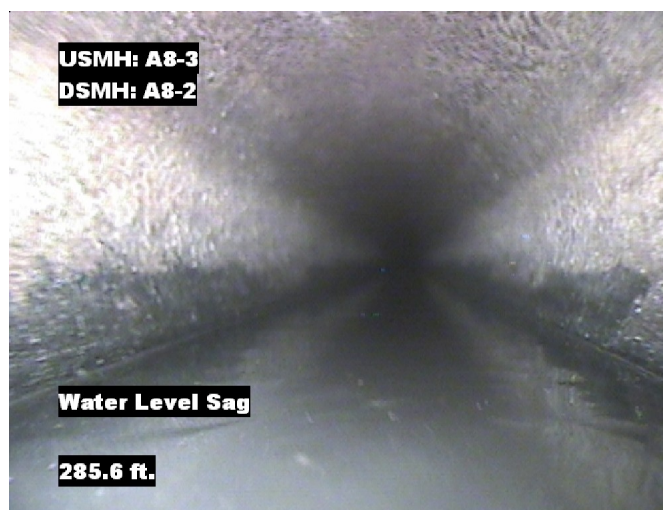
Distance: 285.5 ft. Grade: 2
Condition: Water Level Sag
Remarks: N/A

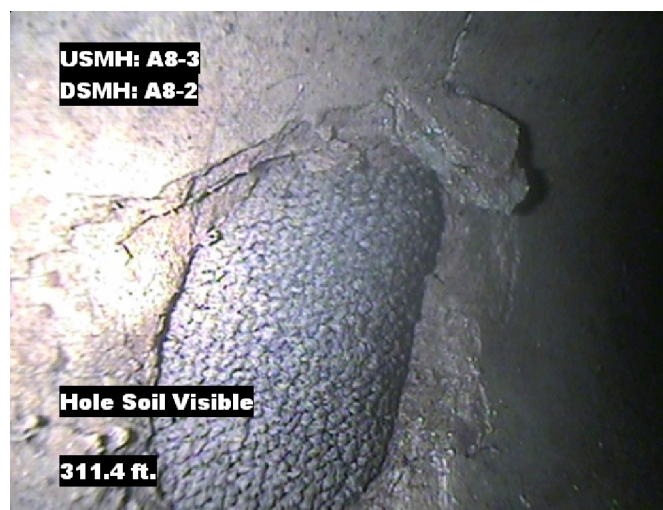
Distance: 311.4 ft. Grade: 5
Condition: Hole Soil Visible
Remarks: N/A

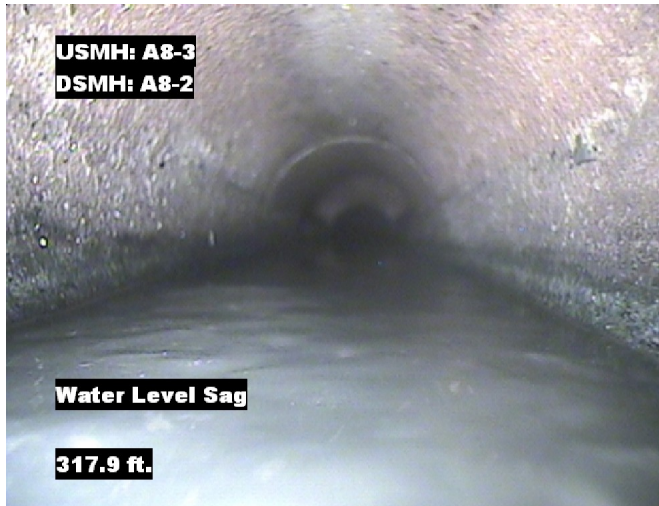
Distance: 317.9 ft. Grade: 2
Condition: Water Level Sag
Remarks: N/A

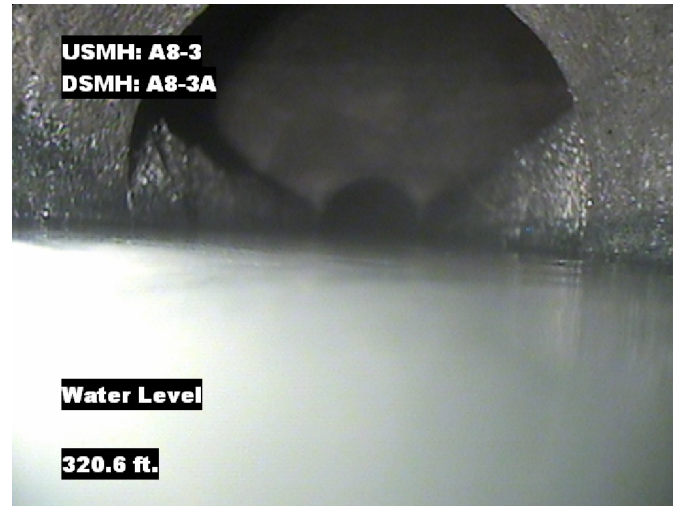
Distance: 320.6 ft. Grade: 0
Condition: Water Level
Remarks: N/A

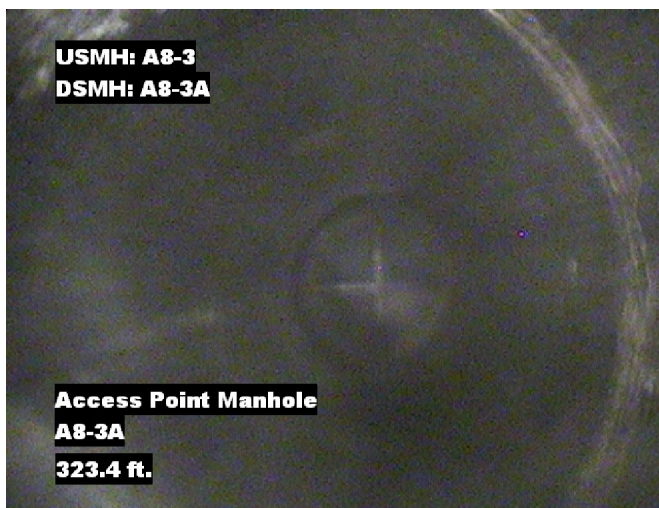
Distance: 323.4 ft. Grade: 0
Condition: Access Point Manhole
Remarks: A8-3A
