## Defect Listing

Pipe Segment Refere... <b>A8-3A_A8-2</b>	City <b>Oliver Springs</b>	Street <b>Main St</b>	Material <b>Fibreglass Reinforc...</b>	Location C... <b>Light High...</b>	Sewer Use <b>Sanitary</b>
Upstream MH <b>A8-3A</b>	Total Length <b>321.3</b>	Year Laid	Shape <b>Circular</b>	Location Details	
DS Manhole <b>A8-2</b>	Length surveyed <b>321.3</b>	Year Renewed	Height <b>8</b>	Width <b>8</b>	Pipe Joint... <b>N/A</b>

## Image Report 4/Page

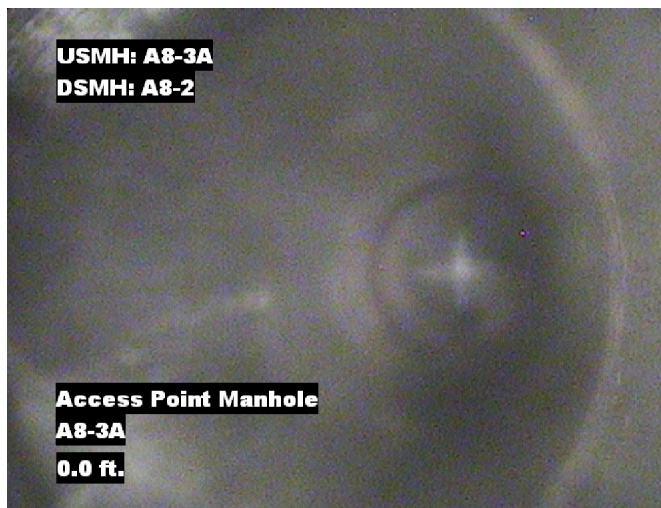
Distance: 0.0 ft. Grade: 0  
Condition: Access Point Manhole  
Remarks: A8-3A

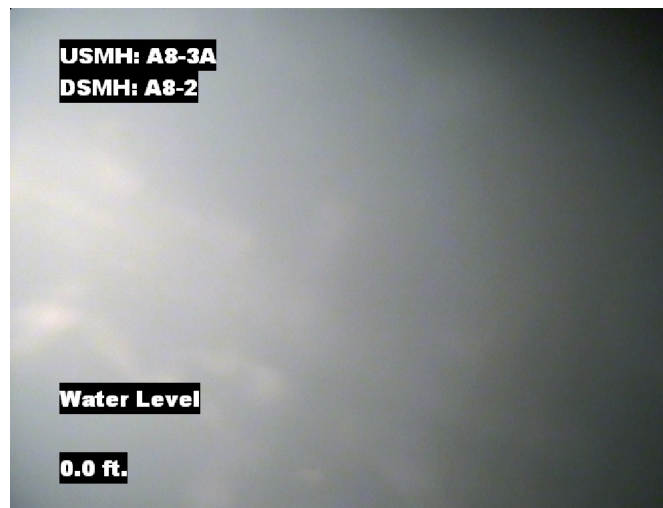
Distance: 0.0 ft. Grade: 0  
Condition: Water Level  
Remarks: N/A

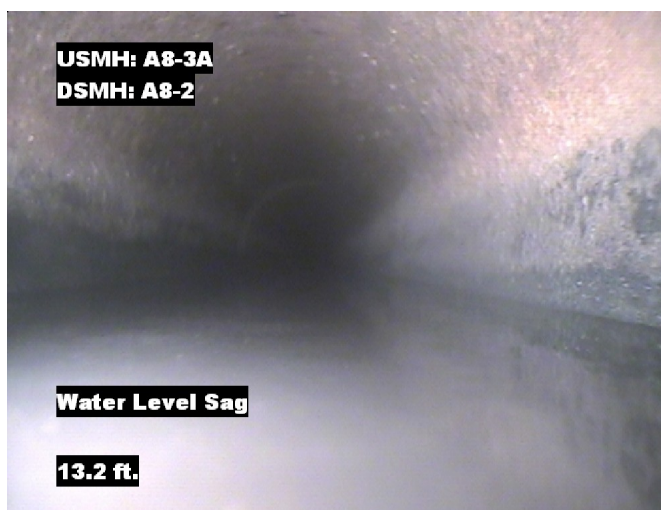
Distance: 13.2 ft. Grade: 2  
Condition: Water Level Sag  
Remarks: N/A

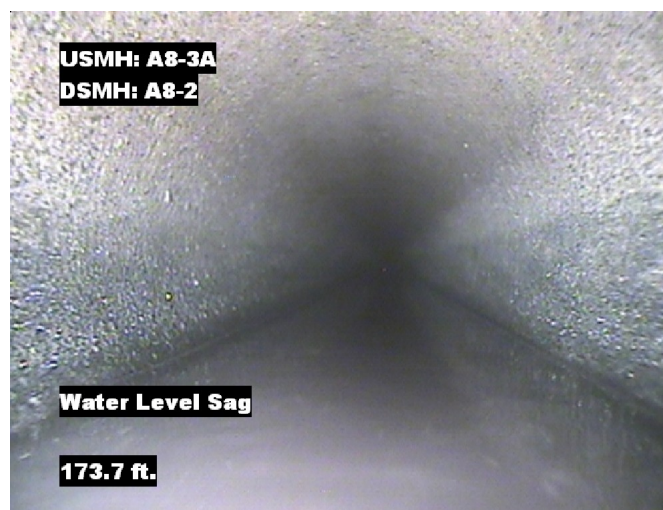
Distance: 173.7 ft. Grade: 2  
Condition: Water Level Sag  
Remarks: N/A

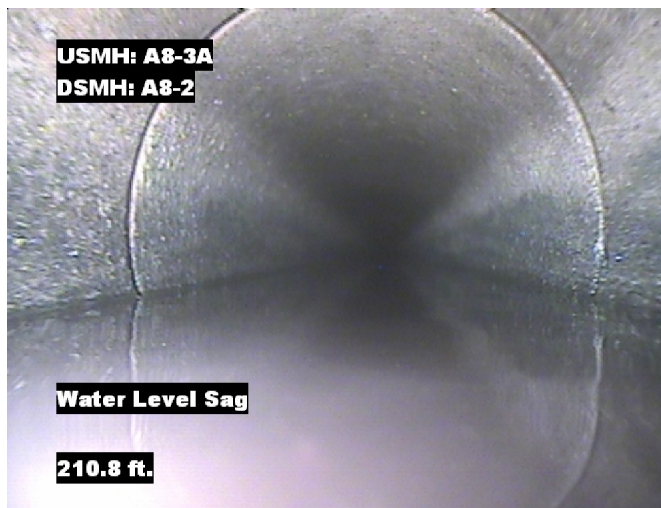
Distance: 210.8 ft. Grade: 2  
Condition: Water Level Sag  
Remarks: N/A

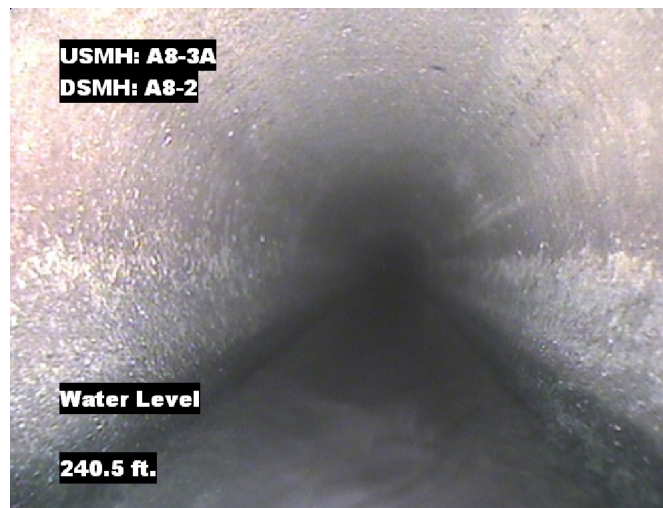
Distance: 240.5 ft. Grade: 0  
Condition: Water Level  
Remarks: N/A

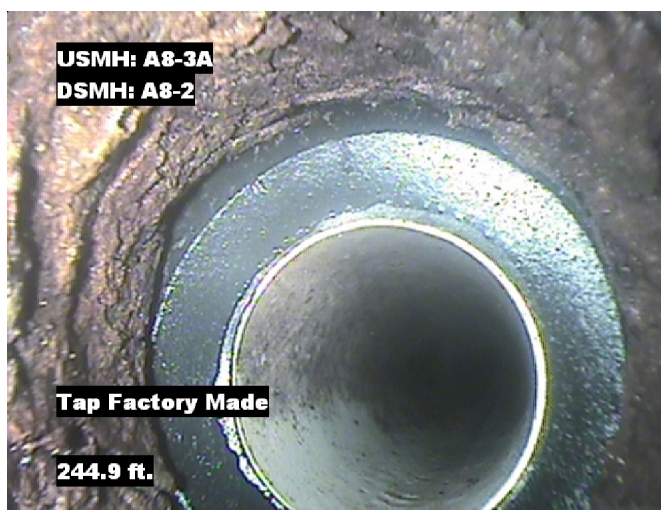
Distance: 244.9 ft. Grade: 0  
Condition: Tap Factory Made  
Remarks: N/A

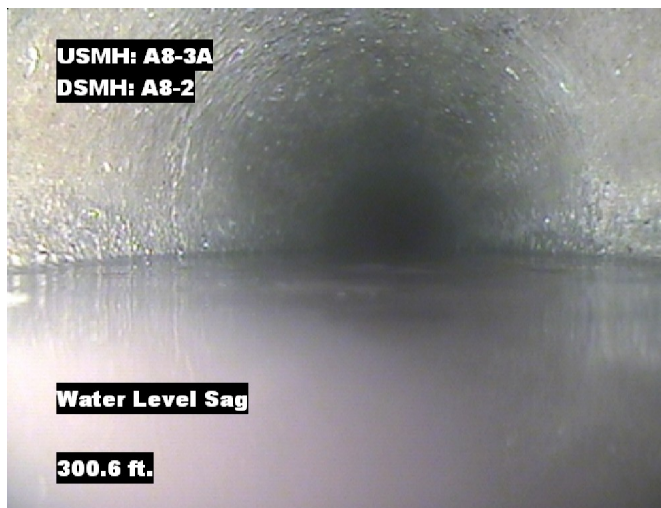
Distance: 300.6 ft. Grade: 3  
Condition: Water Level Sag  
Remarks: N/A

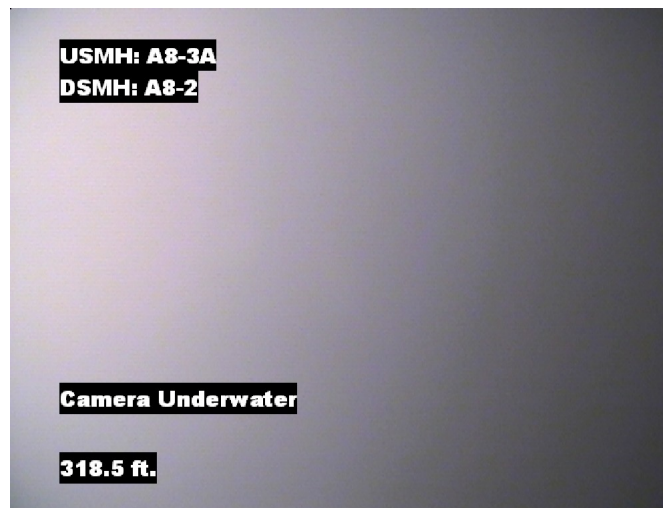
Distance: 318.5 ft. Grade: 4  
Condition: Camera Underwater  
Remarks: N/A
