## **Defect Listing**

Pipe Segment Refere		City		Street	Mat	Material		Sewer Use	
A8-4_	_A8-3	Oliver S	Springs	Main St	Concrete Pipe (non		Light High	Sanitary	
Upstream MH Total Length		Year Laid	Sh	Shape		Details			
A8	A8-4 210		6.1		Circ	cular			
DS Ma	anhole	Length s	urveyed	Year Renewed	Height	Height Width Pipe Joint			
A8	3-3	216.1			8	8	4		
SPR	N/A	MPR	N/A	PO Number			Customer		
0001	N1/A			4397-03		GRW			
SPRI	N/A	MPRI	N/A	Work Order		Purpose			
QSR	N/A	QMR	N/A	4397-02	Pre-Rehabilitation Su			urvey	
OF	PR	Survey	ved By	Direction	Date		Media label		
N/	<b>'</b> A	Barry_Rogers		Downstream	20150814				
OPRI		Certificate Number		Pre-Cleaning	Time		Weather		
N/	N/A U-1012-16405		Jetting	08:40		Dry			
		Date C	leaned		End Time		Additional Info		
		2015	0814	08:53

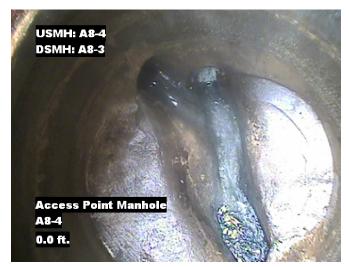
Distance: 0.0 ft. Grade: 0

Condition: Access Point Manhole

Remarks: A8-4

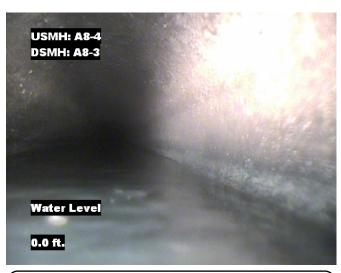
Distance: 0.0 ft. Grade: 0

Condition: Water Level

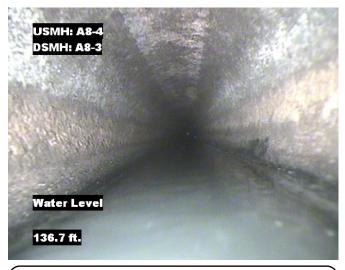
Distance: 136.6 ft. Grade: 0

Condition: Water Level

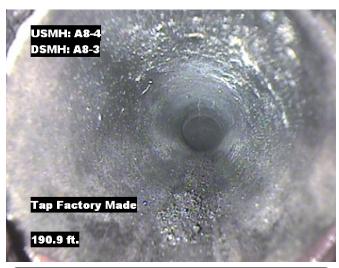
Distance: 190.9 ft. Grade:

Condition: Tap Factory Made

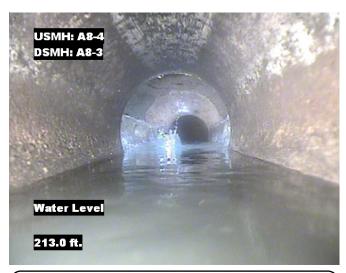
Distance: 213.0 ft. Grade: 0

Condition: Water Level

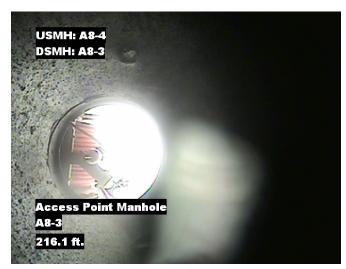
Distance: 216.1 ft. Grade: 0 Condition:

Access Point Manhole

Remarks: A8-3
