## Defect Listing

Pipe Segment Refere... <b>A8-4A_A8-4</b>	City <b>Oliver Springs</b>	Street <b>Main St</b>	Material <b>Concrete Pipe (non-...</b>	Location C... <b>Light High...</b>	Sewer Use <b>Sanitary</b>
Upstream MH <b>A8-4A</b>	Total Length <b>189.7</b>	Year Laid	Shape <b>Circular</b>	Location Details	
DS Manhole <b>A8-4</b>	Length surveyed <b>189.7</b>	Year Renewed	Height <b>8</b>	Width <b>8</b>	Pipe Joint... <b>4</b>

SPR <b>N/A</b>	MPR <b>4</b>	PO Number <b>4397-03</b>	Customer <b>GRW</b>
SPRI <b>N/A</b>	MPRI <b>2</b>	Work Order <b>4397-02</b>	Purpose <b>Pre-Rehabilitation Survey</b>
QSR <b>N/A</b>	QMR <b>2200</b>		
OPR <b>4</b>	Surveyed By <b>Barry Rogers</b>	Direction <b>Downstream</b>	Date <b>20150813</b>
OPRI <b>2</b>	Certificate Number <b>U-1012-16405</b>	Pre-Cleaning <b>Jetting</b>	Time <b>12:46</b>
	Date Cleaned <b>20150813</b>	End Time <b>12:54</b>	Weather <b>Dry</b>
			Additional Info

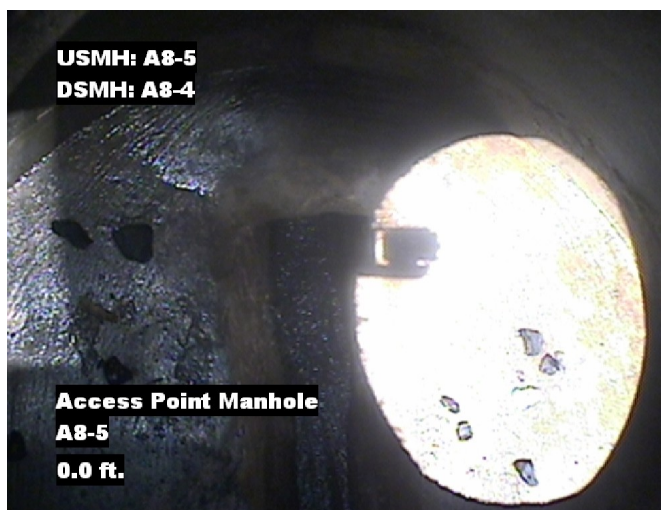
Distance: 0.0 ft. Grade: 0  
Condition: Access Point Manhole  
Remarks: A8-4A

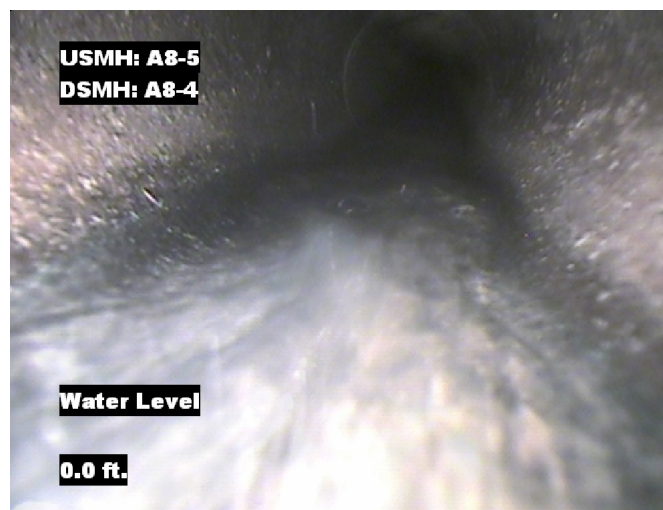
Distance: 0.0 ft. Grade: 0  
Condition: Water Level  
Remarks: N/A

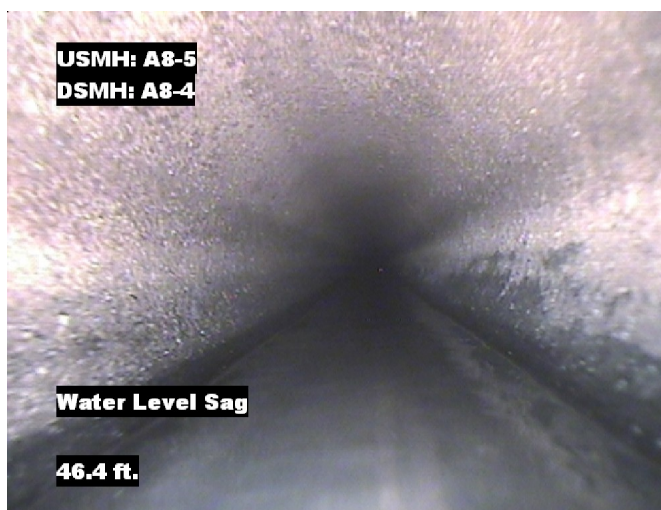
Distance: 46.4 ft. Grade: 2  
Condition: Water Level Sag  
Remarks: N/A

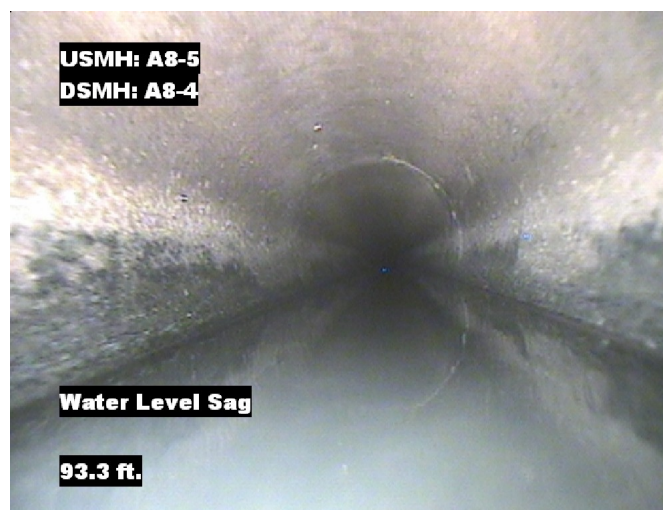
Distance: 93.2 ft. Grade: 2  
Condition: Water Level Sag  
Remarks: N/A

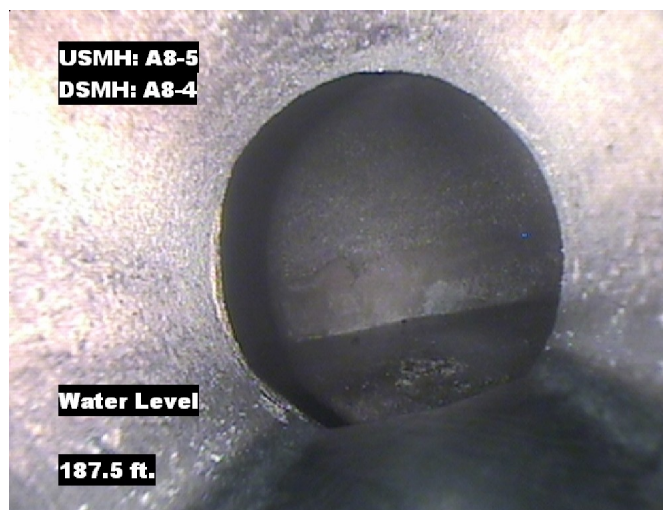
Distance: 187.5 ft.      Grade: 0  
Condition: Water Level  
Remarks: N/A

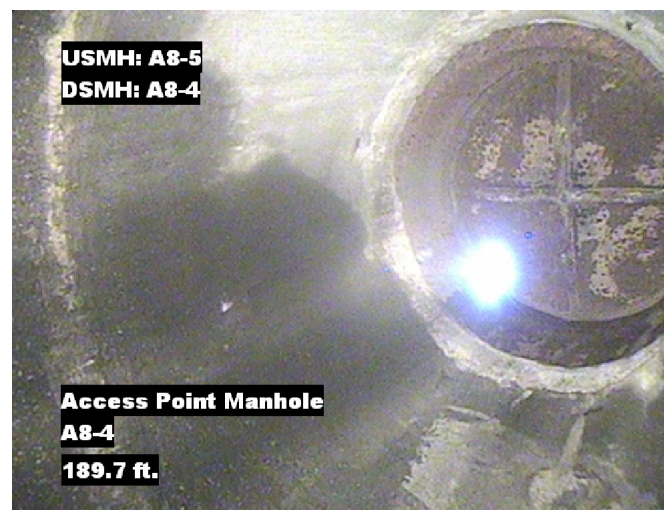
Distance: 189.7 ft.      Grade: 0  
Condition: Access Point Manhole  
Remarks: A8-4
