Defect Listing

Pipe Segment Refere... A8-5_A8-4A	City Oliver Springs	Street Main St	Material Concrete Pipe (non-...	Location C... Light High...	Sewer Use Sanitary
Upstream MH A8-5	Total Length 126.1	Year Laid	Shape Circular	Location Details	
DS Manhole A8-4A	Length surveyed 126.1	Year Renewed	Height 8	Width 8	Pipe Joint... 4

SPR N/A	MPR 7	PO Number 4397-03	Customer GRW
SPRI N/A	MPRI 2.3	Work Order 4397-02	Purpose Pre-Rehabilitation Survey
QSR N/A	QMR 3122		
OPR 7	Surveyed By Barry Rogers	Direction Downstream	Date 20150813
OPRI 2.3	Certificate Number U-1012-16405	Pre-Cleaning No Pre-Cleaning	Time 12:08
	Date Cleaned	End Time 12:18	Weather Very Dry
			Media label
			Additional Info

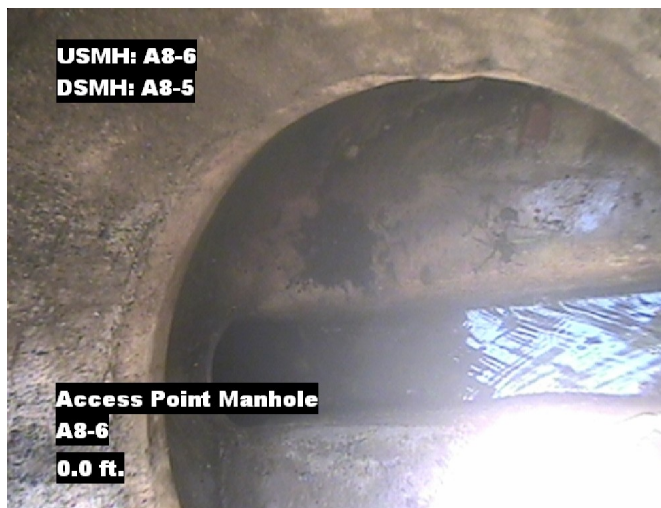
Distance: 0.0 ft. Grade: 0
Condition: Access Point Manhole
Remarks: A8-5

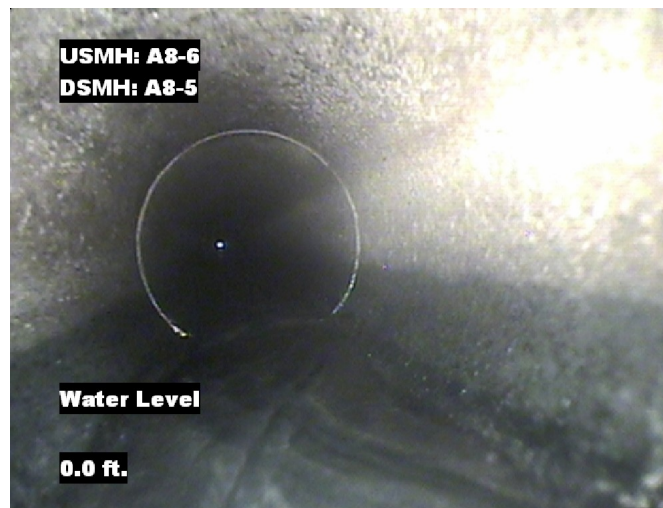
Distance: 0.0 ft. Grade: 0
Condition: Water Level
Remarks: N/A

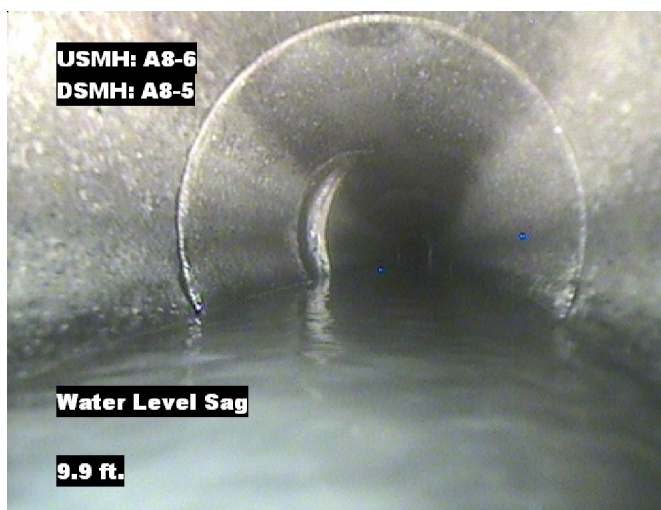
Distance: 9.9 ft. Grade: 2
Condition: Water Level Sag
Remarks: N/A

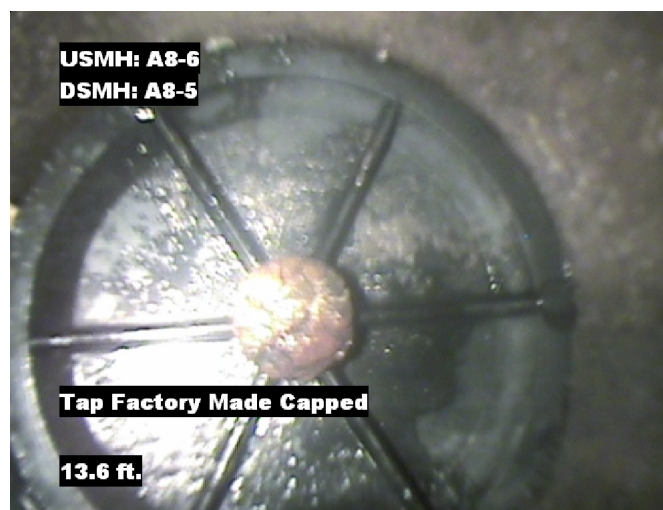
Distance: 13.6 ft. Grade: 0
Condition: Tap Factory Made Capped
Remarks: N/A

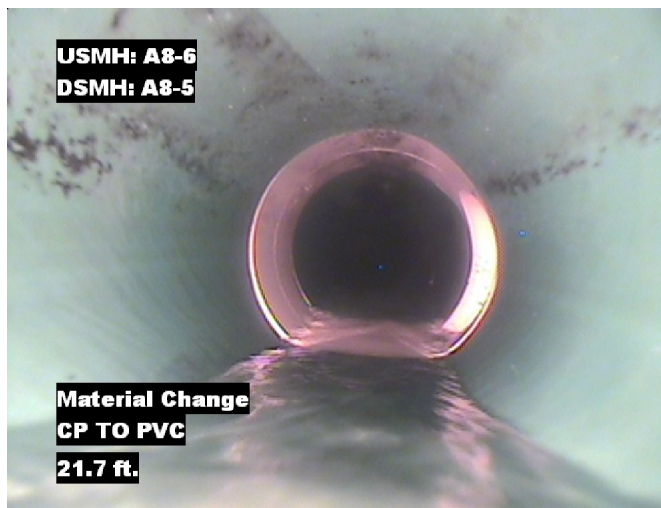
Distance: 21.7 ft. Grade: 0
Condition: Material Change
Remarks: CP TO PVC

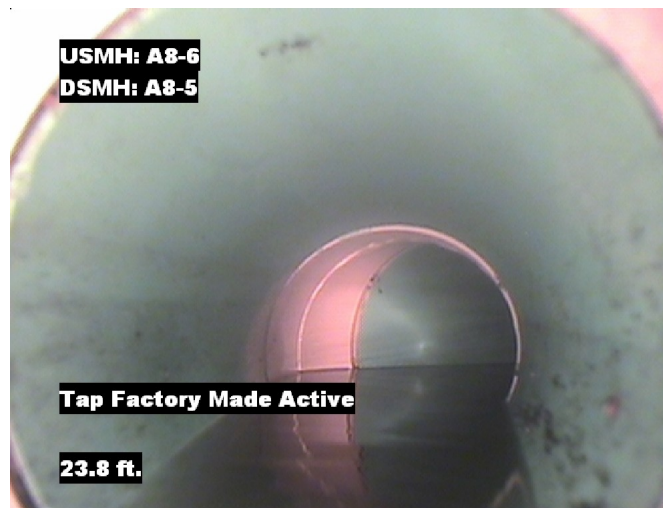
Distance: 23.8 ft. Grade: 0
Condition: Tap Factory Made Active
Remarks: N/A

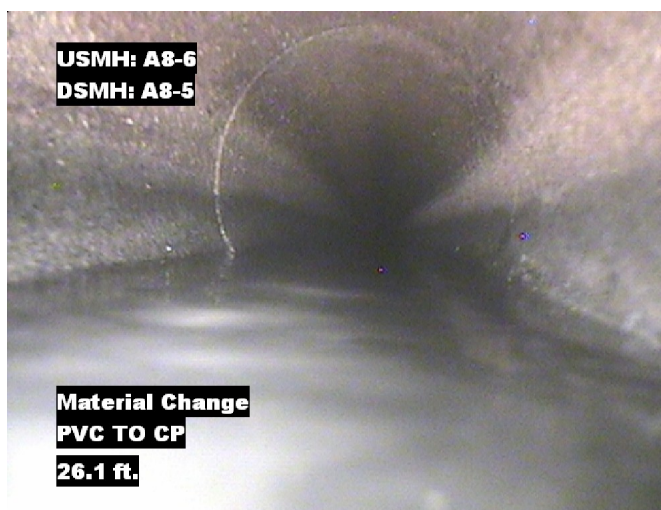
Distance: 26.1 ft. Grade: 0
Condition: Material Change
Remarks: PVC TO CP

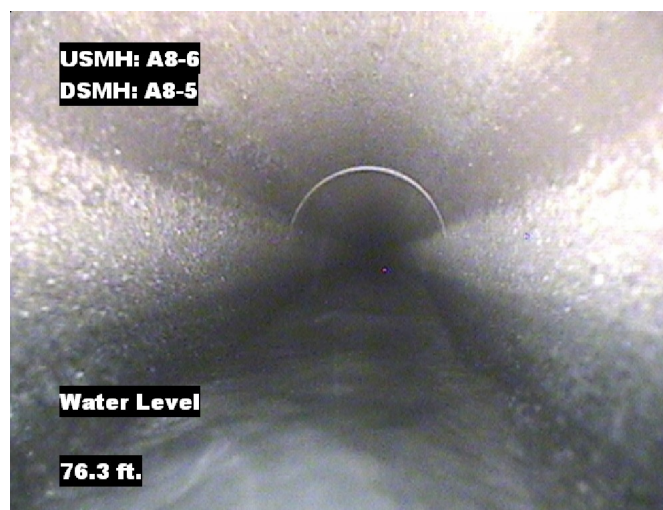
Distance: 76.3 ft. Grade: 0
Condition: Water Level
Remarks: N/A

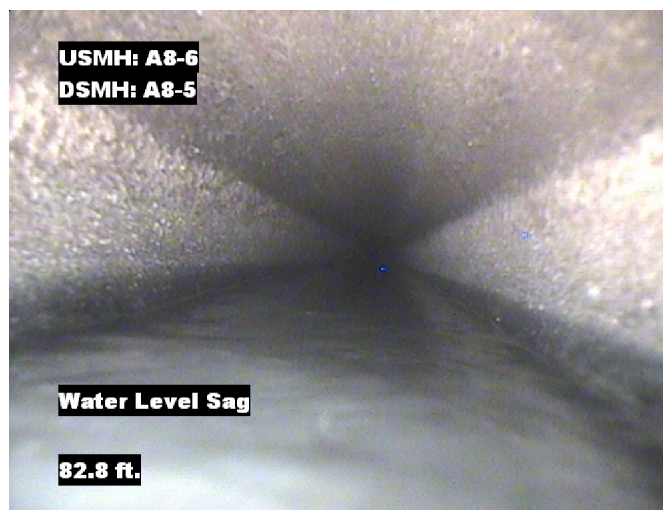
Distance: 82.8 ft. Grade: 2
Condition: Water Level Sag
Remarks: N/A

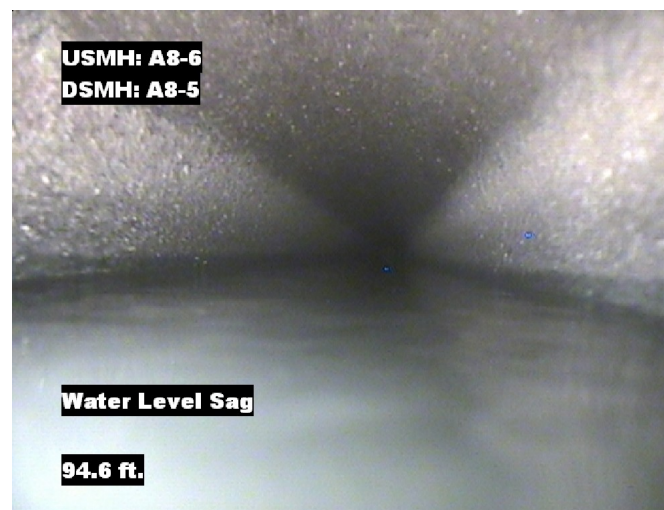
Distance: 94.6 ft. Grade: 3
Condition: Water Level Sag
Remarks: N/A

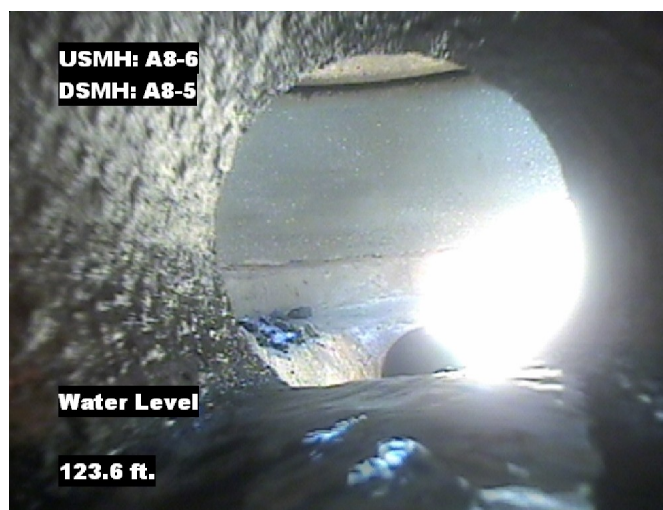
Distance: 123.6 ft. Grade: 0
Condition: Water Level
Remarks: N/A
