## Defect Listing

Pipe Segment Refere...	City	Street	Material	Location C...	Sewer Use
<b>A8-6_A8-5</b>	<b>Oliver Springs</b>	<b>Main St</b>	<b>Concrete Pipe (non-...</b>	<b>Light High...</b>	<b>Sanitary</b>
Upstream MH	Total Length	Year Laid	Shape	Location Details	
<b>A8-6</b>	<b>371</b>		<b>Circular</b>		
DS Manhole	Length surveyed	Year Renewed	Height	Width	Pipe Joint...
<b>A8-5</b>	<b>371</b>		<b>8</b>	<b>8</b>	<b>4</b>

SPR	N/A	MPR	18	PO Number		Customer	
SPRI	N/A	MPRI	2.3	4397-03		GRW	
QSR	N/A	QMR	3226	Work Order		Purpose	
				4397-02		Pre-Rehabilitation Survey	
OPR		Surveyed By		Direction		Date	
18		Barry_Rogers		Downstream		20150813	
OPRI		Certificate Number		Pre-Cleaning		Weather	
2.3		U-1012-16405		Heavy Cleaning		Dry	
Date Cleaned				End Time		Additional Info	
20150813				09:53

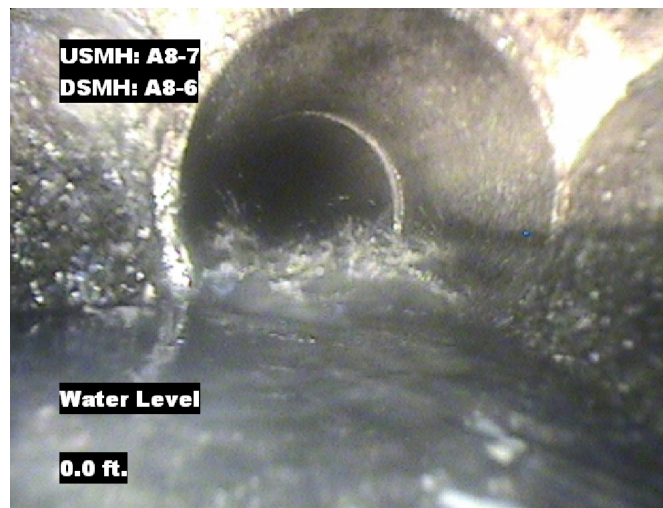
Distance: 0.0 ft. Grade: 0  
Condition: Water Level  
Remarks: N/A

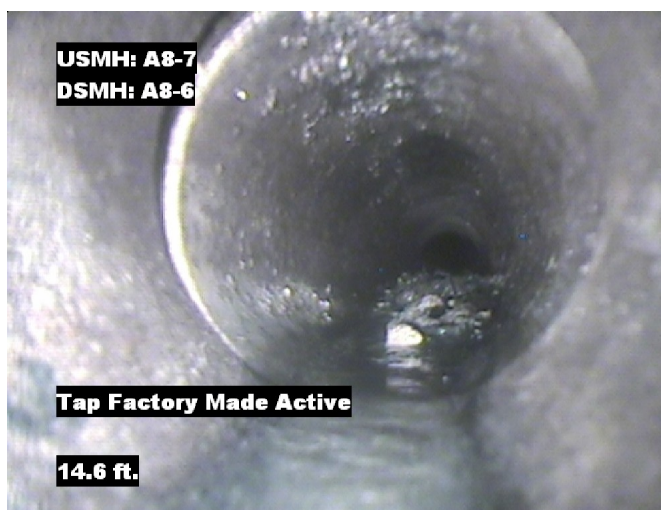
Distance: 14.6 ft. Grade: 0  
Condition: Tap Factory Made Active  
Remarks: N/A

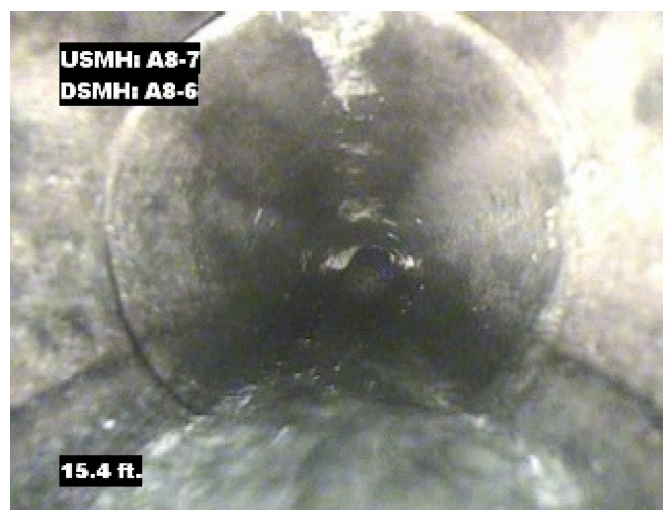
Distance: 15.4 ft. Grade: 2  
Condition: Deposits Attached Grease  
Remarks: N/A

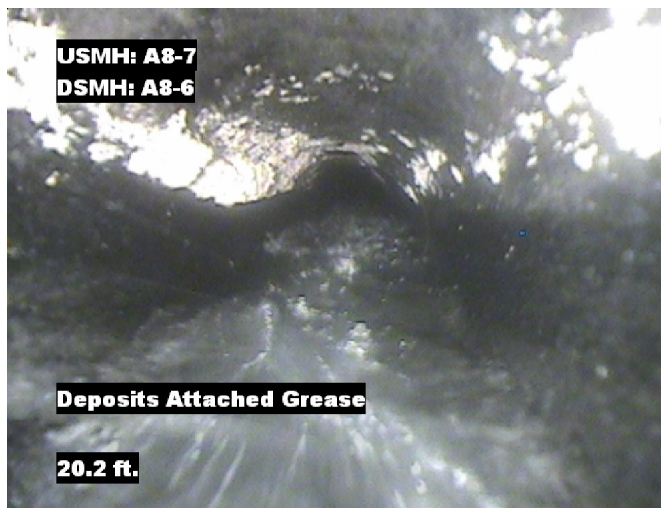
Distance: 20.2 ft. Grade: 2  
Condition: Deposits Attached Grease  
Remarks: N/A

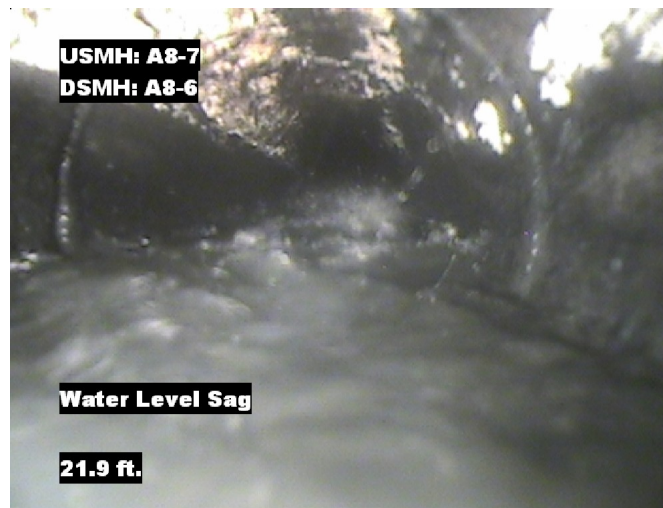
Distance: 21.9 ft. Grade: 2  
Condition: Water Level Sag  
Remarks: N/A

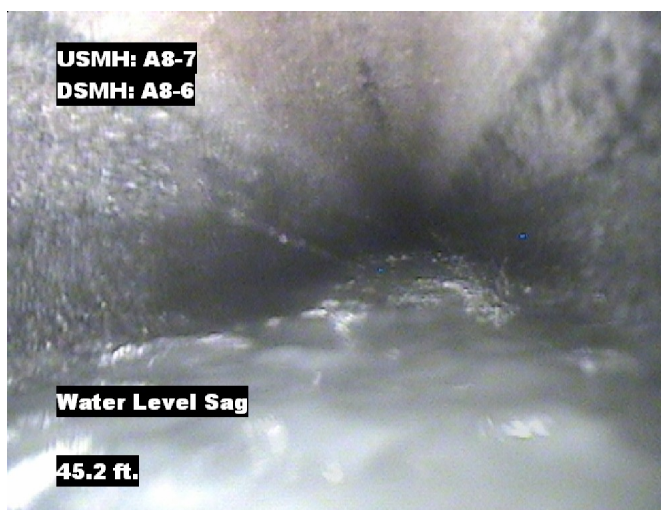
Distance: 45.1 ft. Grade: 2  
Condition: Water Level Sag  
Remarks: N/A

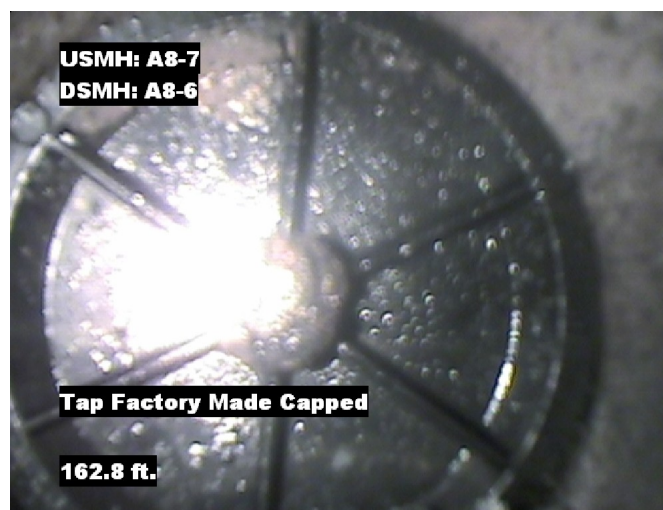
Distance: 162.8 ft. Grade: 0  
Condition: Tap Factory Made Capped  
Remarks: N/A

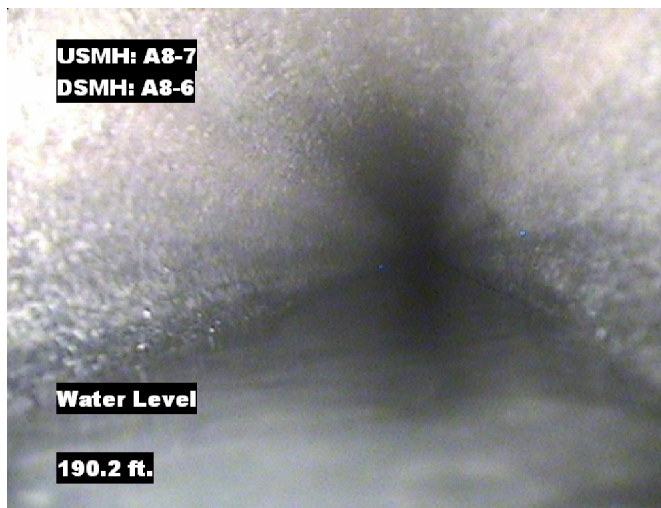
Distance: 190.2 ft. Grade: 0  
Condition: Water Level  
Remarks: N/A

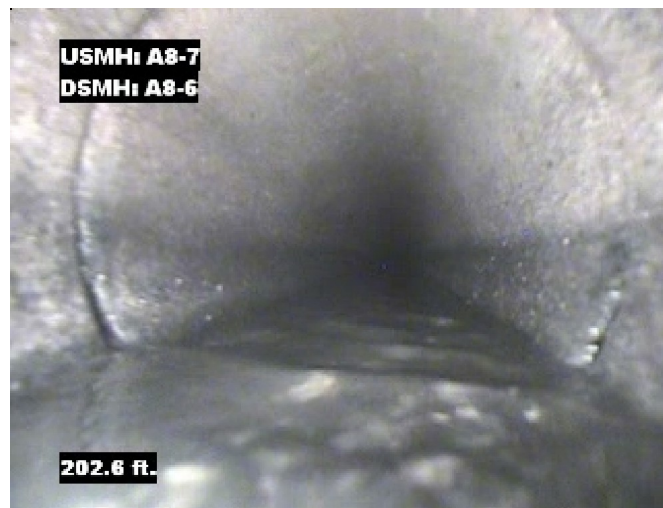
Distance: 202.6 ft. Grade: 2  
Condition: Deposits Settled Gravel  
Remarks: N/A

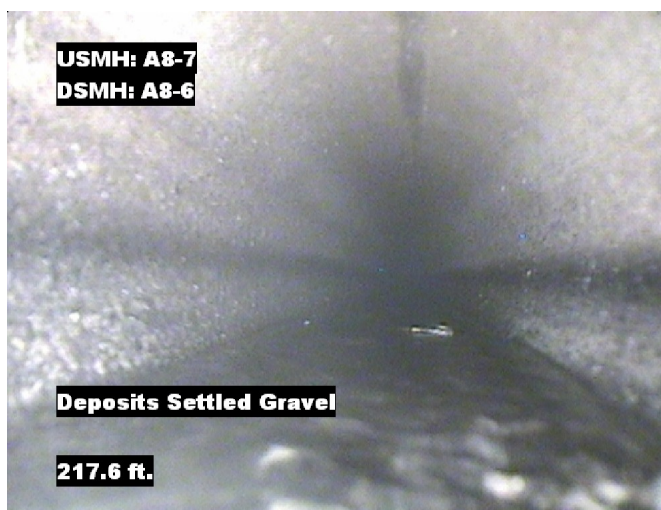
Distance: 217.6 ft. Grade: 3  
Condition: Deposits Settled Gravel  
Remarks: N/A

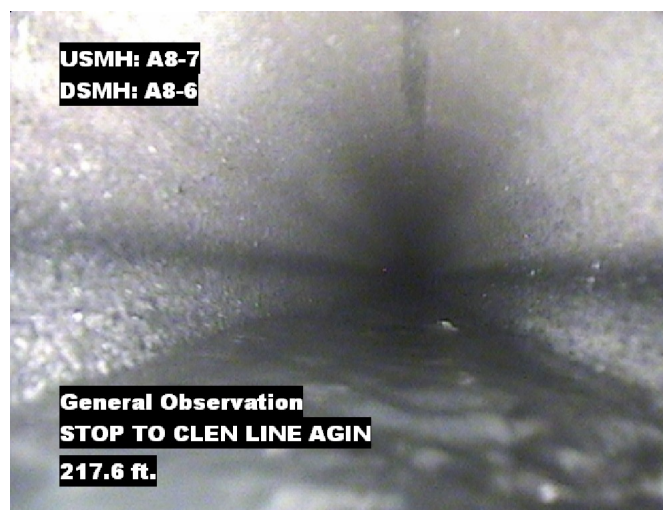
Distance: 217.6 ft. Grade: 0  
Condition: General Observation  
Remarks: STOP TO CLEN LINE AGIN

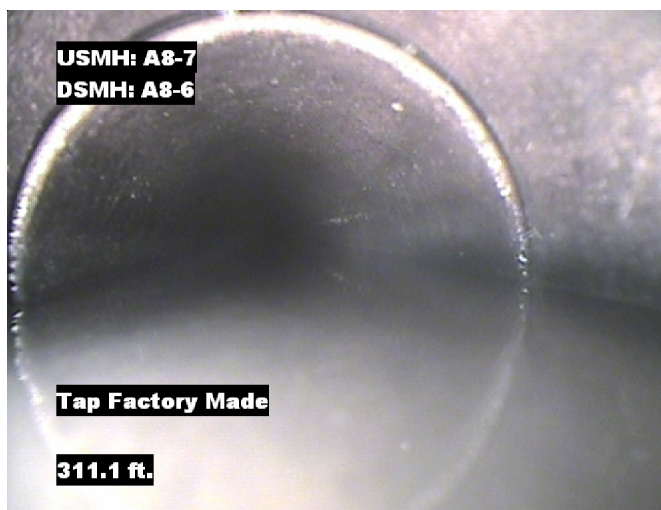
Distance: 311.1 ft. Grade: 0  
Condition: Tap Factory Made  
Remarks: N/A

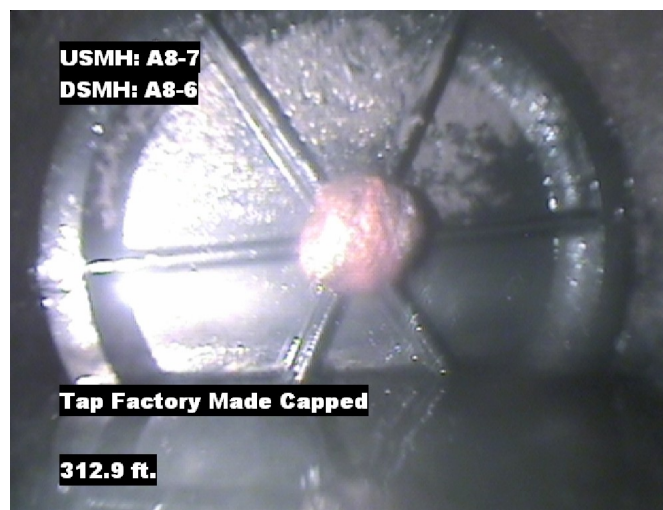
Distance: 312.9 ft. Grade: 0  
Condition: Tap Factory Made Capped  
Remarks: N/A

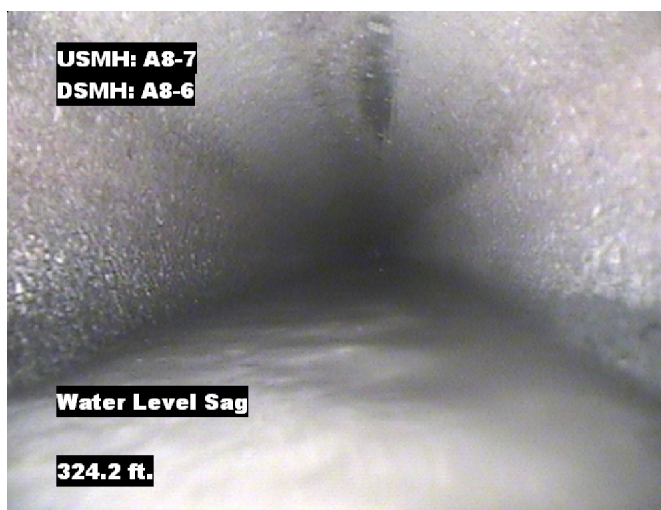
Distance: 324.2 ft. Grade: 2  
Condition: Water Level Sag  
Remarks: N/A

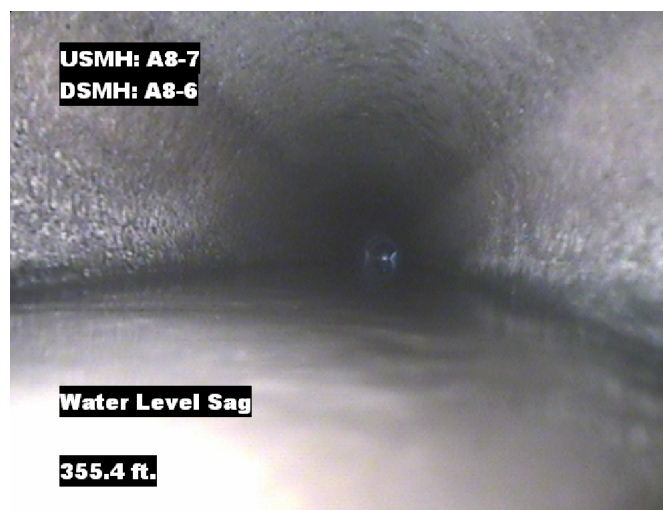
Distance: 355.4 ft. Grade: 3  
Condition: Water Level Sag  
Remarks: N/A

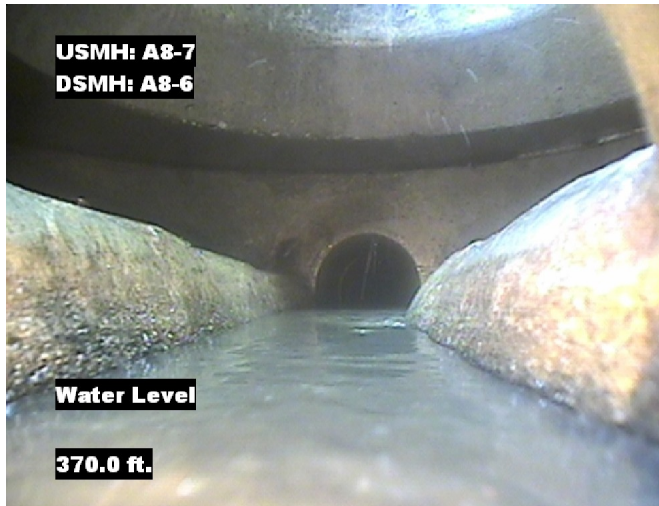
Distance: 370.0 ft. Grade: 0  
Condition: Water Level  
Remarks: N/A
