Defect Listing

Pipe Segment Refere... A8-7_A8-6	City Oliver Springs	Street Main St	Material Fibreglass Reinforc...	Location C... Light High...	Sewer Use Sanitary
Upstream MH A8-7	Total Length 40.1	Year Laid	Shape Circular	Location Details	
DS Manhole A8-6	Length surveyed 40.1	Year Renewed	Height 8	Width 8	Pipe Joint... N/A

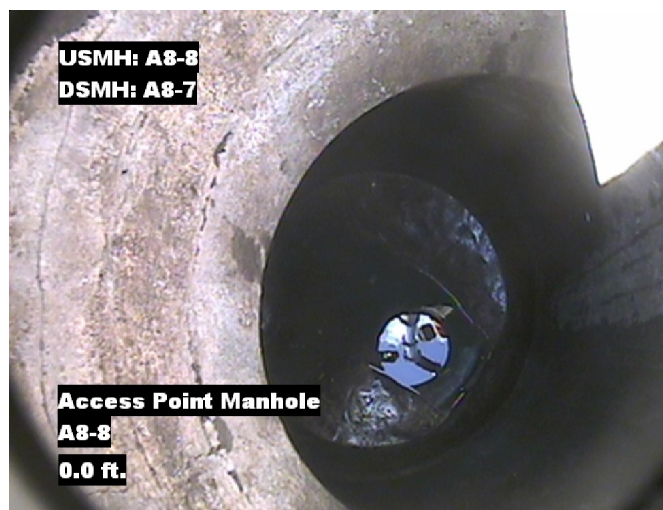
Distance: 0.0 ft. Grade: 0
Condition: Access Point Manhole
Remarks: A8-7

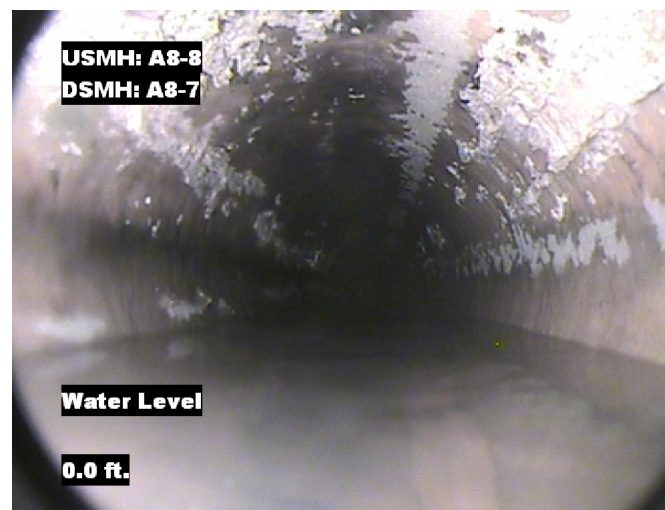
Distance: 0.0 ft. Grade: 0
Condition: Water Level
Remarks: N/A

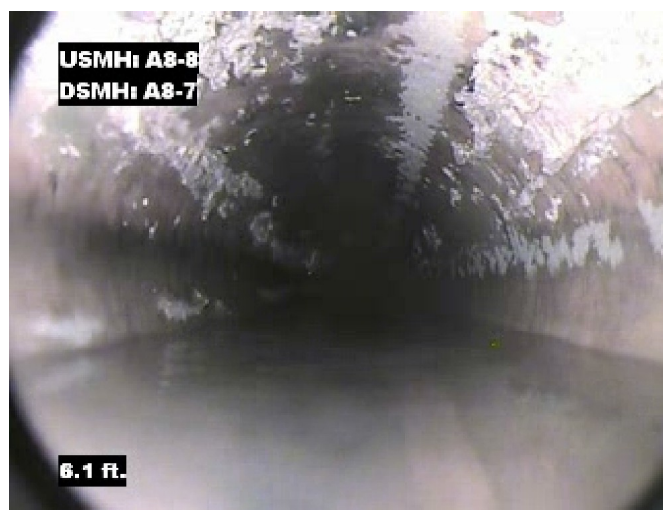
Distance: 6.1 ft. Grade: 2
Condition: Deposits Attached Grease
Remarks: This is a continious defect

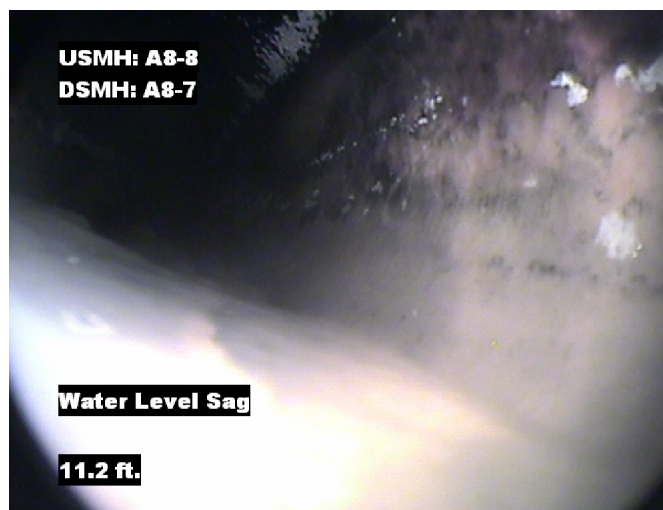
Distance: 11.2 ft. Grade: 2
Condition: Water Level Sag
Remarks: N/A

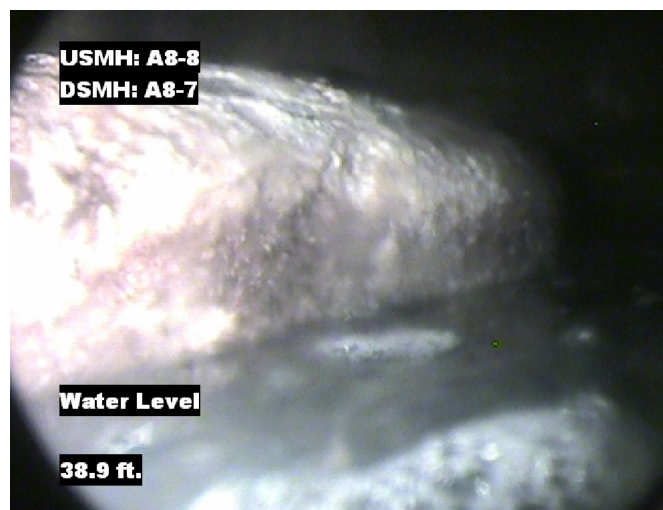
Distance: 38.9 ft. Grade: 0
Condition: Water Level
Remarks: N/A

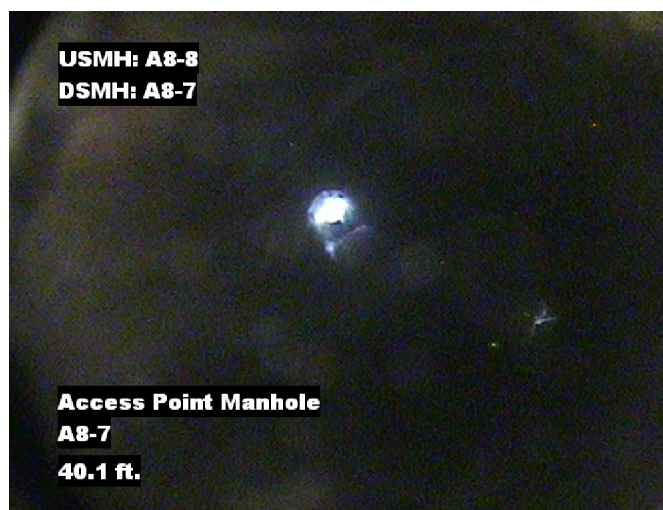
Distance: 40.1 ft. Grade: 0
Condition: Access Point Manhole
Remarks: A8-6
