Defect Listing

Pipe Segment Refere... A8-9_A8-8	City Oliver Springs	Street RAILROAD RD	Material Fibreglass Reinforc...	Location C... Light High...	Sewer Use Sanitary
Upstream MH A8-9	Total Length 230.8	Year Laid	Shape Circular	Location Details	
DS Manhole A8-8	Length surveyed 230.8	Year Renewed	Height 8	Width 8	Pipe Joint... N/A

SPR 5	MPR 21	PO Number 4397-03	Customer GRW
SPRI 2.5	MPRI 2.6	Work Order 4397-02	Purpose Pre-Rehabilitation Survey
QSR 3121	QMR 5133		
OPR 26	Surveyed By Barry Rogers	Direction Downstream	Date 20150731
OPRI 2.6	Certificate Number U-1012-16405	Pre-Cleaning Jetting	Time 10:41
	Date Cleaned 20150731	End Time 11:03	Weather Dry
			Additional Info

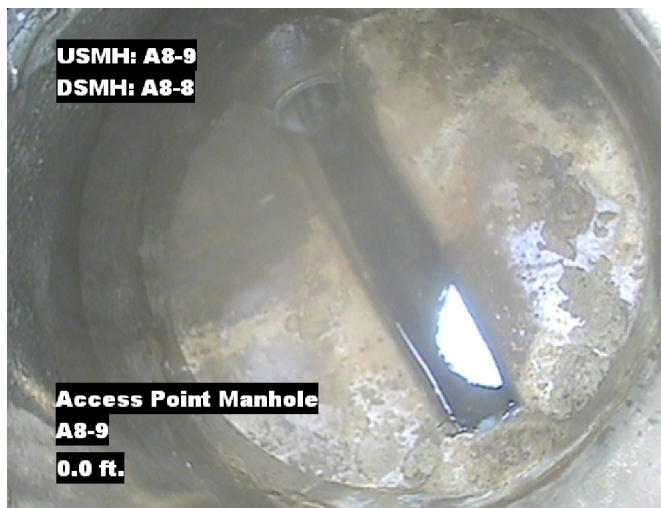
Distance: 0.0 ft. Grade: 0
Condition: Access Point Manhole
Remarks: A8-9

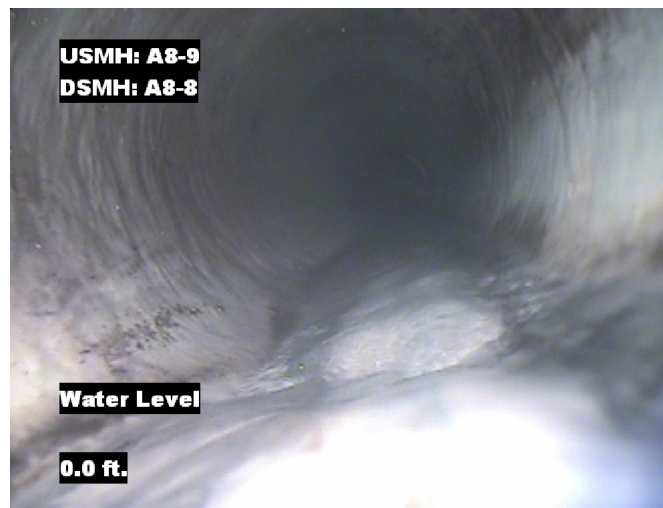
Distance: 0.0 ft. Grade: 0
Condition: Water Level
Remarks: N/A

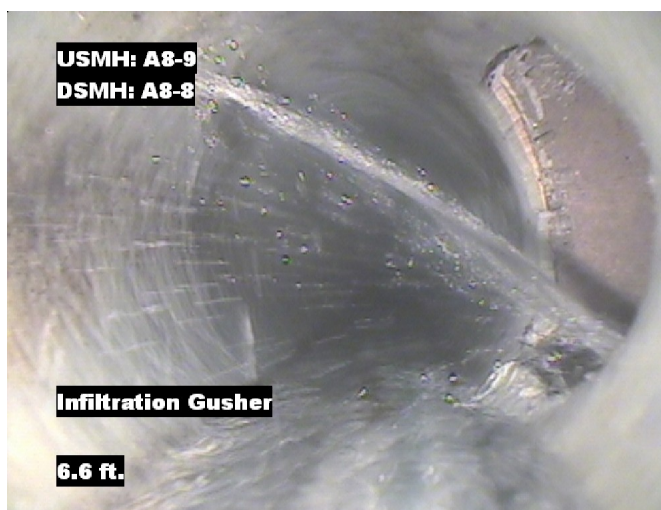
Distance: 6.6 ft. Grade: 5
Condition: Infiltration Gusher
Remarks: N/A

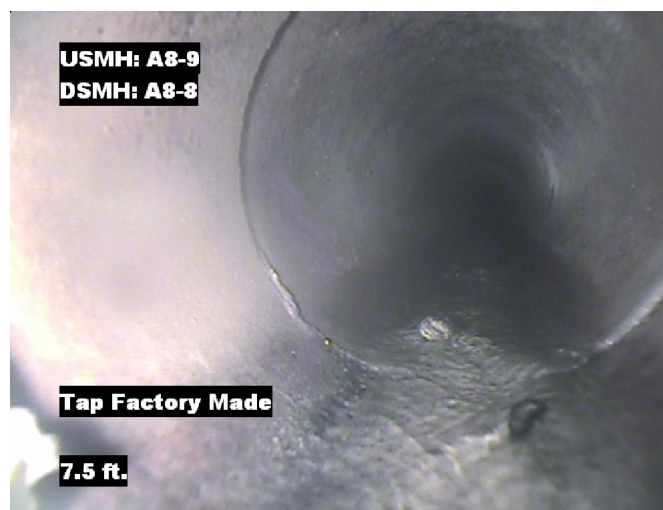
Distance: 7.5 ft. Grade: 0
Condition: Tap Factory Made
Remarks: N/A

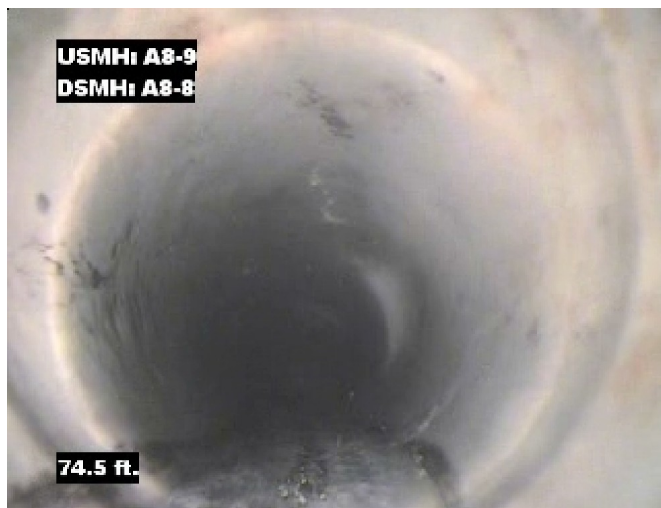
Distance: 74.5 ft. Grade: 2
Condition: Joint Angular Large
Remarks: N/A

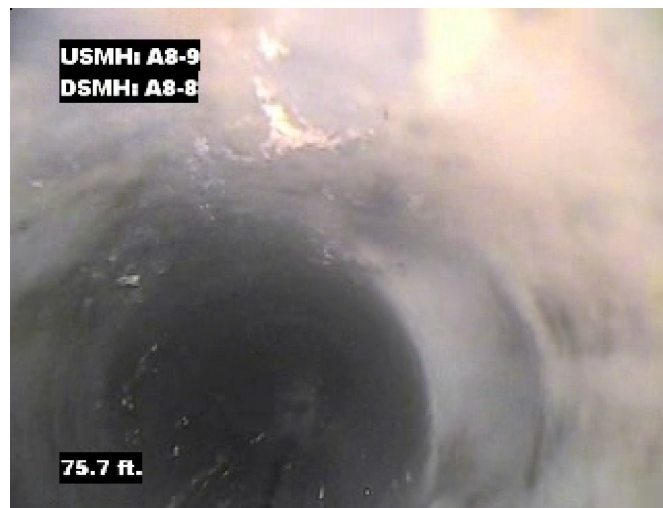
Distance: 75.8 ft. Grade: 3
Condition: Lining Failure Buckled
Remarks: N/A

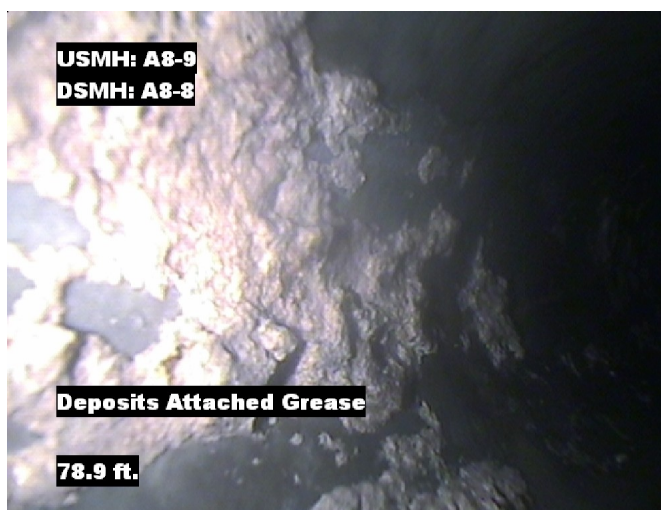
Distance: 78.9 ft. Grade: 2
Condition: Deposits Attached Grease
Remarks: N/A

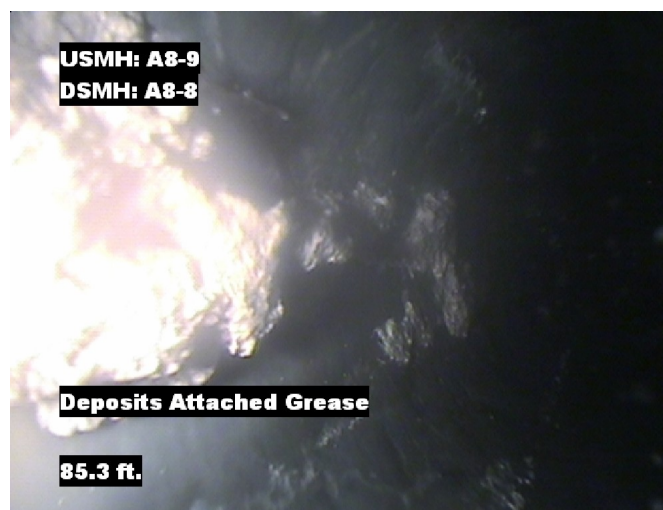
Distance: 85.3 ft. Grade: 2
Condition: Deposits Attached Grease
Remarks: N/A

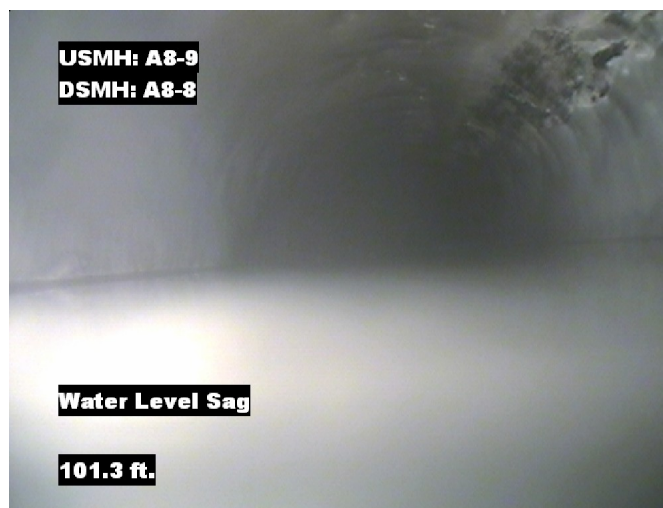
Distance: 101.3 ft. Grade: 3
Condition: Water Level Sag
Remarks: N/A

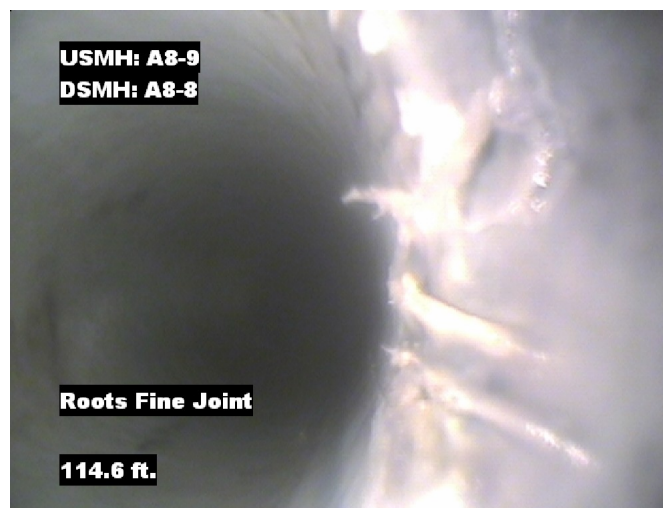
Distance: 114.6 ft. Grade: 1
Condition: Roots Fine Joint
Remarks: N/A

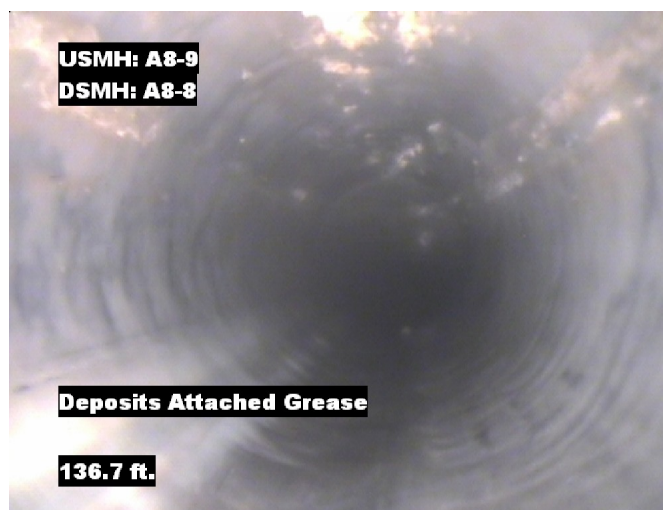
Distance: 136.7 ft. Grade: 2
Condition: Deposits Attached Grease
Remarks: N/A

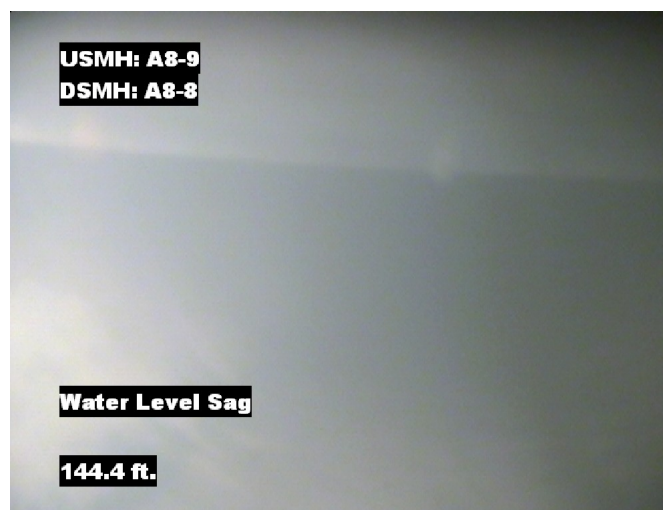
Distance: 144.4 ft. Grade: 3
Condition: Water Level Sag
Remarks: N/A

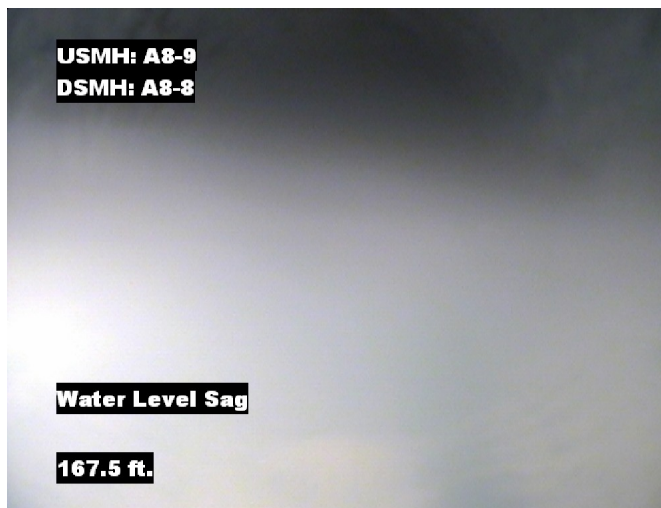
Distance: 167.4 ft. Grade: 3
Condition: Water Level Sag
Remarks: N/A

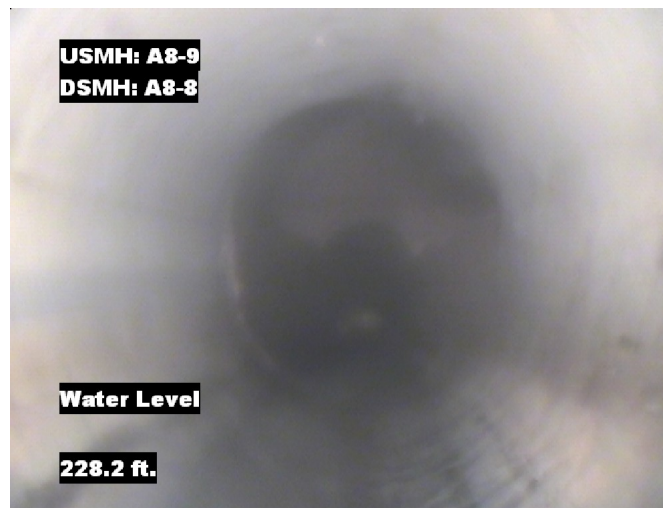
Distance: 228.2 ft. Grade: 0
Condition: Water Level
Remarks: N/A

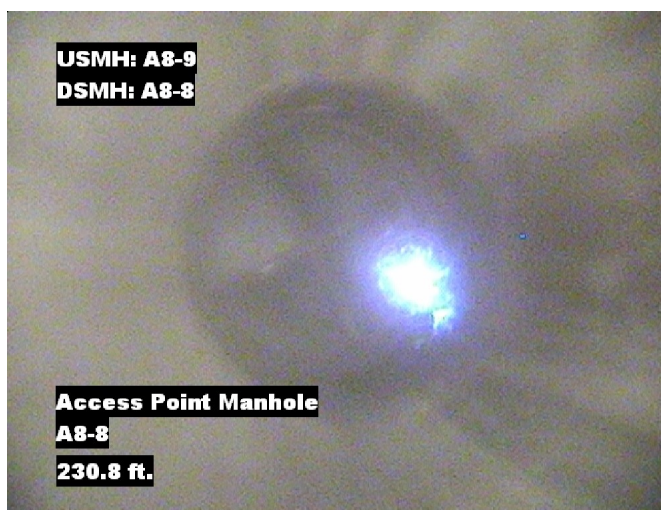
Distance: 230.8 ft. Grade: 0
Condition: Access Point Manhole
Remarks: A8-8
