## Defect Listing

Pipe Segment Refere...	City	Street	Material	Location C...	Sewer Use
<b>A9-1_A8-2</b>	<b>Oliver Springs</b>	<b>Central Ave</b>	<b>Concrete Pipe (non-...</b>	<b>Light High...</b>	<b>Sanitary</b>
Upstream MH	Total Length	Year Laid	Shape	Location Details	
<b>A9-1</b>	<b>207.1</b>		<b>Circular</b>		
DS Manhole	Length surveyed	Year Renewed	Height	Width	Pipe Joint...
<b>A8-2</b>	<b>207.1</b>		<b>8</b>	<b>8</b>	<b>4</b>

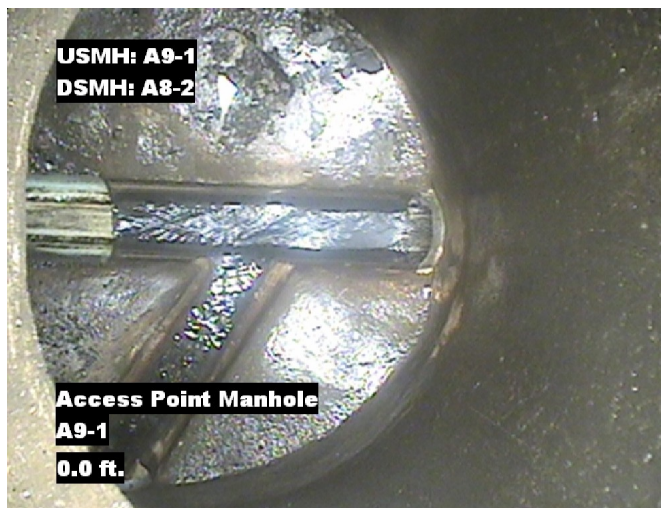
Distance: 0.0 ft. Grade: 0  
Condition: Access Point Manhole  
Remarks: A9-1

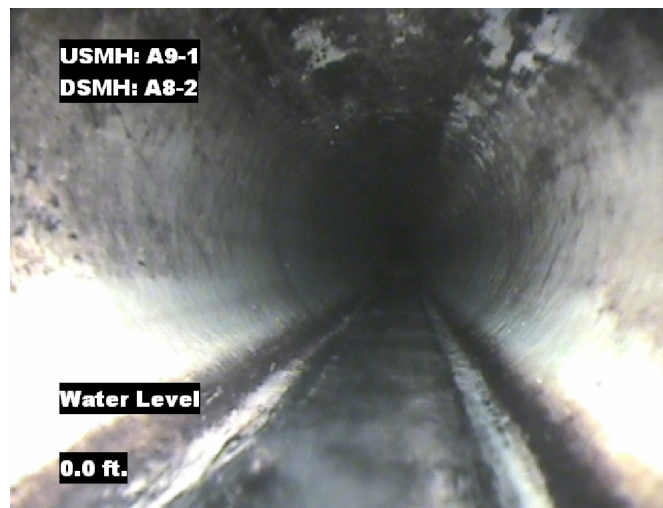
Distance: 0.0 ft. Grade: 0  
Condition: Water Level  
Remarks: N/A

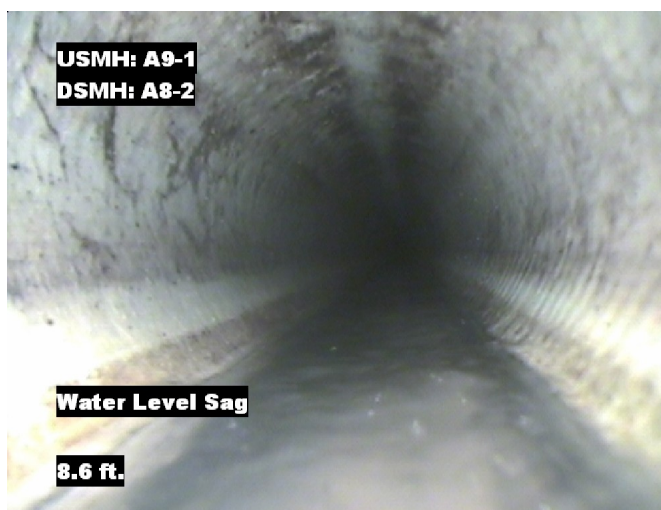
Distance: 8.6 ft. Grade: 2  
Condition: Water Level Sag  
Remarks: N/A

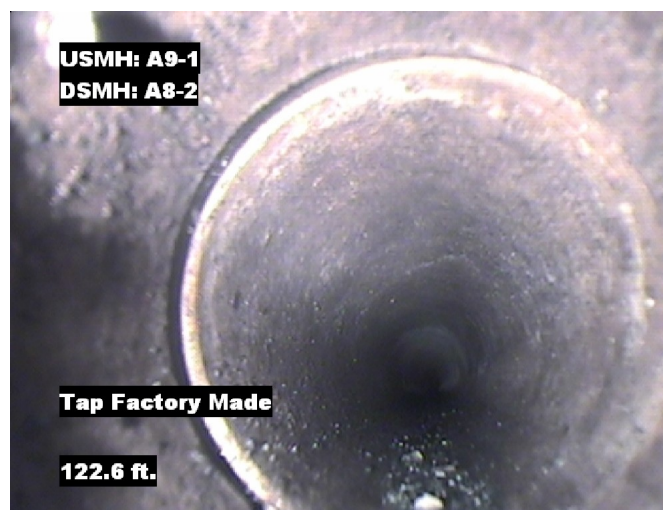
Distance: 122.6 ft. Grade: 0  
Condition: Tap Factory Made  
Remarks: N/A

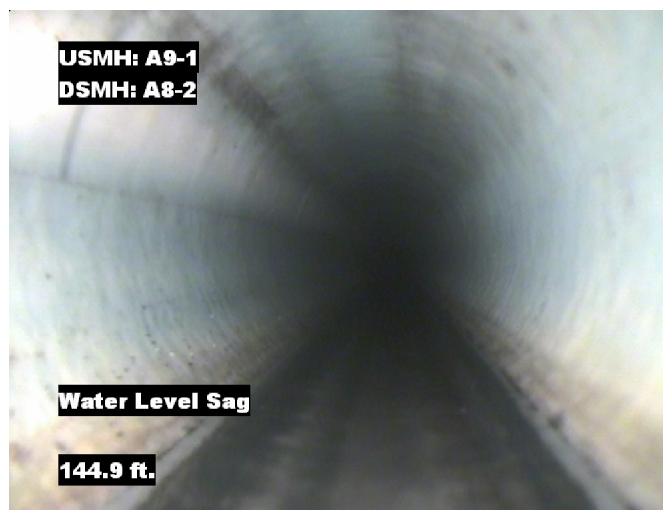
Distance: 144.9 ft. Grade: 2  
Condition: Water Level Sag  
Remarks: N/A

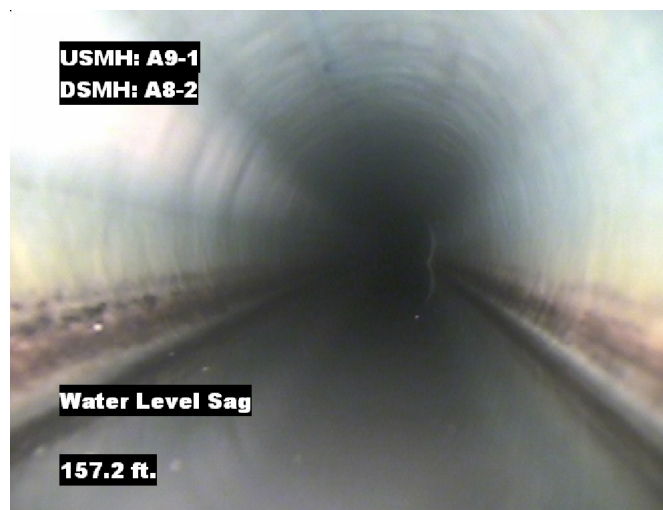
Distance: 157.1 ft. Grade: 2  
Condition: Water Level Sag  
Remarks: N/A

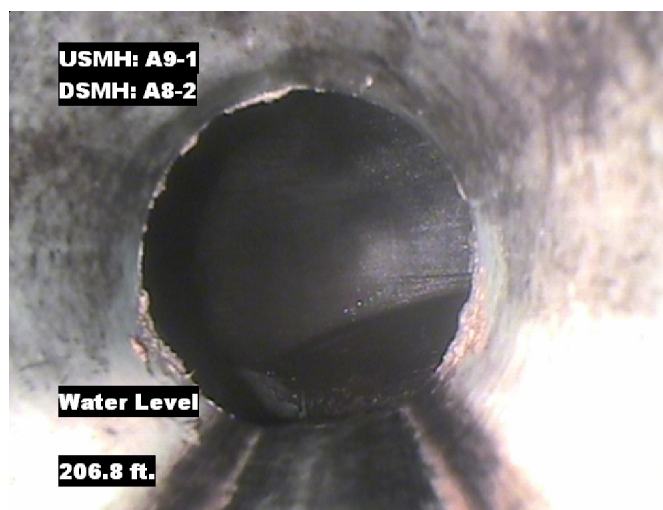
Distance: 206.8 ft. Grade: 0  
Condition: Water Level  
Remarks: N/A

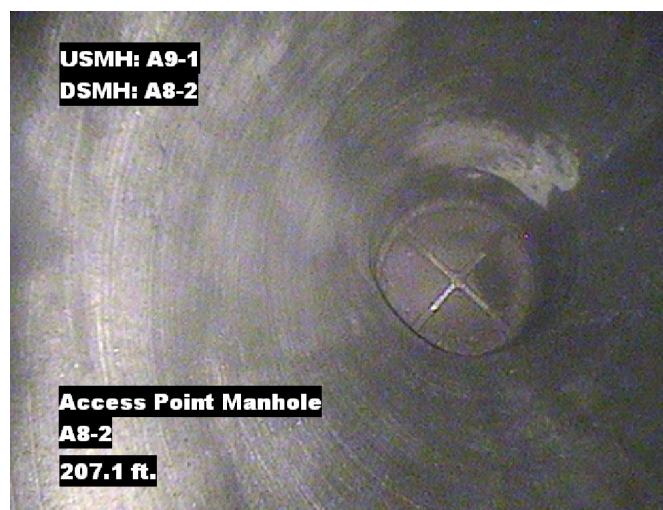
Distance: 207.1 ft. Grade: 0  
Condition: Access Point Manhole  
Remarks: A8-2
