Defect Listing

Pipe Segment Refere... A9-2_A9-1	City Oliver Springs	Street Winter Gap Ave	Material Fibreglass Reinforc...	Location C... Light High...	Sewer Use Sanitary
Upstream MH A9-2	Total Length 118	Year Laid	Shape Circular	Location Details	
DS Manhole A9-1	Length surveyed 118	Year Renewed	Height 8	Width 8	Pipe Joint... N/A

Image Report 4/Page

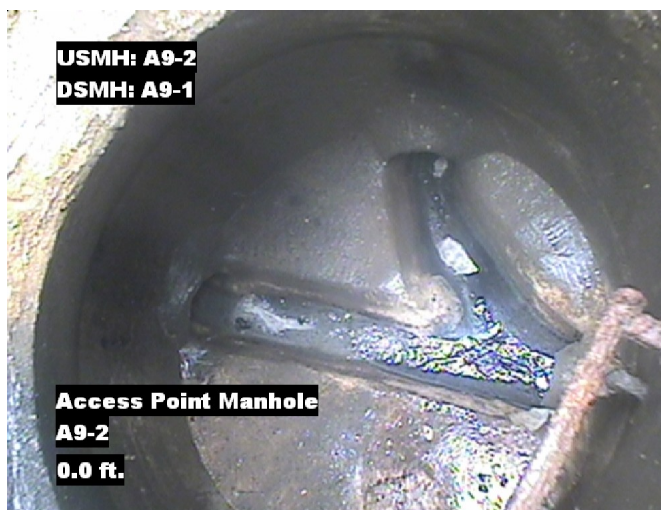
Distance: 0.0 ft. Grade: 0
Condition: Access Point Manhole
Remarks: A9-2

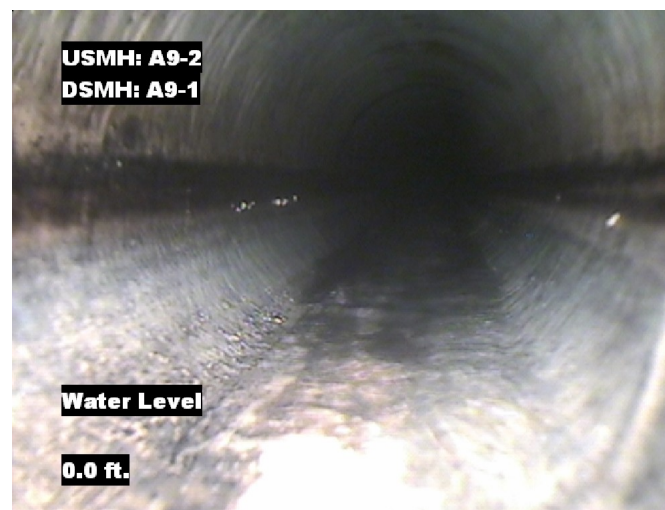
Distance: 0.0 ft. Grade: 0
Condition: Water Level
Remarks: N/A

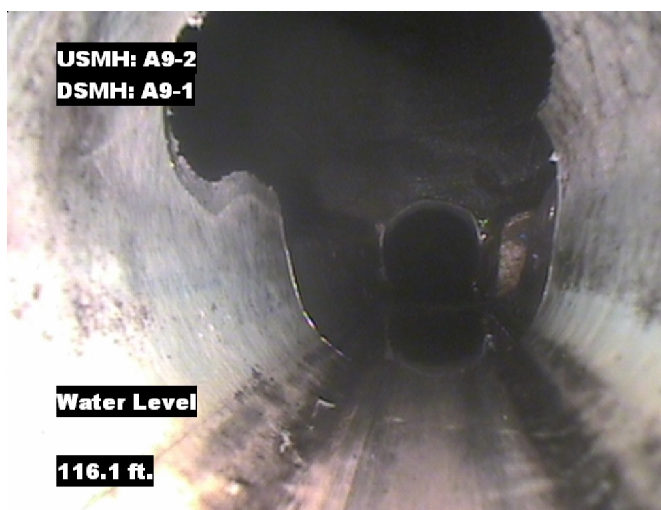
Distance: 116.1 ft. Grade: 0
Condition: Water Level
Remarks: N/A

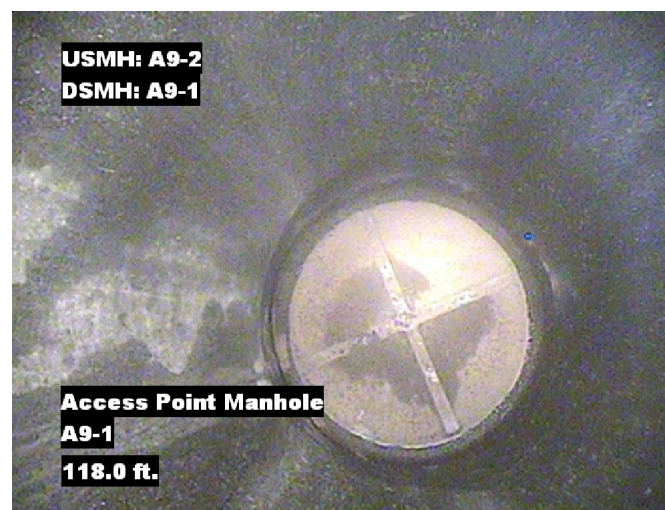
Distance: 118.0 ft. Grade: 0
Condition: Access Point Manhole
Remarks: A9-1
