## Defect Listing

Pipe Segment Refere... <b>A9-3_A9-2</b>	City <b>Oliver Springs</b>	Street <b>Winter Gap Ave</b>	Material <b>Concrete Pipe (non-...</b>	Location C... <b>Light High...</b>	Sewer Use <b>Sanitary</b>
Upstream MH <b>A9-3</b>	Total Length <b>351</b>	Year Laid	Shape <b>Circular</b>	Location Details	
DS Manhole <b>A9-2</b>	Length surveyed <b>351</b>	Year Renewed	Height <b>8</b>	Width <b>8</b>	Pipe Joint... <b>4</b>

SPR <b>N/A</b>	MPR <b>16</b>	PO Number <b>4397-03</b>	Customer <b>GRW</b>
SPRI <b>N/A</b>	MPRI <b>2</b>	Work Order <b>4397-02</b>	Purpose <b>Pre-Rehabilitation Survey</b>
QSR <b>N/A</b>	QMR <b>2800</b>		
OPR <b>16</b>	Surveyed By <b>Charlie Gordon</b>	Direction <b>Downstream</b>	Date <b>20150817</b>
OPRI <b>2</b>	Certificate Number <b>U-615-07000491</b>	Pre-Cleaning <b>Jetting</b>	Time <b>10:08</b>
	Date Cleaned <b>20150817</b>	End Time <b>10:33</b>	Weather <b>Light Rain</b>
			Media label
			Additional Info

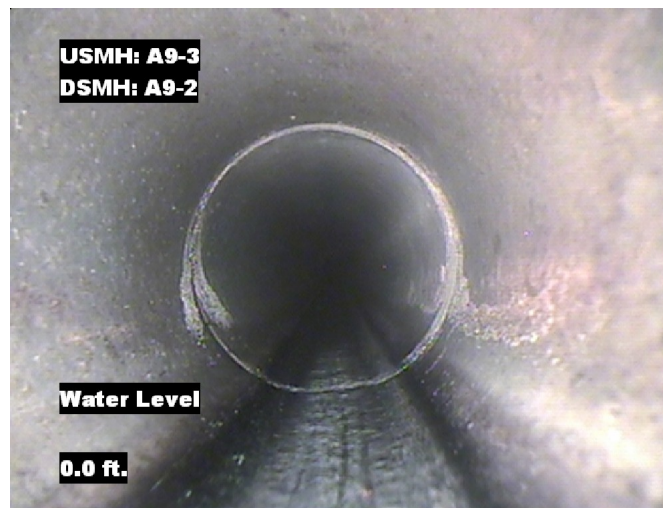
Distance: 0.0 ft. Grade: 0  
Condition: Water Level  
Remarks: N/A

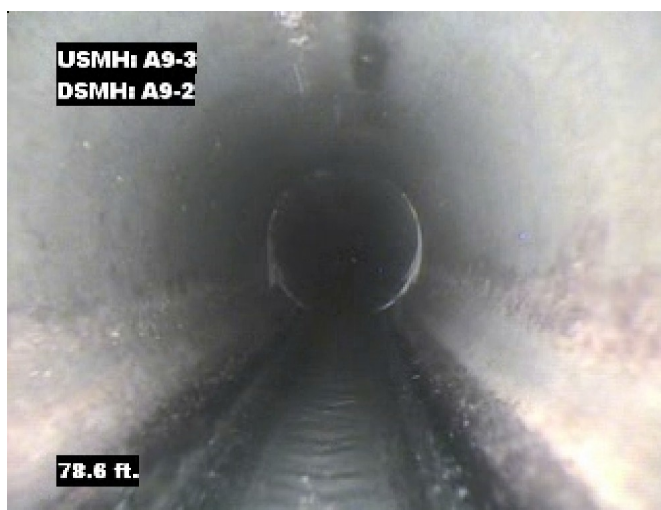
Distance: 78.6 ft. Grade: 2  
Condition: Deposits Attached Grease  
Remarks: N/A

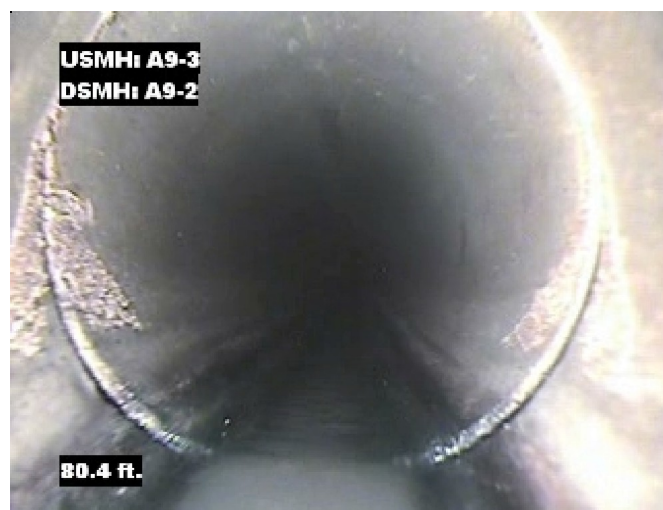
Distance: 80.4 ft. Grade: 2  
Condition: Deposits Attached Grease  
Remarks: N/A

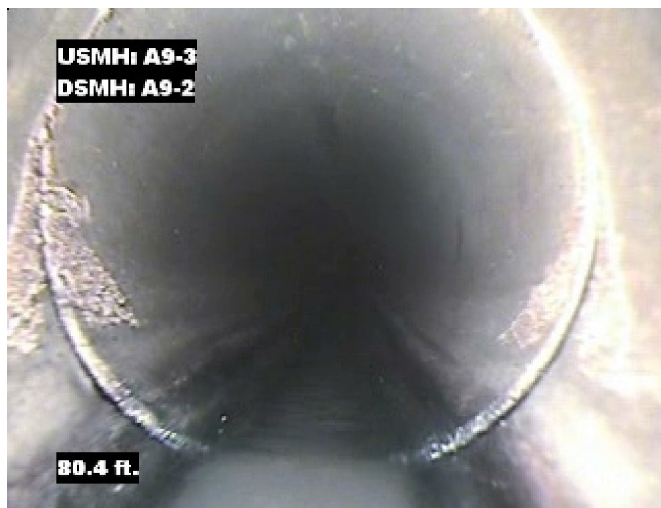
Distance: 80.4 ft. Grade: 2  
Condition: Deposits Attached Grease  
Remarks: N/A

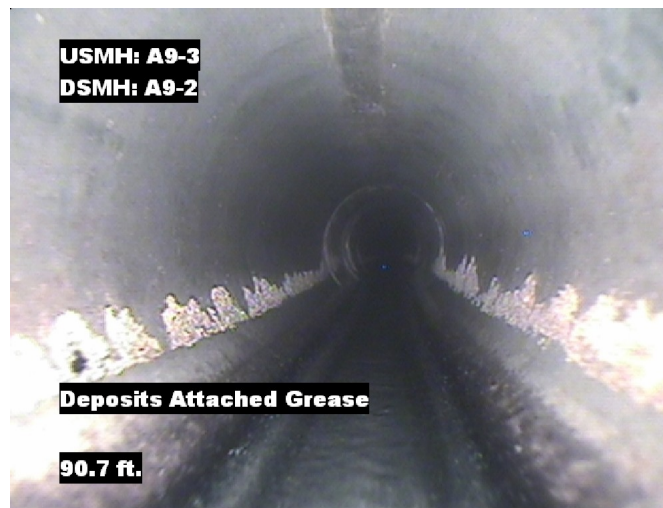
Distance: 90.6 ft. Grade: 2  
Condition: Deposits Attached Grease  
Remarks: this is a continous defect

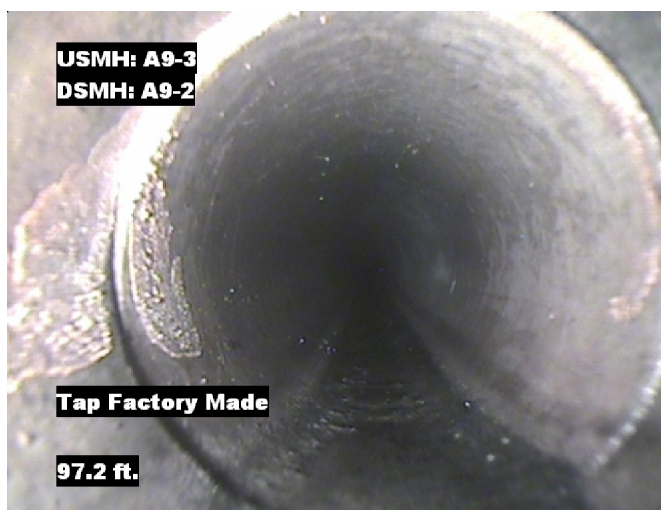
Distance: 97.2 ft. Grade: 0  
Condition: Tap Factory Made  
Remarks: N/A

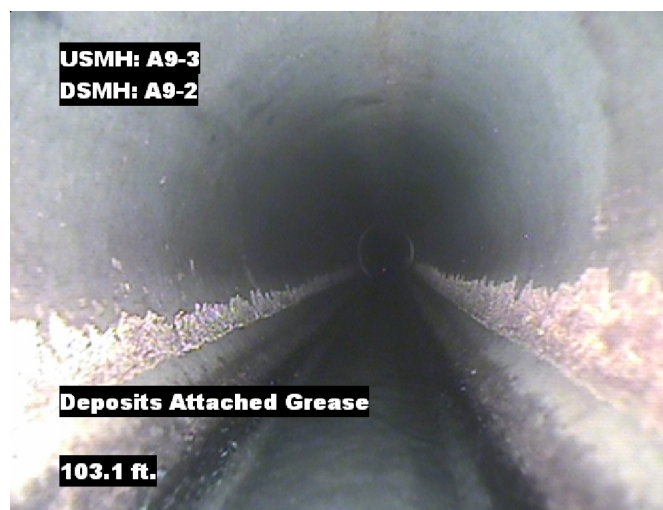
Distance: 103.1 ft. Grade: 2  
Condition: Deposits Attached Grease  
Remarks: N/A

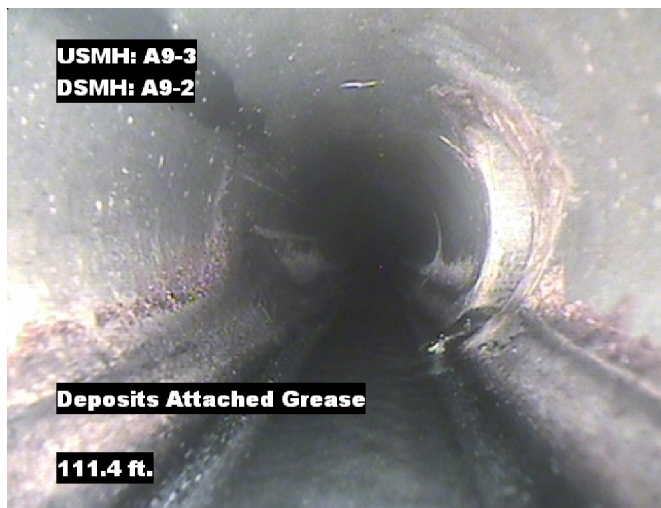
Distance: 111.4 ft. Grade: 2  
Condition: Deposits Attached Grease  
Remarks: N/A

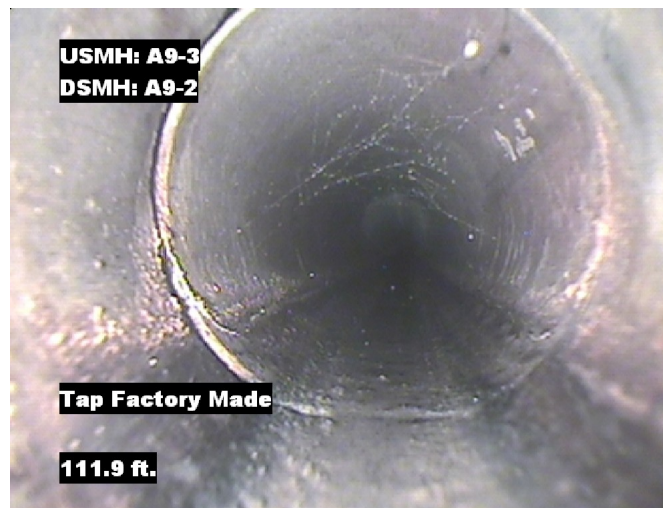
Distance: 111.9 ft. Grade: 0  
Condition: Tap Factory Made  
Remarks: N/A

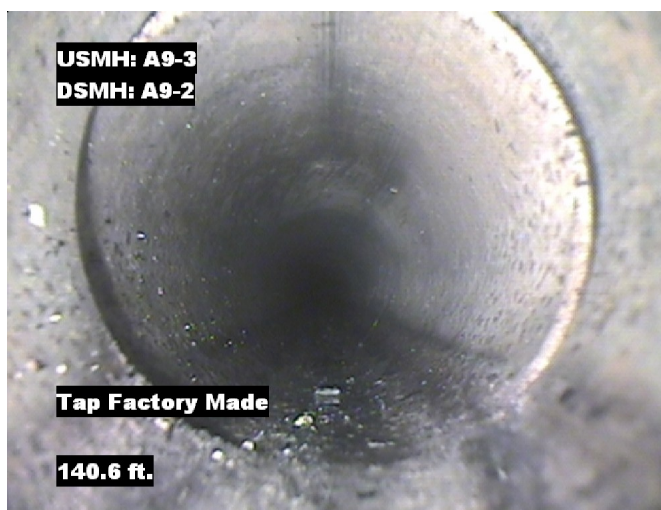
Distance: 140.6 ft. Grade: 0  
Condition: Tap Factory Made  
Remarks: N/A

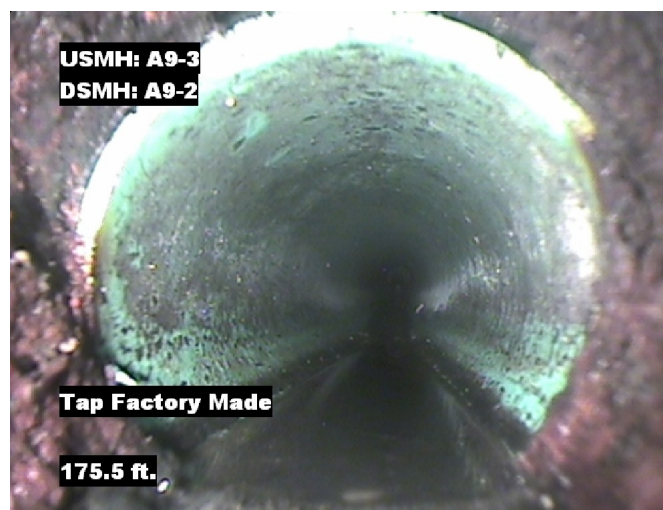
Distance: 175.5 ft. Grade: 0  
Condition: Tap Factory Made  
Remarks: N/A

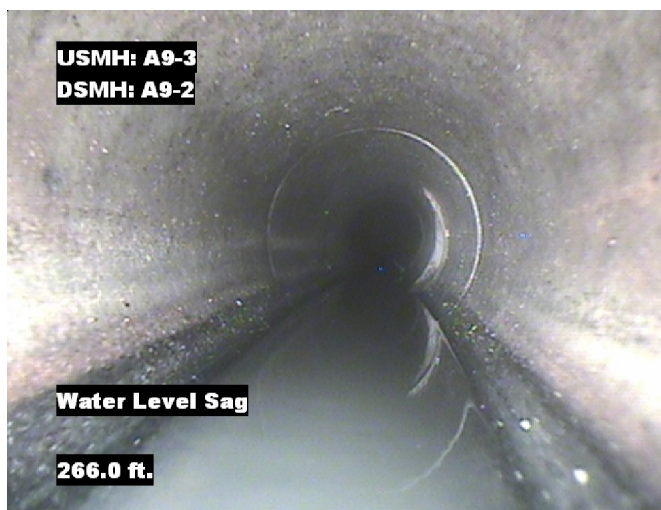
Distance: 266.0 ft. Grade: 2  
Condition: Water Level Sag  
Remarks: N/A

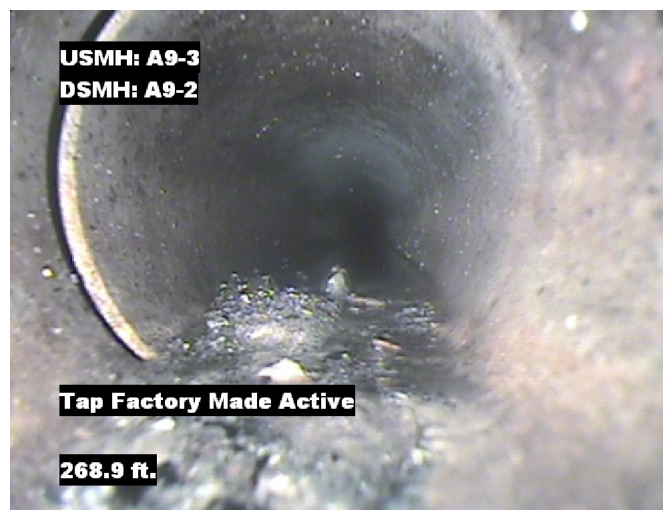
Distance: 268.9 ft. Grade: 0  
Condition: Tap Factory Made Active  
Remarks: N/A

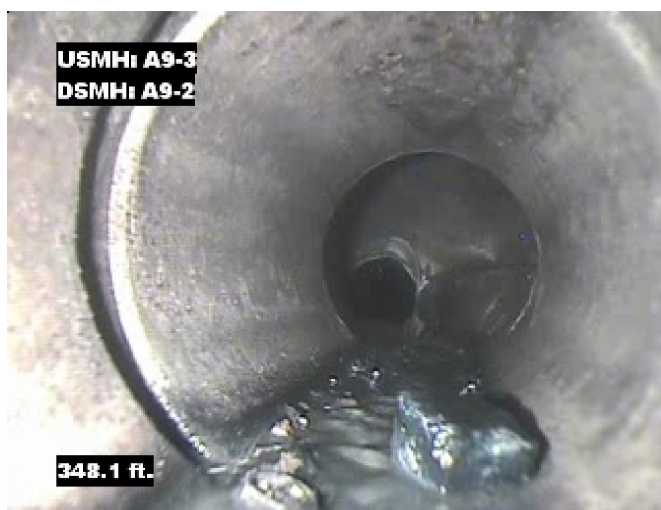
Distance: 348.1 ft. Grade: 2  
Condition: Deposits Settled Gravel  
Remarks: N/A

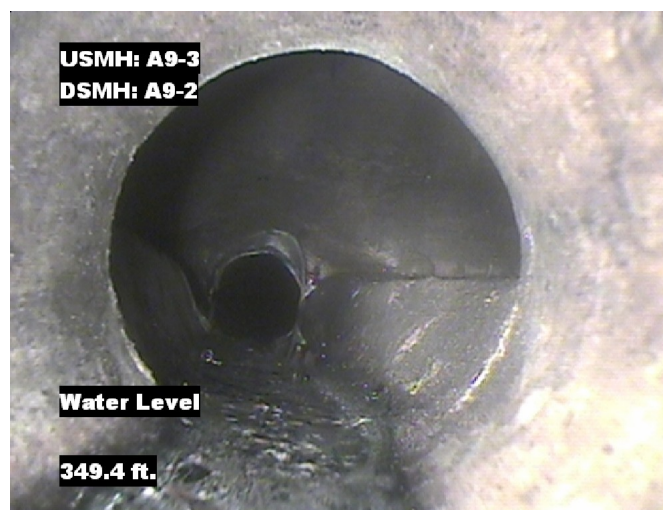
Distance: 349.4 ft. Grade: 0  
Condition: Water Level  
Remarks: N/A
