Defect Listing

Pipe Segment Refere... A9-4_A9-3	City Oliver Springs	Street Winter Gap Ave	Material Fibreglass Reinforc...	Location C... Light High...	Sewer Use Sanitary
Upstream MH A9-4	Total Length 326.7	Year Laid	Shape Circular	Location Details	
DS Manhole A9-3	Length surveyed 10.9	Year Renewed	Height 8	Width 8	Pipe Joint... N/A

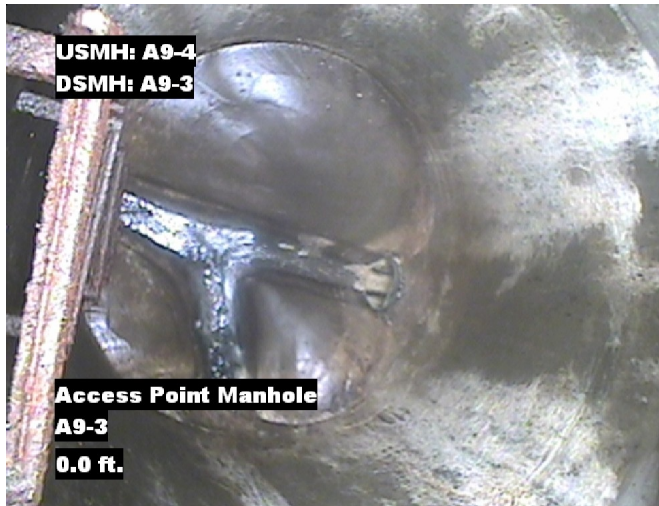
Distance: 0.0 ft. Grade: 0
Condition: Access Point Manhole
Remarks: A9-3

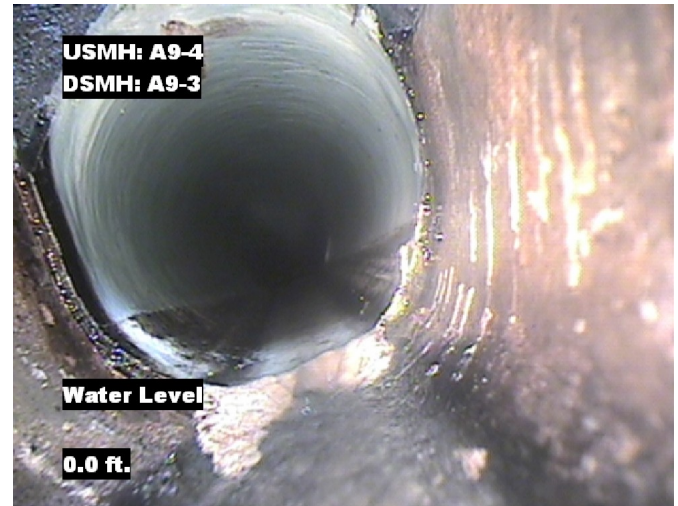
Distance: 0.0 ft. Grade: 0
Condition: Water Level
Remarks: N/A

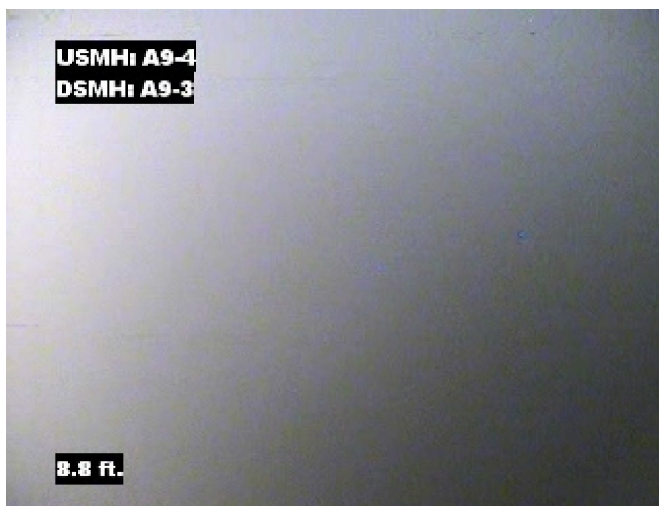
Distance: 8.8 ft. Grade: 4
Condition: Camera Underwater
Remarks: N/A

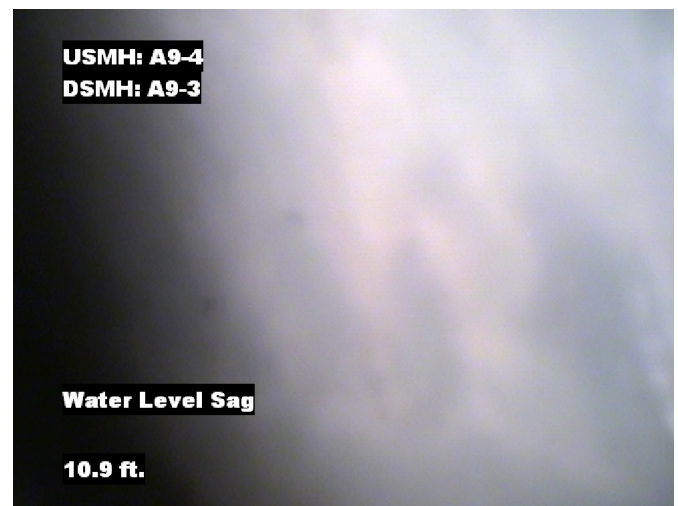
Distance: 10.9 ft. Grade: 3
Condition: Water Level Sag
Remarks: N/A

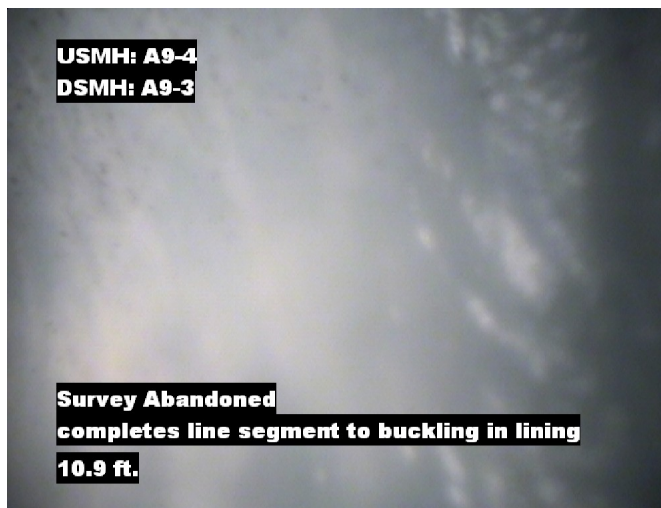
Distance: 10.9 ft. Grade: 0
Condition: Survey Abandoned
Remarks: completes line segment to buckling in lining
