## Defect Listing

Pipe Segment Refere... <b>A9-5_A9-4</b>	City <b>Oliver Springs</b>	Street <b>Winter Gap Ave</b>	Material <b>Concrete Pipe (non-...</b>	Location C... <b>Light High...</b>	Sewer Use <b>Sanitary</b>
Upstream MH <b>A9-5</b>	Total Length <b>316.4</b>	Year Laid	Shape <b>Circular</b>	Location Details	
DS Manhole <b>A9-4</b>	Length surveyed <b>316.4</b>	Year Renewed	Height <b>8</b>	Width <b>8</b>	Pipe Joint... <b>4</b>

SPR <b>N/A</b>	MPR <b>N/A</b>	PO Number <b>4397-03</b>	Customer <b>GRW</b>
SPRI <b>N/A</b>	MPRI <b>N/A</b>	Work Order <b>4397-02</b>	Purpose <b>Pre-Rehabilitation Survey</b>
QSR <b>N/A</b>	QMR <b>N/A</b>		
OPR <b>N/A</b>	Surveyed By <b>Barry Rogers</b>	Direction <b>Downstream</b>	Date <b>20150814</b>
OPRI <b>N/A</b>	Certificate Number <b>U-1012-16405</b>	Pre-Cleaning <b>Jetting</b>	Time <b>13:02</b>
	Date Cleaned <b>20150814</b>	End Time <b>13:19</b>	Weather <b>Damp</b>
			Media label
			Additional Info

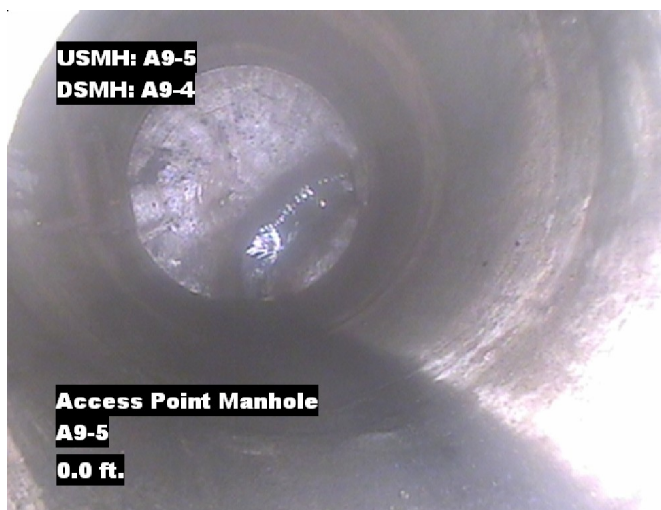
Distance: 0.0 ft. Grade: 0  
Condition: Access Point Manhole  
Remarks: A9-5

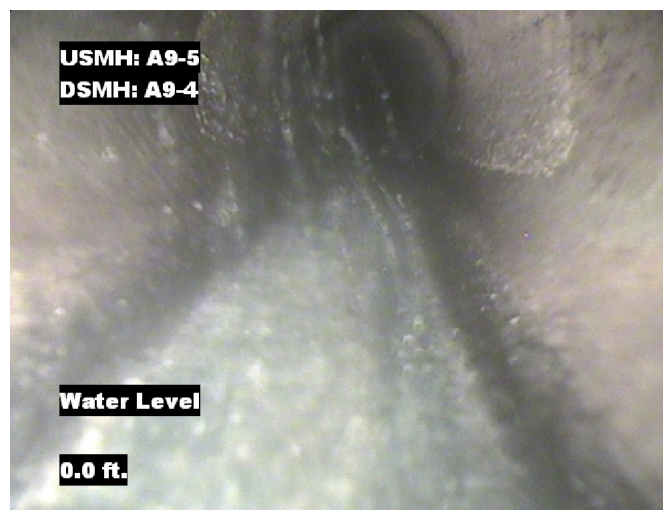
Distance: 0.0 ft. Grade: 0  
Condition: Water Level  
Remarks: N/A

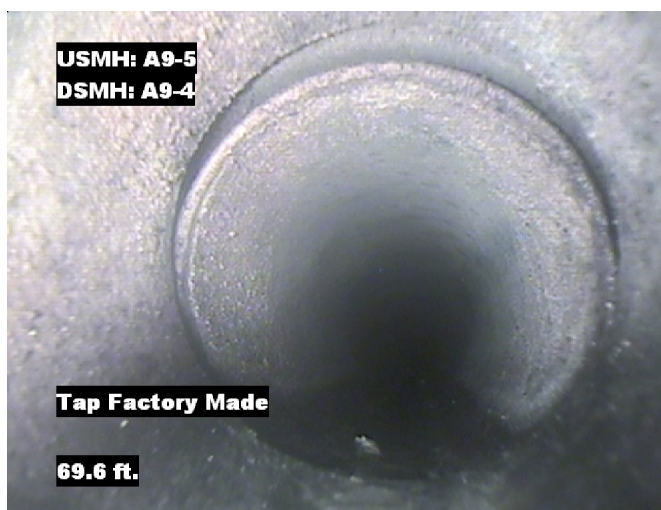
Distance: 69.6 ft. Grade: 0  
Condition: Tap Factory Made  
Remarks: N/A

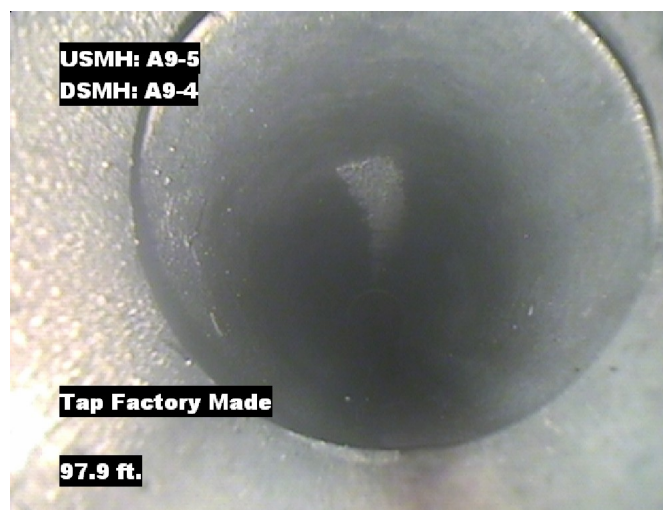
Distance: 97.9 ft. Grade: 0  
Condition: Tap Factory Made  
Remarks: N/A

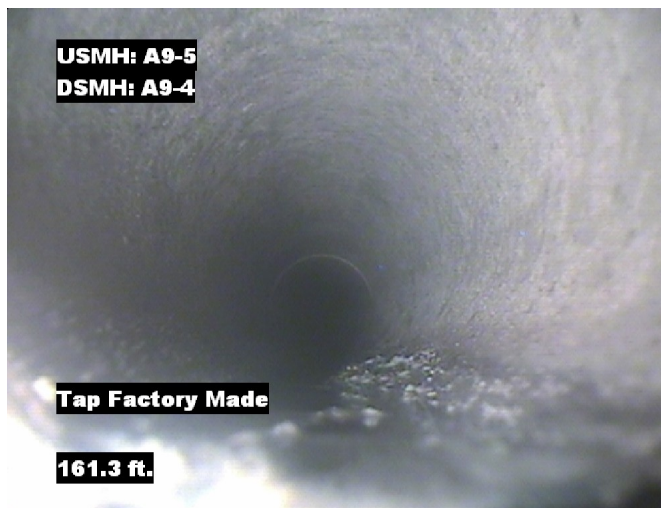
Distance: 161.3 ft. Grade: 0  
Condition: Tap Factory Made  
Remarks: N/A

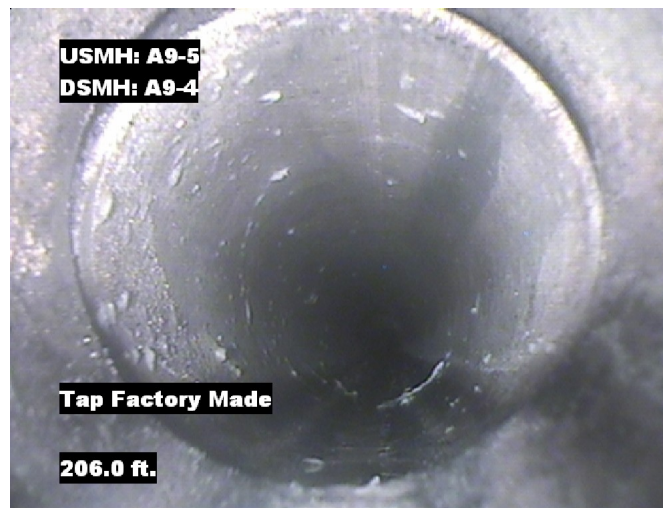
Distance: 206.0 ft. Grade: 0  
Condition: Tap Factory Made  
Remarks: N/A

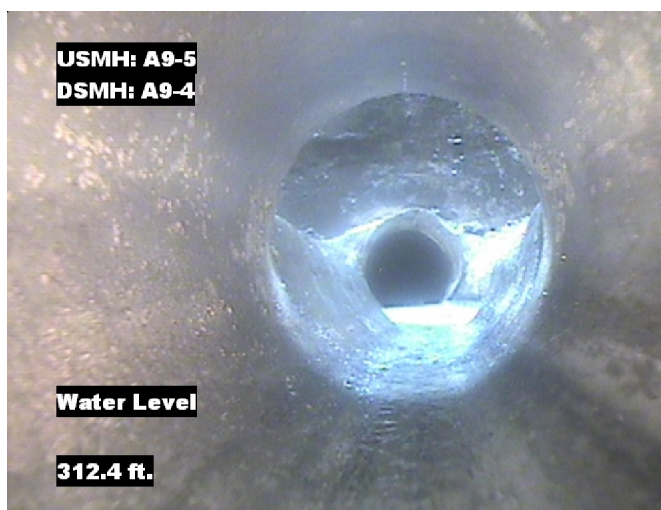
Distance: 312.3 ft. Grade: 0  
Condition: Water Level  
Remarks: N/A

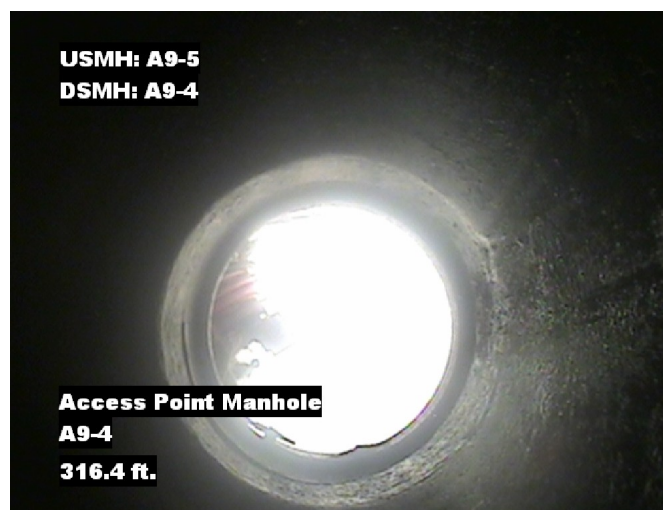
Distance: 316.4 ft. Grade: 0  
Condition: Access Point Manhole  
Remarks: A9-4
