Defect Listing

Pipe Segment Refere		С	ity	Street	Mat	erial	Location C	Sewer Use	
A9-6_	_A9-5	Oliver	Springs	W Springs St	Concrete F	Pipe (non	Light High	Sanitary	
Upstre	am MH	Total I	_ength	Year Laid	Sh	pe Location De		Details	
AS	9-6	25	1.7		Circ	ular	r		
DS Ma	anhole	Length s	surveyed	Year Renewed	Height	Width	Pipe Joint		
AS	9-5	25	1.7		8	8	4		
SPR	N/A	MPR	2	PO Number			Customer		
0001		MDDI		4397-03	GRW				
SPRI	N/A	MPRI	2	Work Order		Purpose			
QSR	N/A	QMR	2100	4397-02		Pre-	Pre-Rehabilitation Survey		
OF	PR	Surve	yed By	Direction	Da	ate	Media	label	
2	2	Barry_	Rogers	Downstream	2015	0814			
OF	PRI	Certificate Number		Pre-Cleaning	Time		Weather		
2		U-1012-16405		Jetting	12:27		Damp		
		Date C	leaned		End Time		Additional Info		
		2015	0814		12	:46

Image Report 4/Page

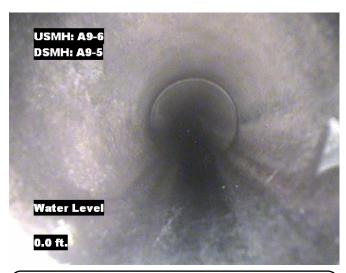
Distance: 0.0 ft. Grade: 0

Condition: Access Point Manhole

Remarks: A9-6

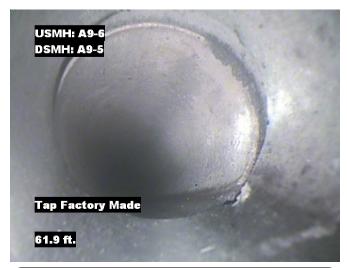
Distance: 61.9 ft. Grade: 0

Condition: Tap Factory Made

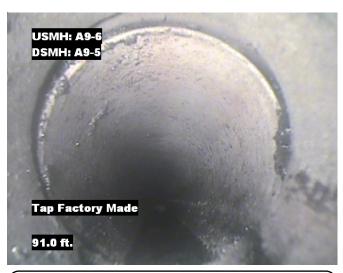
Distance: 91.0 ft. Grade: 0

Condition: Tap Factory Made

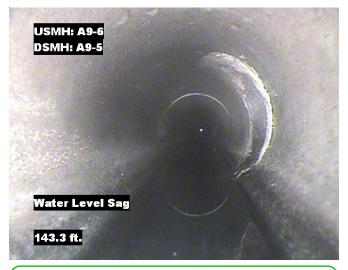
Distance: 143.3 ft. Grade: 2

Condition: Water Level Sag

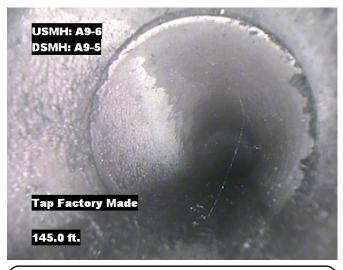
Distance: 145.0 ft. Grade: 0

Condition: Tap Factory Made

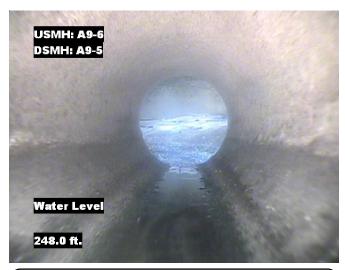
Distance: 247.8 ft. Grade: 0

Condition: Water Level

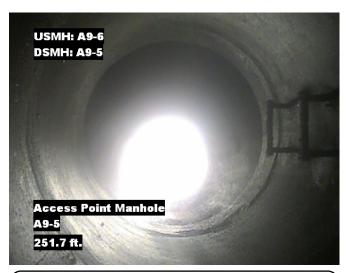
Distance: 251.7 ft. Grade:

Condition: Access Point Manhole

Remarks: A9-5
