## Defect Listing

Pipe Segment Refere... <b>B-1_A-21</b>	City <b>OLiver Springs</b>	Street <b>Old Harriman Hwy</b>	Material <b>Fibreglass Reinforc...</b>	Location C... <b>Easement/R...</b>	Sewer Use <b>Sanitary</b>
Upstream MH <b>B-1</b>	Total Length <b>2.3</b>	Year Laid	Shape <b>Circular</b>	Location Details	
DS Manhole <b>A-20</b>	Length surveyed <b>2.3</b>	Year Renewed	Height <b>10</b>	Width <b>10</b>	Pipe Joint... <b>N/A</b>

SPR <b>3</b>	MPR <b>1</b>	PO Number <b>4397-03</b>	Customer <b>GRW</b>
SPRI <b>3</b>	MPRI <b>1</b>	Work Order <b>4397-02</b>	Purpose <b>Pre-Rehabilitation Survey</b>
QSR <b>3100</b>	QMR <b>1100</b>		
OPR <b>4</b>	Surveyed By <b>Charlie Gordon</b>	Direction <b>Downstream</b>	Date <b>20150916</b>
OPRI <b>2</b>	Certificate Number <b>U-615-07000491</b>	Pre-Cleaning <b>No Pre-Cleaning</b>	Time <b>08:43</b>
	Date Cleaned	End Time <b>08:48</b>	Weather <b>Damp</b>
			Additional Info <b>Due to liner defect...</b>

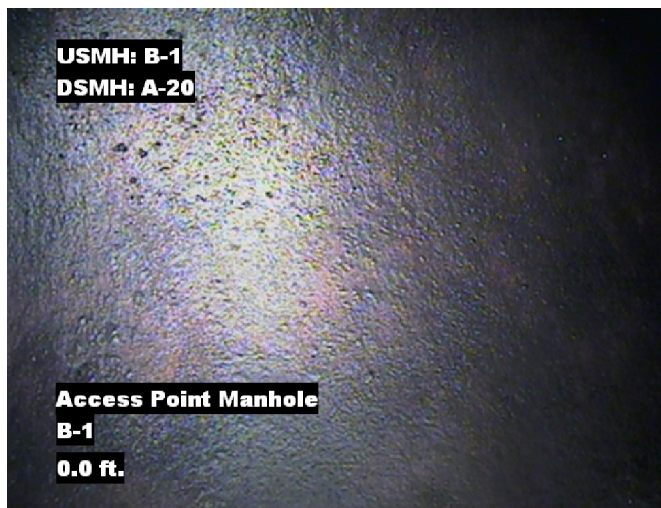
Distance: 0.0 ft. Grade: 0  
Condition: Access Point Manhole  
Remarks: B-1

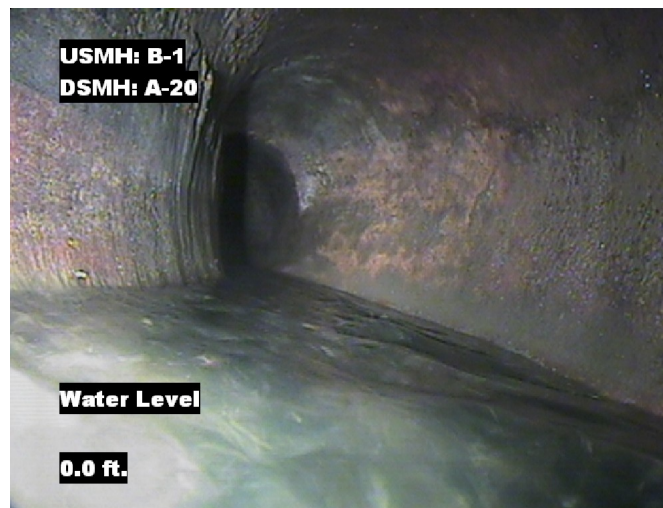
Distance: 0.0 ft. Grade: 0  
Condition: Water Level  
Remarks: N/A

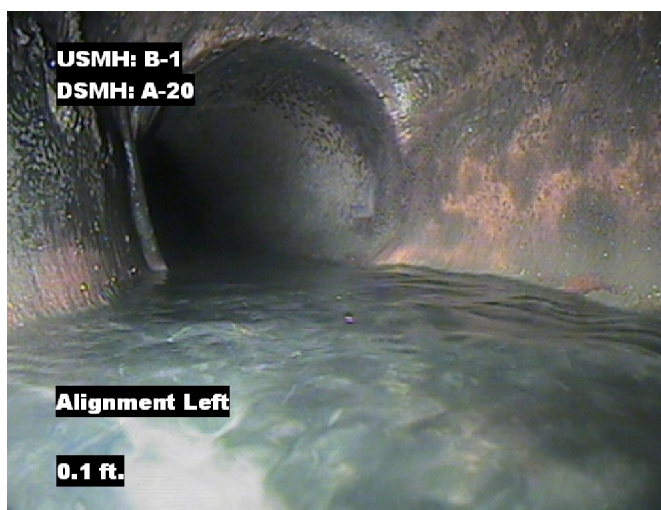
Distance: 0.1 ft. Grade: 1  
Condition: Alignment Left  
Remarks: N/A

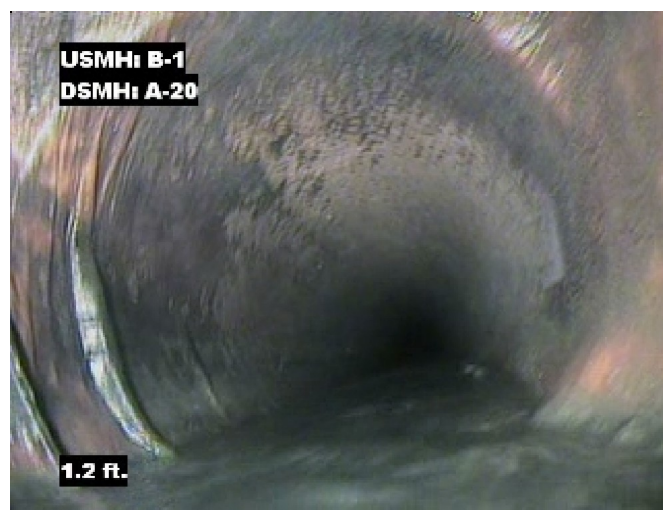
Distance: 1.2 ft. Grade: 3  
Condition: Lining Failure Wrinkled  
Remarks: N/A

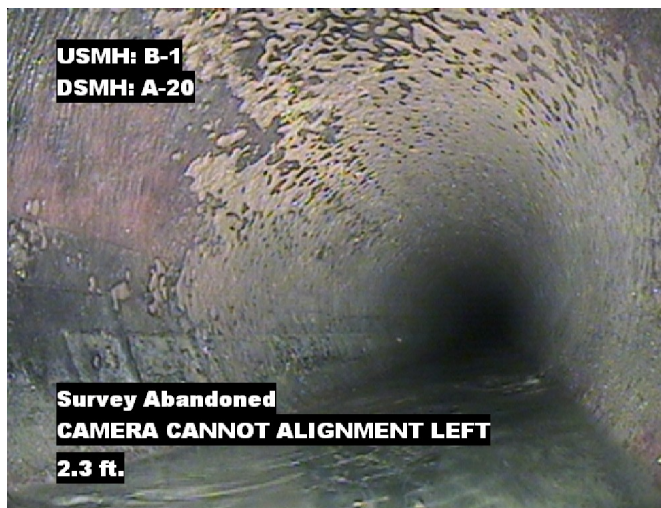
Distance: 2.3 ft. Grade: 0  
Condition: Survey Abandoned  
Remarks: CAMERA CANNOT ALIGNMENT LEFT
