## Defect Listing

Pipe Segment Refere... <b>B-10_B-9</b>	City <b>Oliver Sprtngs</b>	Street <b>Cemetery Rd</b>	Material <b>Fibreglass Reinforc...</b>	Location C... <b>Easement/R...</b>	Sewer Use <b>Sanitary</b>
Upstream MH <b>B-10</b>	Total Length <b>257.1</b>	Year Laid	Shape <b>Circular</b>	Location Details	
DS Manhole <b>B-9</b>	Length surveyed <b>257.1</b>	Year Renewed	Height <b>8</b>	Width <b>8</b>	Pipe Joint... <b>N/A</b>

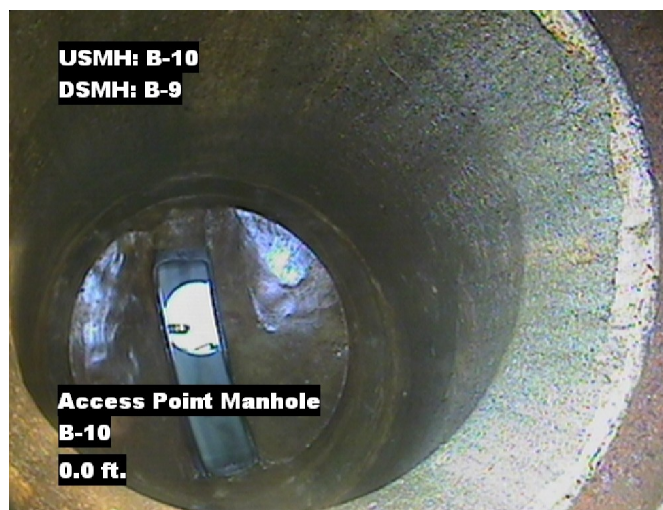
Distance: 0.0 ft. Grade: 0  
Condition: Access Point Manhole  
Remarks: B-10

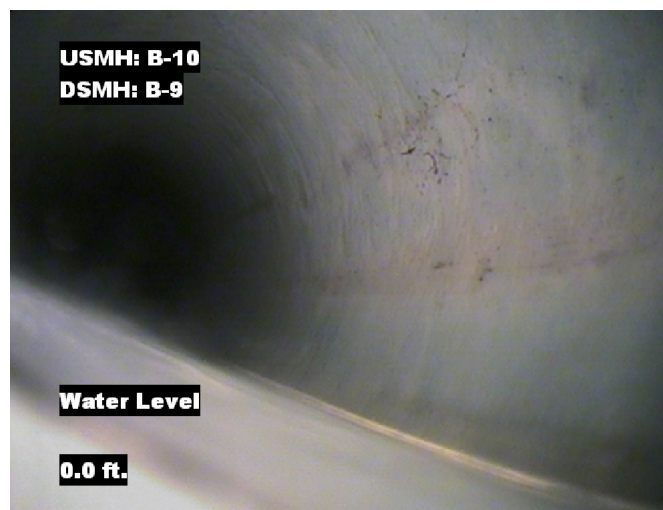
Distance: 0.0 ft. Grade: 0  
Condition: Water Level  
Remarks: N/A

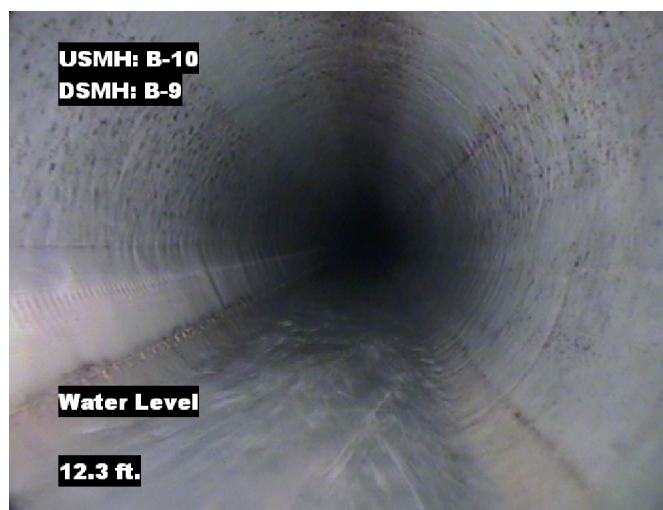
Distance: 12.3 ft. Grade: 0  
Condition: Water Level  
Remarks: N/A

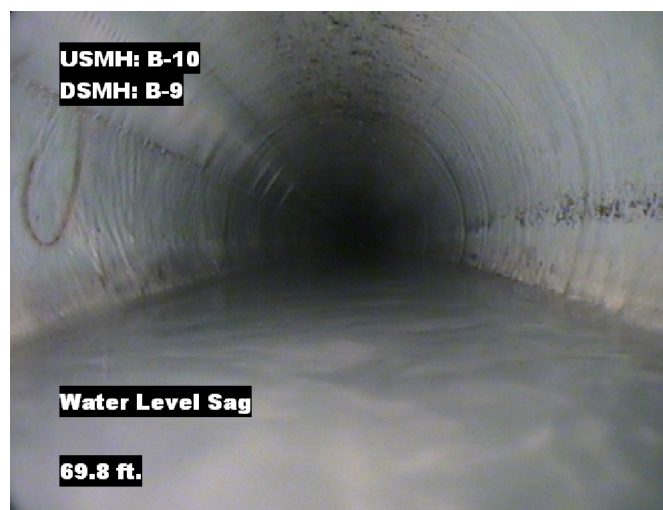
Distance: 69.8 ft. Grade: 2  
Condition: Water Level Sag  
Remarks: N/A

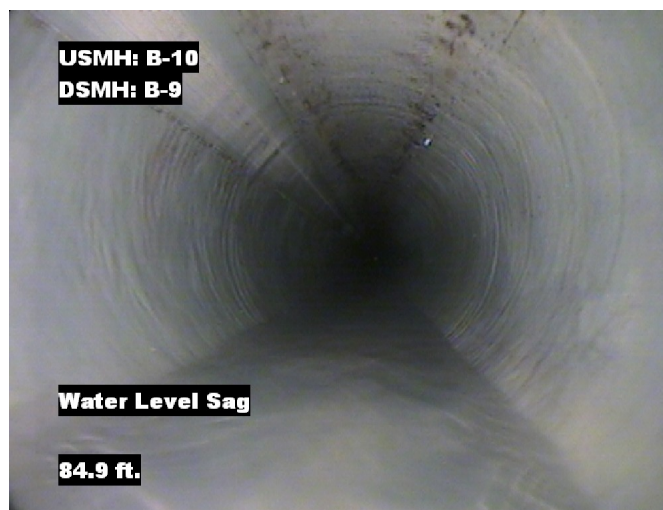
Distance: 84.6 ft. Grade: 2  
Condition: Water Level Sag  
Remarks: N/A

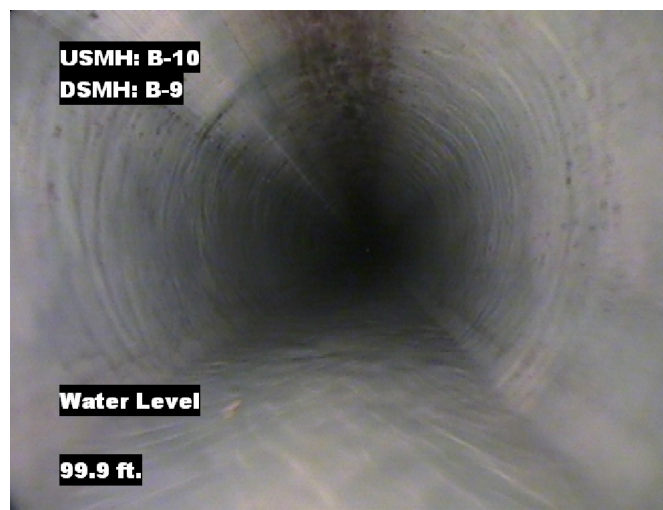
Distance: 99.8 ft. Grade: 0  
Condition: Water Level  
Remarks: N/A

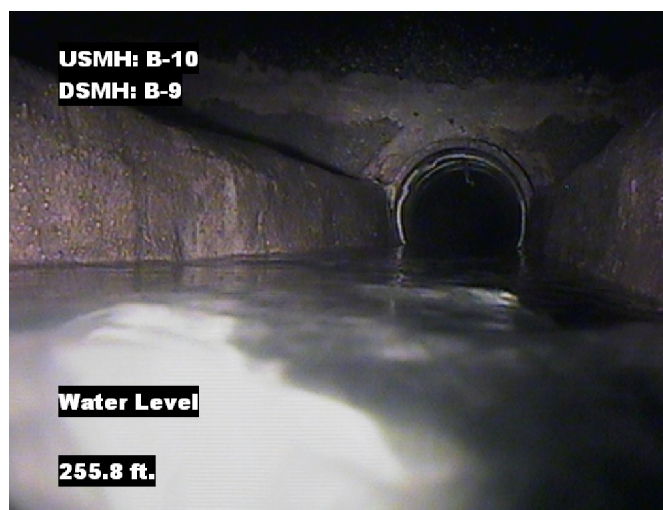
Distance: 255.8 ft. Grade: 0  
Condition: Water Level  
Remarks: N/A

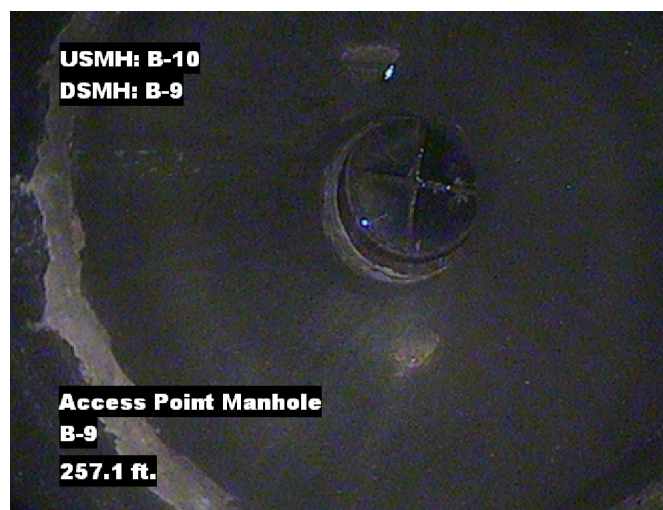
Distance: 257.1 ft. Grade: 0  
Condition: Access Point Manhole  
Remarks: B-9
