Defect Listing

Pipe Segment Refere... B-11_B-10	City Oliver Springs	Street Cemetery Rd	Material Fibreglass Reinforc...	Location C... Easement/R...	Sewer Use Sanitary
Upstream MH B-11	Total Length 344.2	Year Laid	Shape Circular	Location Details	
DS Manhole B-10	Length surveyed 344.2	Year Renewed	Height 10	Width 10	Pipe Joint... N/A

Image Report 4/Page

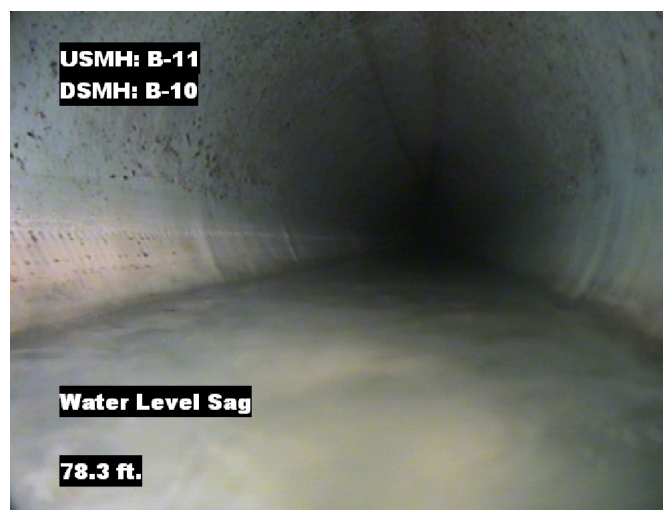
0.0 ft.	Water Level				5	<input type="checkbox"/>			
31.4 ft.	Water Level				10	<input type="checkbox"/>			
78.3 ft.	Water Level Sag	S01			15	<input type="checkbox"/>			2

Distance: 78.3 ft. Grade: 2
Condition: Water Level Sag
Remarks: N/A

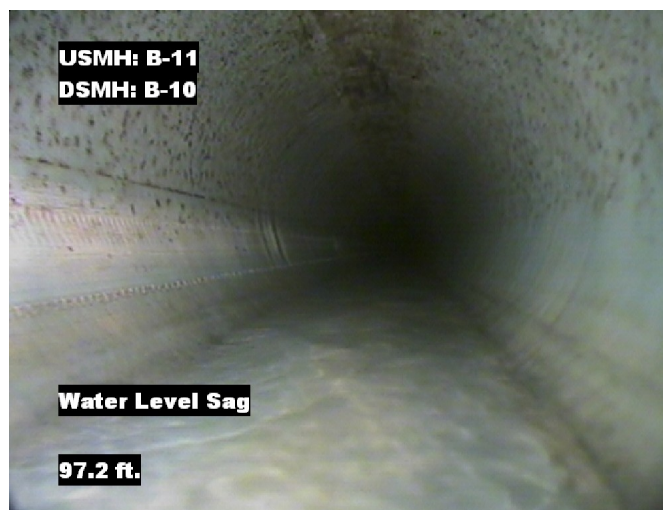
97.0 ft.	Water Level Sag	F01			15	<input type="checkbox"/>			2
213.5 ft.	Water Level				15	<input type="checkbox"/>			
237.5 ft.	Water Level				5	<input type="checkbox"/>

Distance: 97.0 ft. Grade: 2
Condition: Water Level Sag
Remarks: N/A

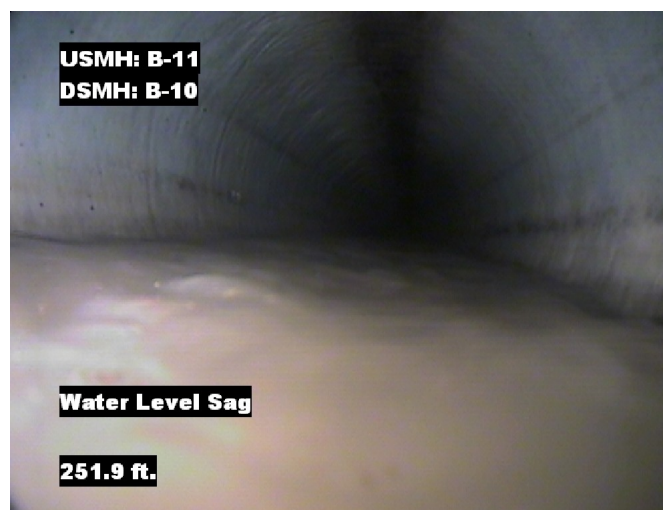
251.9 ft.	Water Level Sag	S02			20	<input type="checkbox"/>			2
257.5 ft.	Camera Underwater				0	<input type="checkbox"/>			4
326.5 ft.	Water Level Sag	F02			20	<input type="checkbox"/>			2

Distance: 251.9 ft. Grade: 2
Condition: Water Level Sag
Remarks: N/A

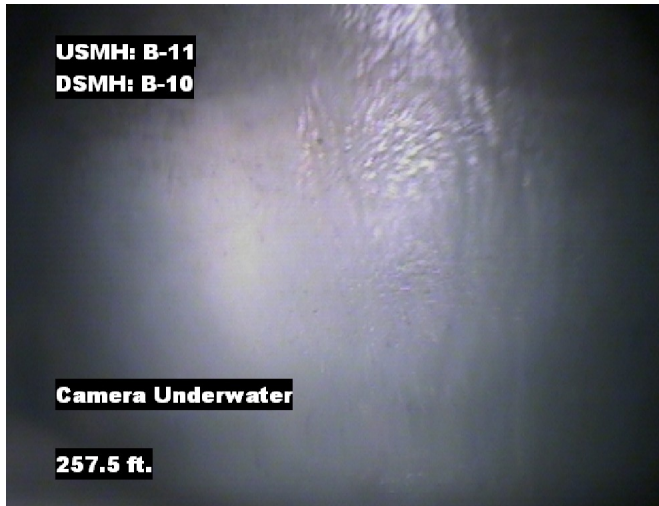
Distance: 257.5 ft. Grade: 4
Condition: Camera Underwater
Remarks: N/A

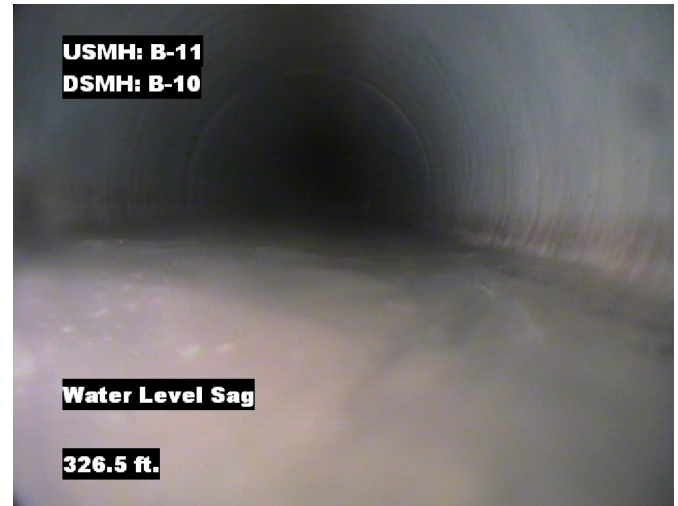
Distance: 326.5 ft. Grade: 2
Condition: Water Level Sag
Remarks: N/A

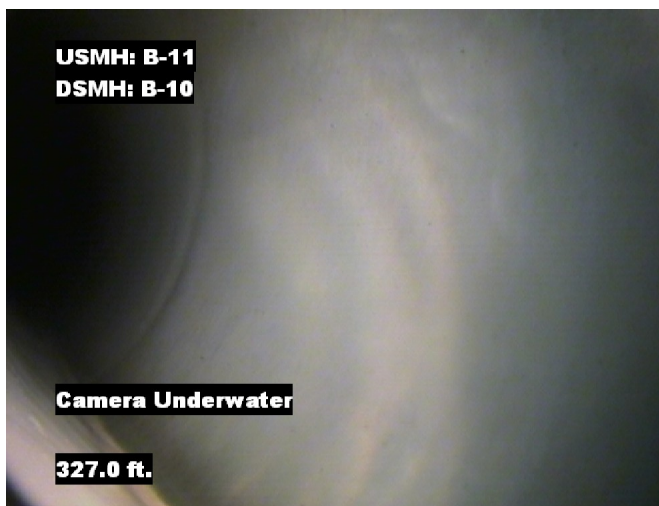
Distance: 327.0 ft. Grade: 4
Condition: Camera Underwater
Remarks: N/A
