Defect Listing

Pipe Segment Refere... B-13_B-11	City Oliver springs	Street Cemetery Rd	Material Fibreglass Reinforc...	Location C... Easement/R...	Sewer Use Sanitary
Upstream MH B-13	Total Length 336.9	Year Laid	Shape Circular	Location Details	
DS Manhole B-11	Length surveyed 336.9	Year Renewed	Height 8	Width 8	Pipe Joint... N/A

SPR N/A	MPR 24	PO Number 4397-03		Customer GRW	
SPRI N/A	MPRI 2	Work Order 4397-02		Purpose Pre-Rehabilitation Survey	
QSR N/A	QMR 2A00				
OPR 24	Surveyed By Charlie Gordon	Direction Downstream	Date 20150911	Media label	
OPRI 2	Certificate Number U-615-07000491	Pre-Cleaning Jetting	Time 11:43	Weather Damp	
Date Cleaned 20150911			End Time 12:07	Additional Info

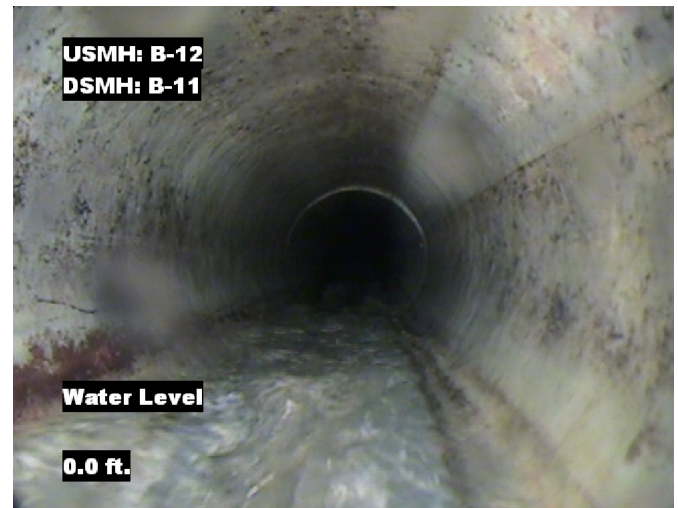
Distance: 0.0 ft. Grade: 0
Condition: Water Level
Remarks: N/A

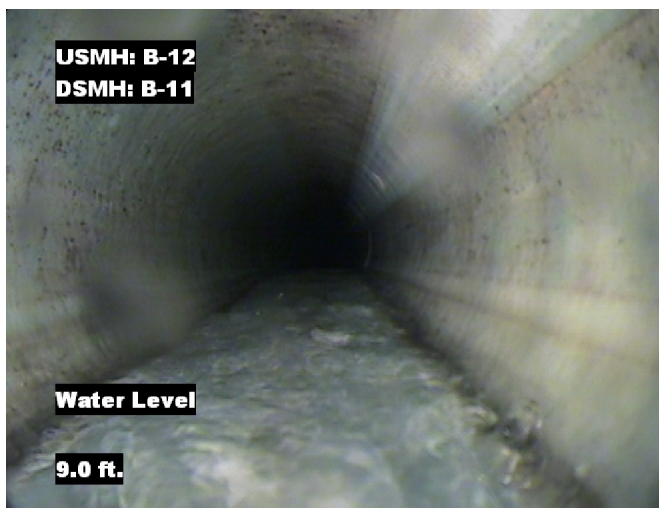
Distance: 9.0 ft. Grade: 0
Condition: Water Level
Remarks: N/A

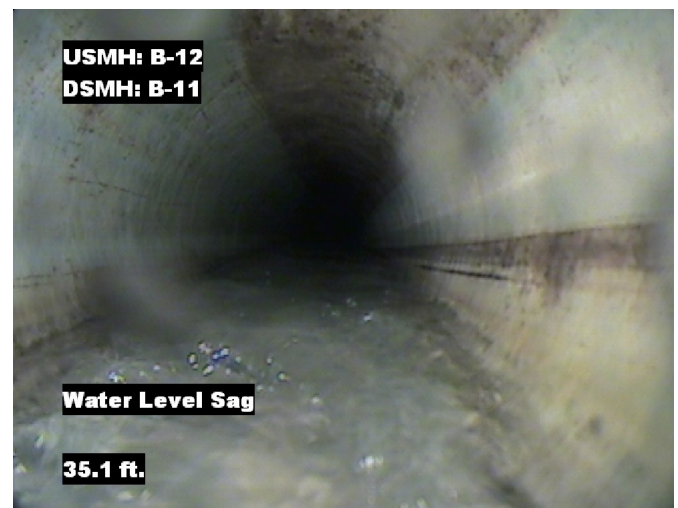
Distance: 35.1 ft. Grade: 2
Condition: Water Level Sag
Remarks: N/A

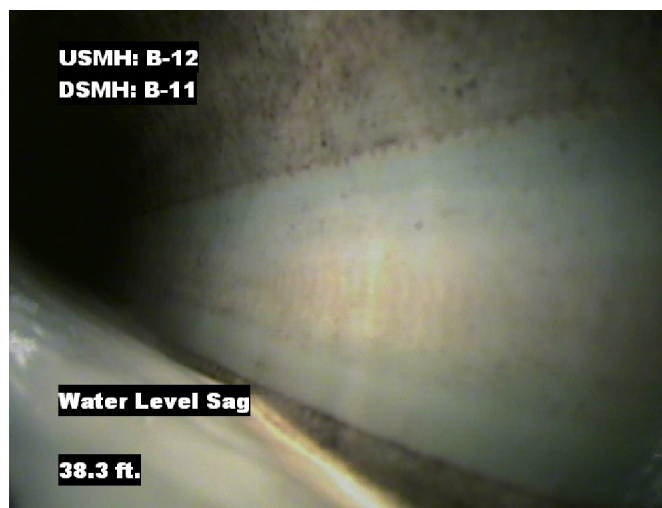
Distance: 38.3 ft. Grade: 2
Condition: Water Level Sag
Remarks: N/A

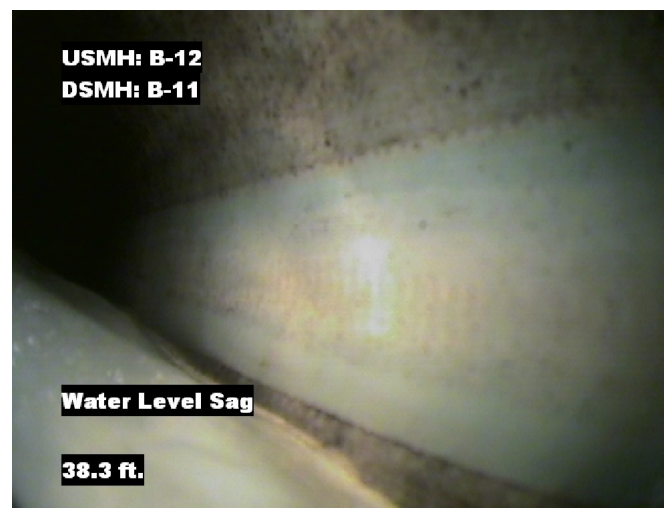
Distance: 38.3 ft. Grade: 2
Condition: Water Level Sag
Remarks: N/A

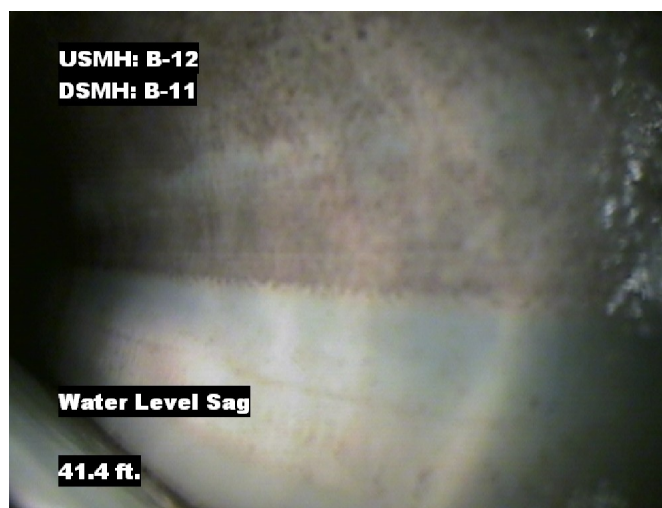
Distance: 41.4 ft. Grade: 2
Condition: Water Level Sag
Remarks: N/A

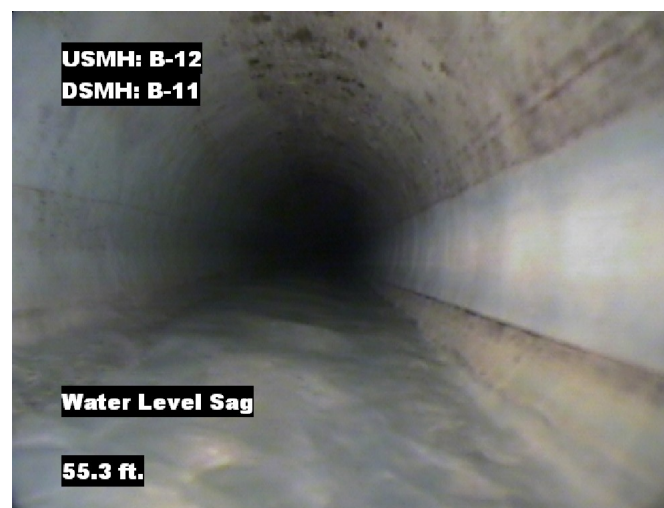
Distance: 55.1 ft. Grade: 2
Condition: Water Level Sag
Remarks: N/A

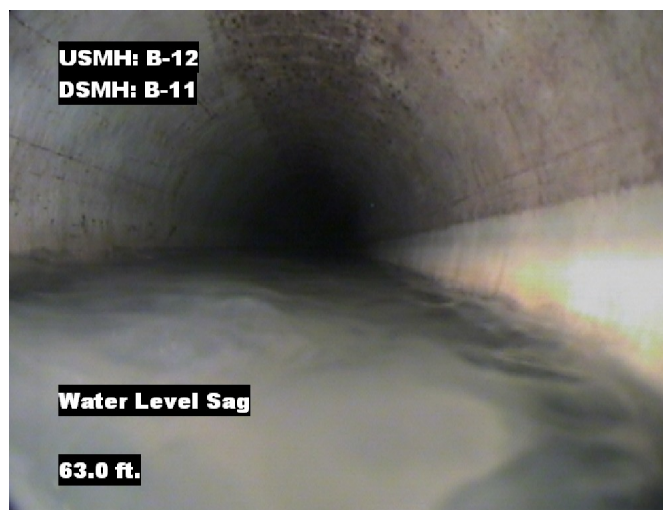
Distance: 63.0 ft. Grade: 2
Condition: Water Level Sag
Remarks: N/A

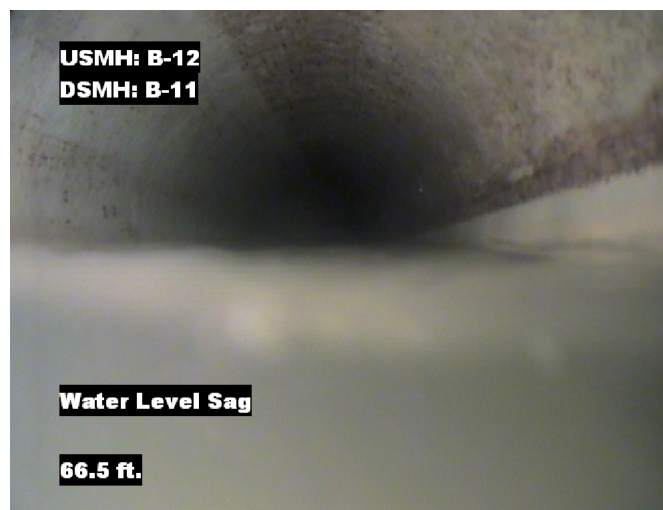
Distance: 66.5 ft. Grade: 2
Condition: Water Level Sag
Remarks: N/A

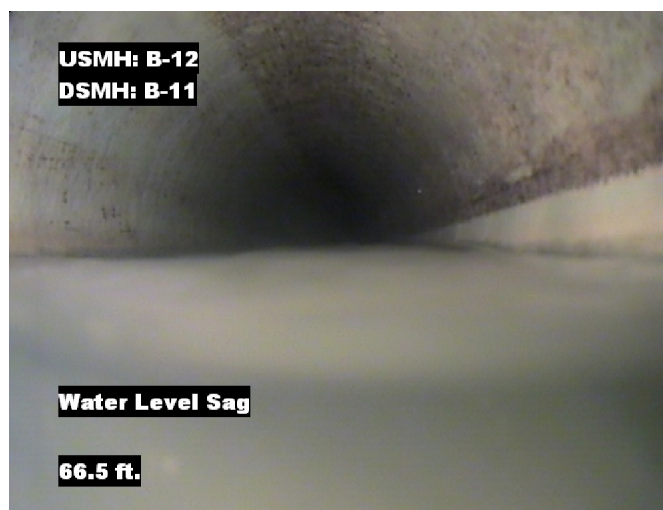
Distance: 66.5 ft. Grade: 2
Condition: Water Level Sag
Remarks: N/A

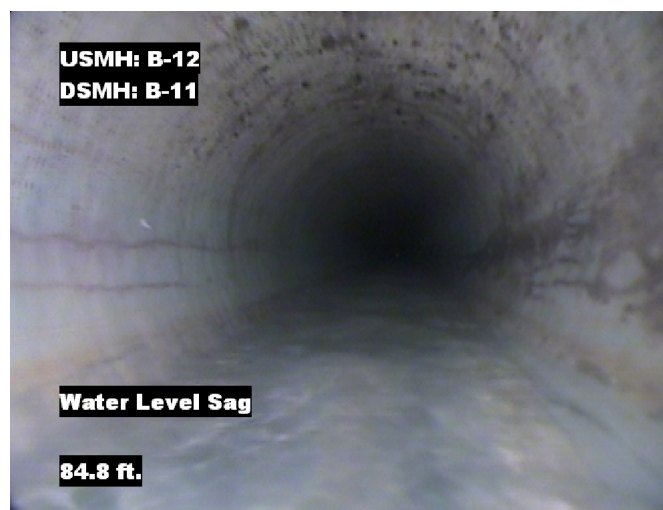
Distance: 84.6 ft. Grade: 2
Condition: Water Level Sag
Remarks: N/A

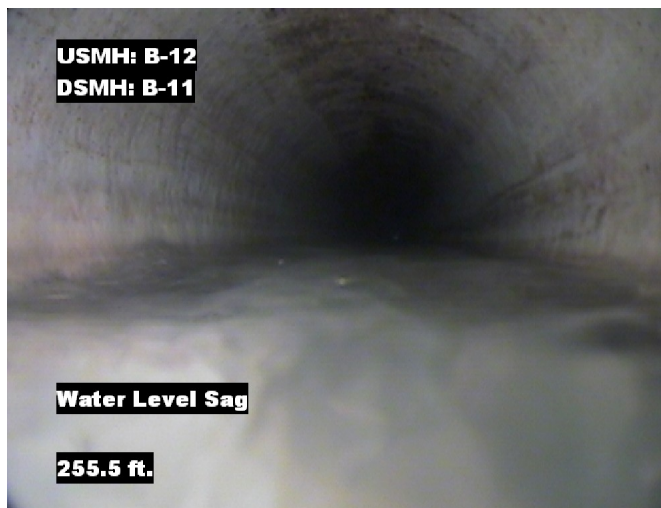
Distance: 255.5 ft. Grade: 2
Condition: Water Level Sag
Remarks: N/A

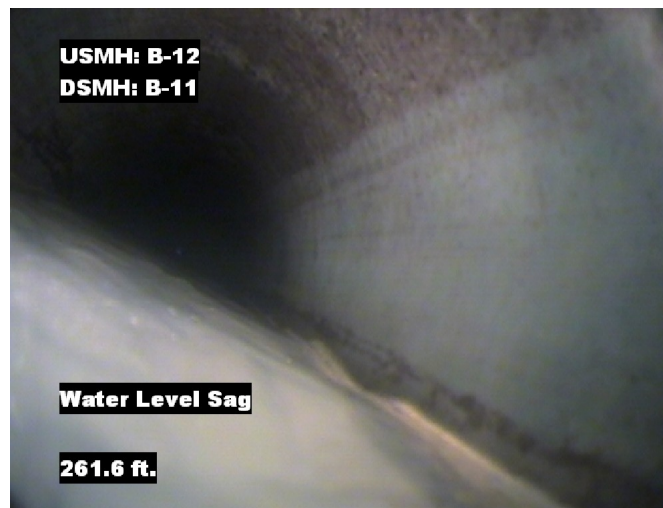
Distance: 261.6 ft. Grade: 2
Condition: Water Level Sag
Remarks: N/A

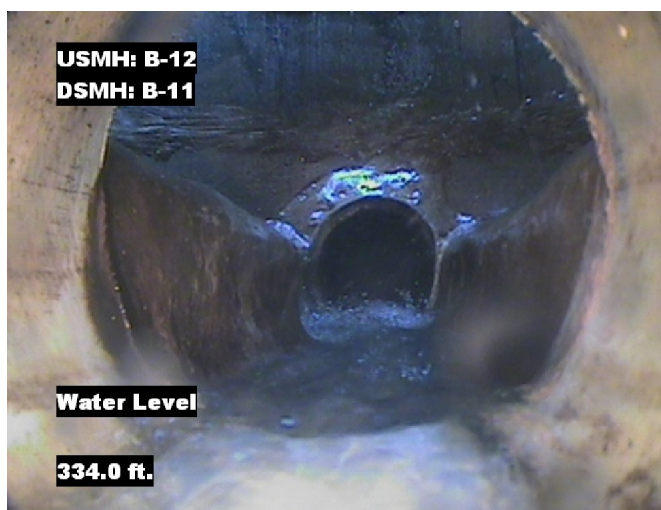
Distance: 334.0 ft. Grade: 0
Condition: Water Level
Remarks: N/A
