## Defect Listing

Pipe Segment Refere... <b>B-14_B-13</b>	City <b>Oliver Springs</b>	Street <b>Cemetery Rd</b>	Material <b>Fibreglass Reinforc...</b>	Location C... <b>Easement/R...</b>	Sewer Use <b>Sanitary</b>
Upstream MH <b>B-14</b>	Total Length <b>327.8</b>	Year Laid	Shape <b>Circular</b>	Location Details	
DS Manhole <b>B-13</b>	Length surveyed <b>327.8</b>	Year Renewed	Height <b>8</b>	Width <b>8</b>	Pipe Joint... <b>N/A</b>

## Image Report 4/Page

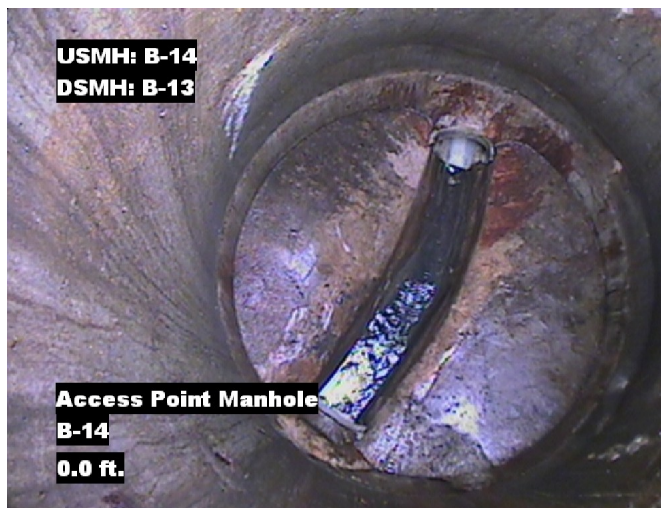
Distance: 0.0 ft. Grade: 0  
Condition: Access Point Manhole  
Remarks: B-14

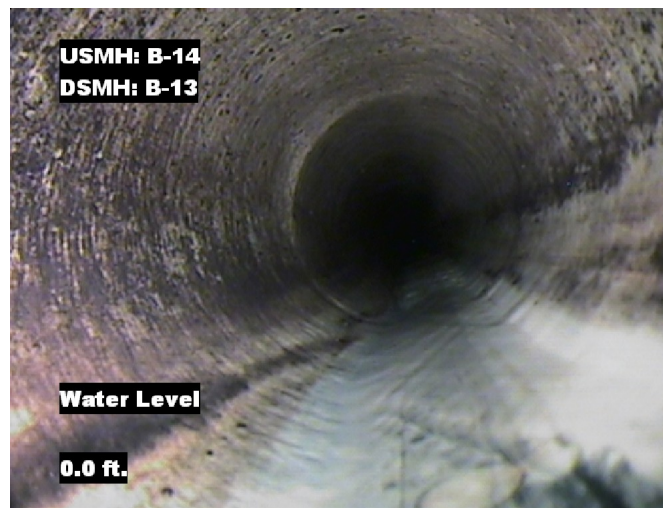
Distance: 0.0 ft. Grade: 0  
Condition: Water Level  
Remarks: N/A

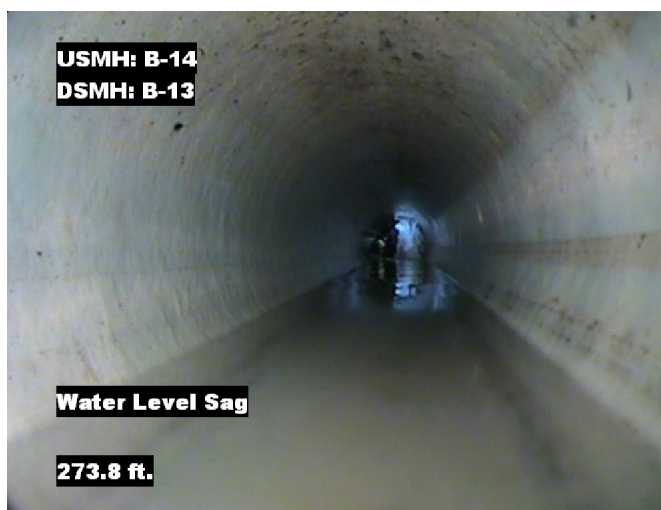
Distance: 273.8 ft. Grade: 2  
Condition: Water Level Sag  
Remarks: N/A

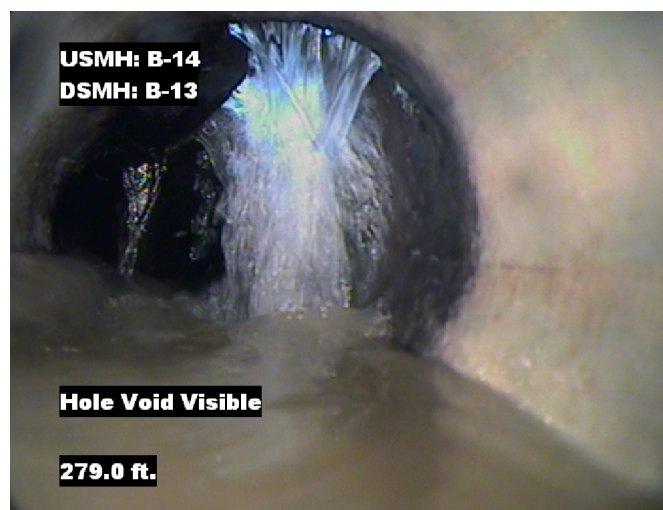
Distance: 279.0 ft. Grade: 5  
Condition: Hole Void Visible  
Remarks: N/A

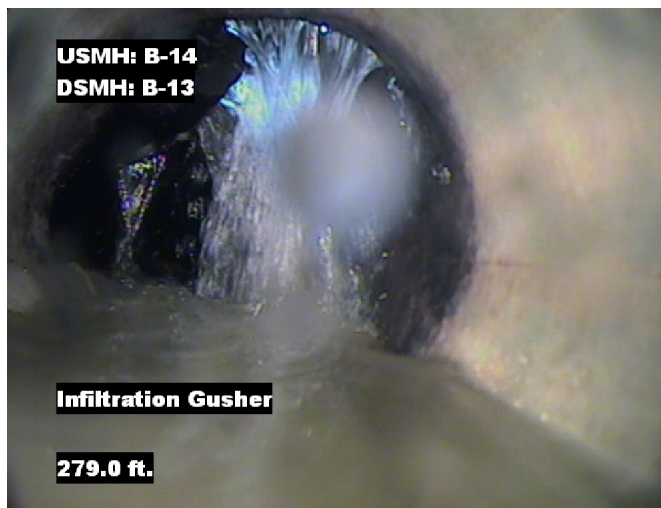
Distance: 279.0 ft. Grade: 5  
Condition: Infiltration Gusher  
Remarks: N/A

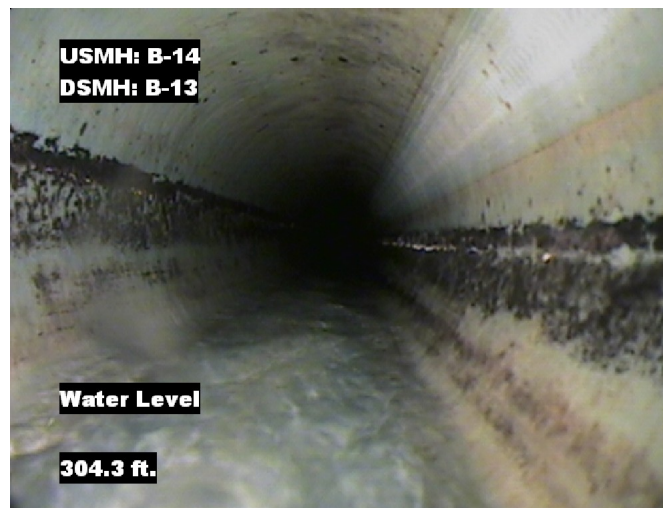
Distance: 304.3 ft. Grade: 0  
Condition: Water Level  
Remarks: N/A

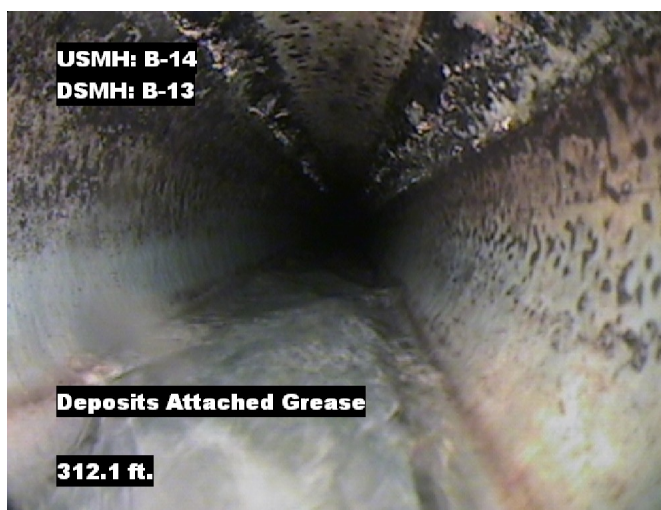
Distance: 312.1 ft. Grade: 2  
Condition: Deposits Attached Grease  
Remarks: N/A

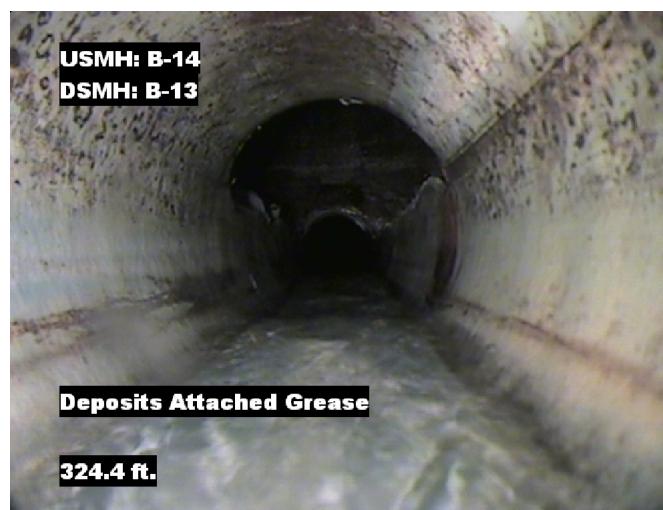
Distance: 324.4 ft. Grade: 2  
Condition: Deposits Attached Grease  
Remarks: N/A

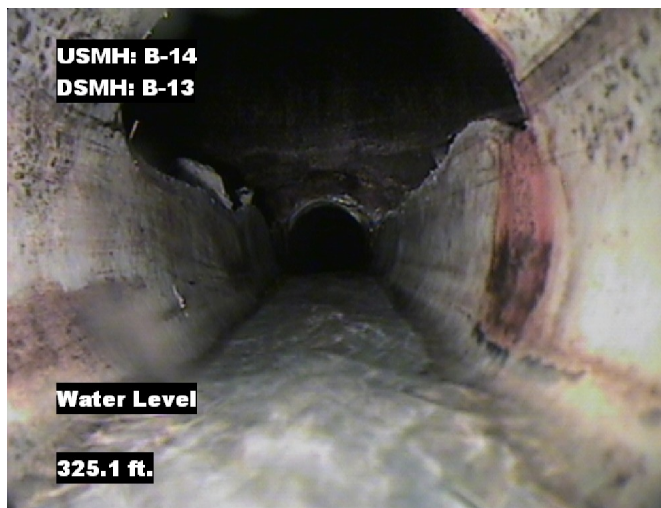
Distance: 325.0 ft.      Grade: 0  
Condition: Water Level  
Remarks: N/A

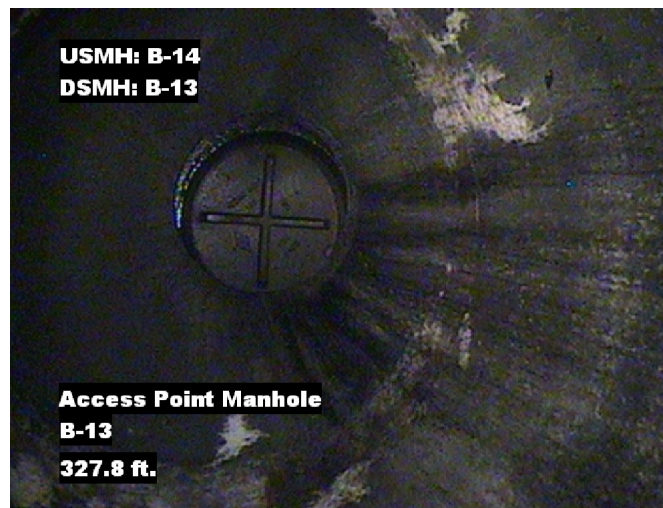
Distance: 327.8 ft.      Grade: 0  
Condition: Access Point Manhole  
Remarks: B-13
