Defect Listing

Pipe Segment Refere... B-16_B-15	City Oliver Springs	Street Cemetery Rd	Material Fibreglass Reinforc...	Location C... Easement/R...	Sewer Use Sanitary
Upstream MH B-16	Total Length 157.2	Year Laid	Shape Circular	Location Details	
DS Manhole B-15	Length surveyed 157.2	Year Renewed	Height 8	Width 8	Pipe Joint... N/A

SPR 3	MPR N/A	PO Number 4397-03	Customer GRW
SPRI 3	MPRI N/A	Work Order 4397-02	Purpose Pre-Rehabilitation Survey
QSR 3100	QMR N/A		
OPR 3	Surveyed By Charlie Gordon	Direction Upstream	Date 20150911
OPRI 3	Certificate Number U-615-07000491	Pre-Cleaning Jetting	Time 08:05
	Date Cleaned 20150911	End Time 08:14	Weather Damp
			Media label
			Additional Info

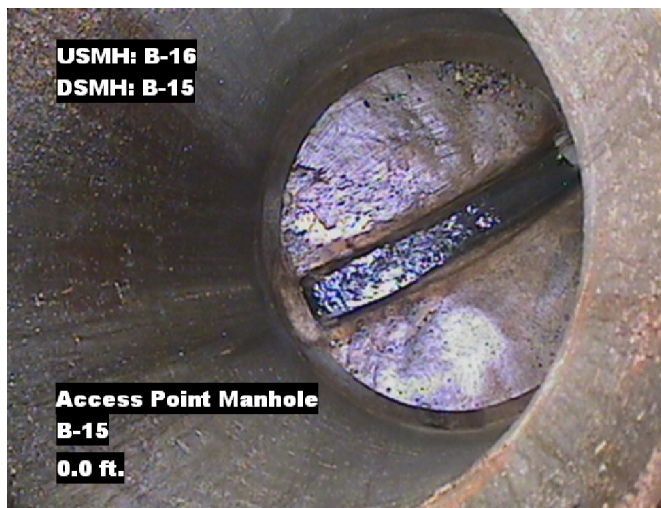
Distance: 0.0 ft. Grade: 0
Condition: Access Point Manhole
Remarks: B-15

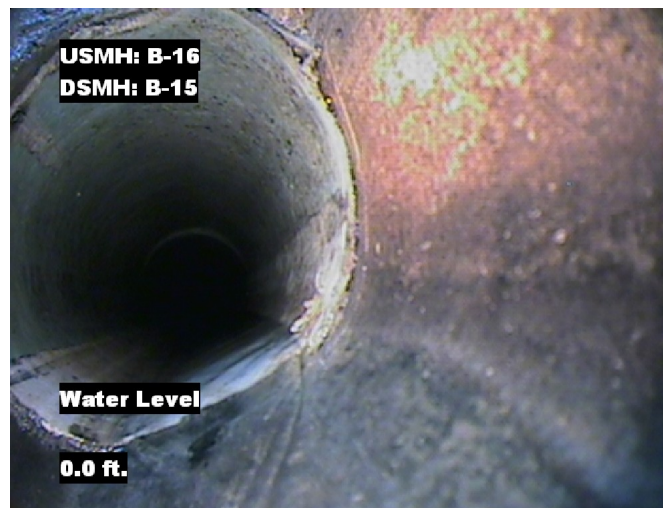
Distance: 0.0 ft. Grade: 0
Condition: Water Level
Remarks: N/A

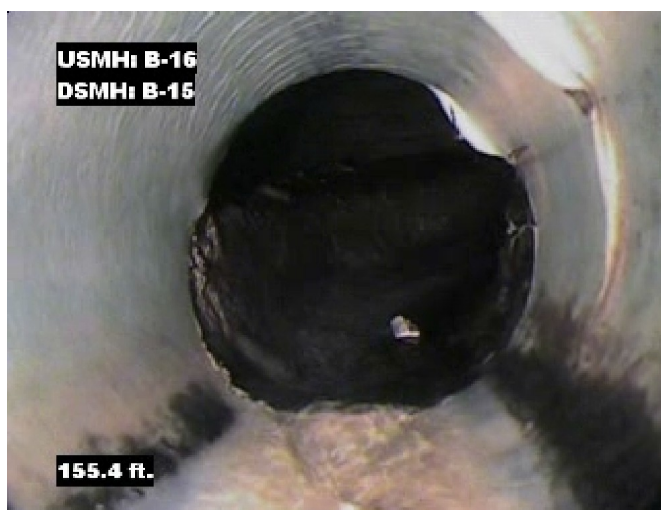
Distance: 155.4 ft. Grade: 3
Condition: Lining Failure Wrinkled
Remarks: N/A

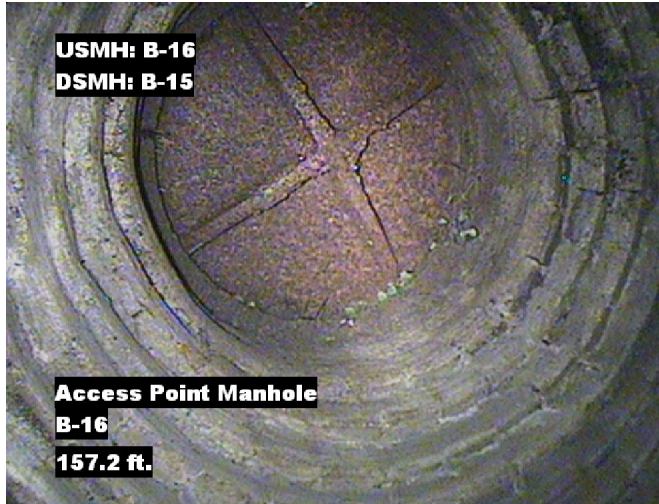
Distance: 157.2 ft. Grade: 0
Condition: Access Point Manhole
Remarks: B-16
