## **Defect Listing**

Pipe Segment Refere		City		Street	Mat	erial	Location C	Sewer Use
B-17_B-16		Oliver Springs		Cemetery Rd	Fibreglass	Fibreglass Reinforc		Sanitary
Upstream MH		Total Length		Year Laid	Sh	Shape		Details
B-	B-17		4.6		Circ	ular		
DS Ma	anhole	Length s	Length surveyed Year Renewed Height Width Pipe Join		Pipe Joint			
B-16		254.6			8	8	N/A	
SPR	N/A	MPR	N/A	PO Number	PO Number		Customer	
0001	-			4397-03		GRW		
SPRI	N/A	MPRI	N/A	Work Order			Purpose	
QSR	N/A	QMR	N/A	4397-02		Pre-Rehabilitation Survey		
Ol	PR	Surveyed By		Direction	Date		Media label	
N	/A	Charlie_Gordon		Downstream	20150910			
OF	PRI	Certificate Number		Pre-Cleaning	Time		Weather	
N/A		U-615-07000491		Jetting	10:02		Light Rain	
		Date C	leaned	End Time		Additional Info		
		2015	10:16

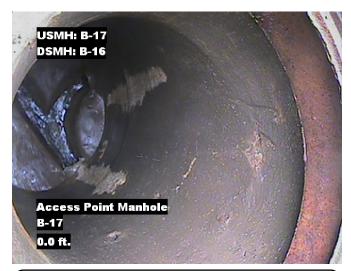
Distance: 0.0 ft. Grade: 0

Condition: Access Point Manhole

Remarks: B-17

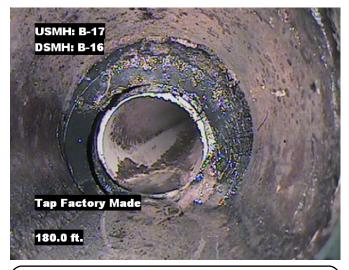
Distance: 180.0 ft. Grade: 0

Condition: Tap Factory Made

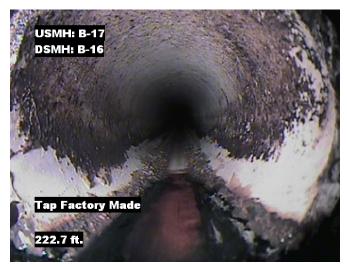
Distance: 222.7 ft. Grade:

Condition: Tap Factory Made

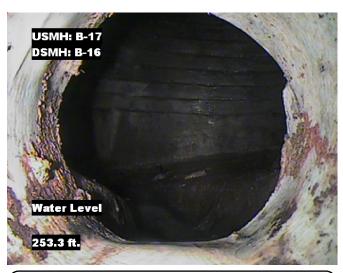
Distance: 253.3 ft. Grade:

Condition: Water Level
