Defect Listing

Image Report 4/Page

PACP Conditions

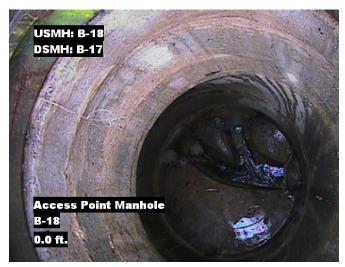
Distance: 0.0 ft. Grade: 0

Condition: Access Point Manhole

Remarks: B-18

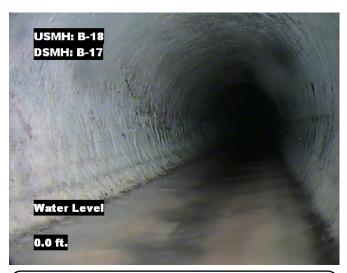
Distance: 0.0 ft. Grade: (

Condition: Water Level

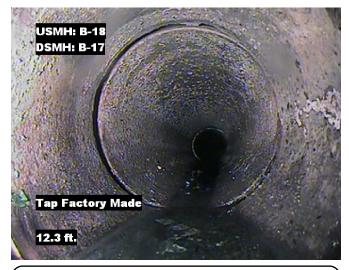
Distance: 12.3 ft. Grade: 0

Condition: Tap Factory Made

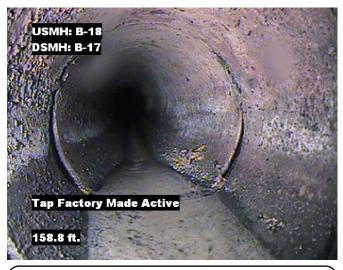
Distance: 158.8 ft. Grade: 0

Condition: Tap Factory Made Active

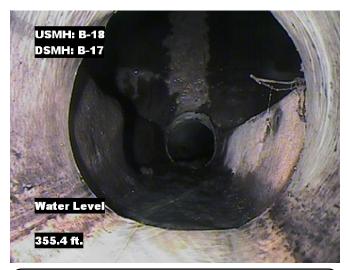
Distance: 355.4 ft. Grade: 0

Condition: Water Level

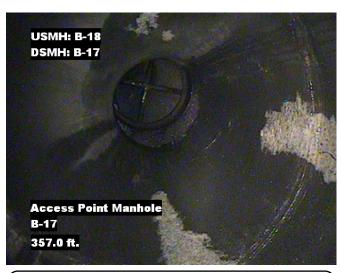
Distance: 357.0 ft. Grade: 0

Condition: Access Point Manhole

Remarks: B-17
