Defect Listing

| B-19_B-18 | Oliver Springs | Cemtery Rd | Fibreglass Reinforc... | Light High... | Sanitary |

| | | | 4397-02 | Pre-Rehabilitation Survey | |

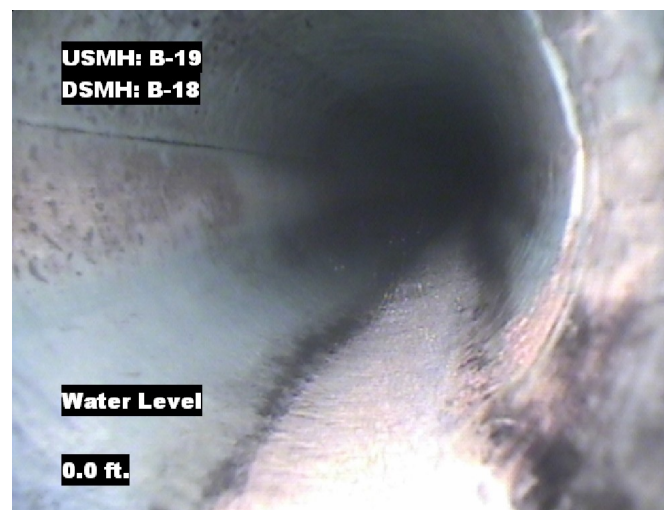
Distance: 0.0 ft. Grade: 0
Condition: Water Level
Remarks: N/A

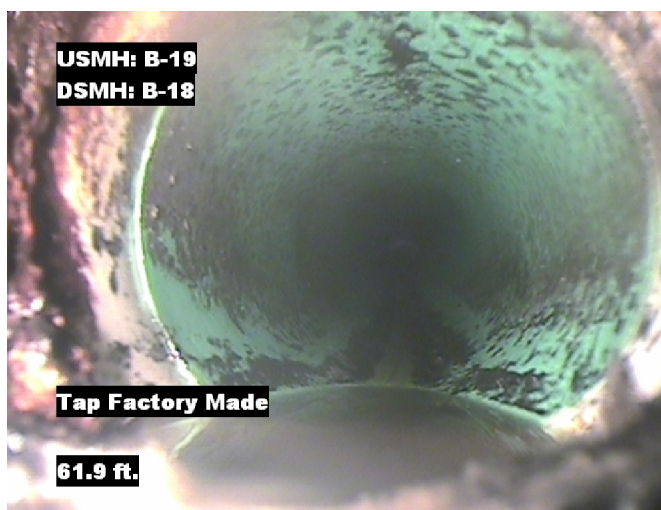
Distance: 61.9 ft. Grade: 0
Condition: Tap Factory Made
Remarks: N/A

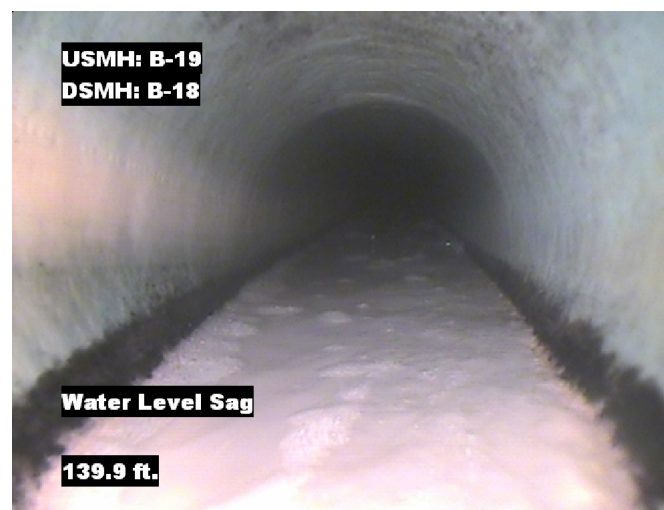
| Distance | Condition | Cont. Dfct. | Values | | | Joint | Clock Position | | Grade |
|---|---|---|---|---|---|---|---|---|---|
| 139.9 ft. | Water Level Sag | | | | 15 | <input type="checkbox"/> | | | 2 |

Distance: 139.9 ft. Grade: 2
Condition: Water Level Sag
Remarks: N/A

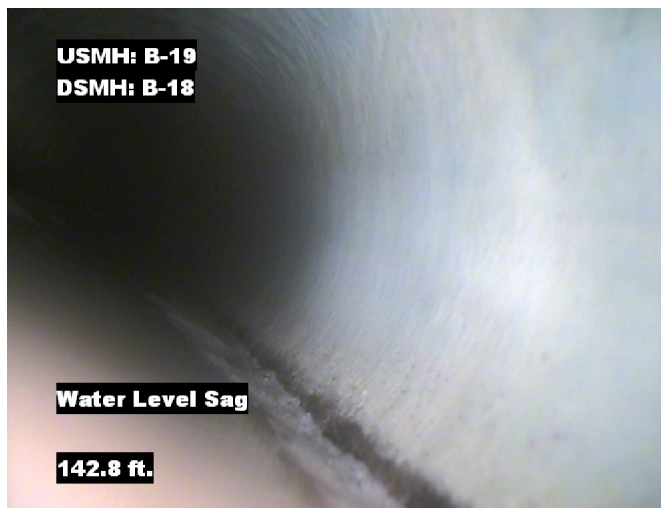
| Distance | Condition | Cont. Dfct. | Values | | | Joint | Clock Position | | Grade |
|---|---|---|---|---|---|---|---|---|---|
| 142.8 ft. | Water Level Sag | S01 | | | 15 | <input type="checkbox"/> | | | 2 |

Distance: 142.8 ft. Grade: 2
Condition: Water Level Sag
Remarks: N/A

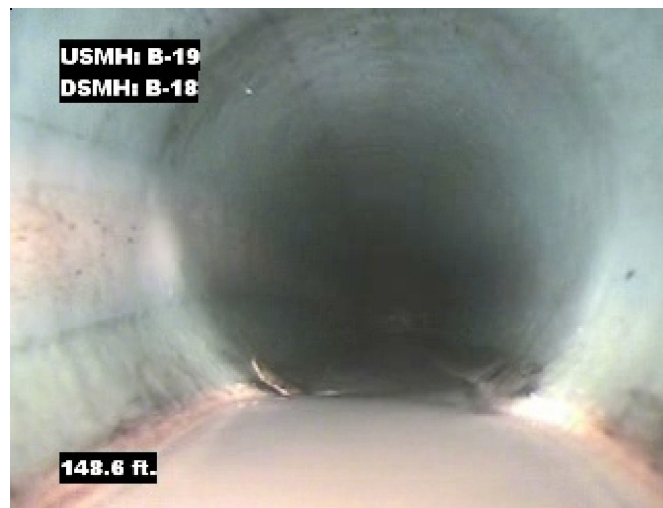
| Distance | Condition | Cont. Dfct. | Values | | | Joint | Clock Position | | Grade |
|---|---|---|---|---|---|---|---|---|---|
| 148.6 ft. | Alignment Down | | | | 10 | <input type="checkbox"/> | | | 1 |

Distance: 148.6 ft. Grade: 1
Condition: Alignment Down
Remarks: N/A

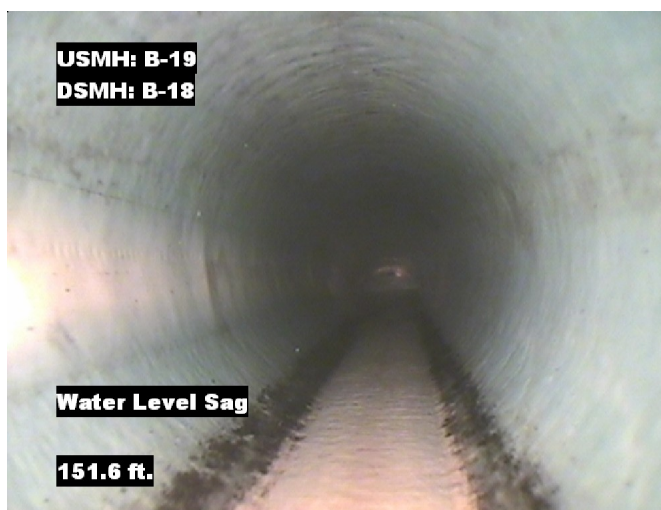
| Distance | Condition | Cont. Dfct. | Values | | | Joint | Clock Position | | Grade |
|---|---|---|---|---|---|---|---|---|---|
| 151.6 ft. | Water Level Sag | F01 | | | 15 | <input type="checkbox"/> | | | 2 |

Distance: 151.6 ft. Grade: 2
Condition: Water Level Sag
Remarks: N/A

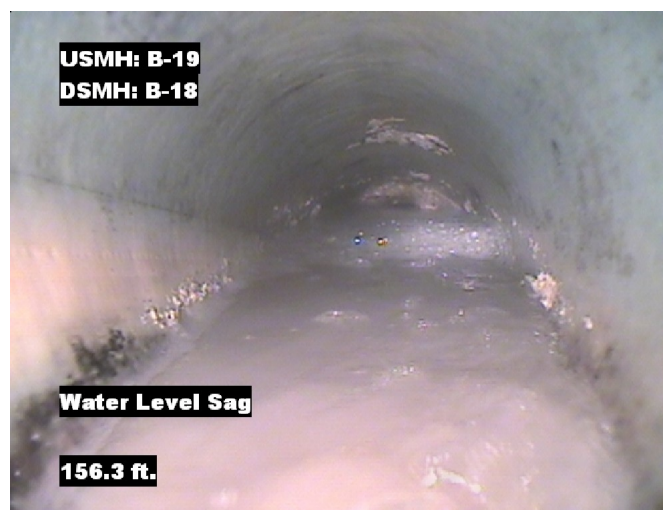
| Distance | Condition | Cont. Dfct. | Values | | | Joint | Clock Position | | Grade |
|---|---|---|---|---|---|---|---|---|---|
| 156.3 ft. | Water Level Sag | | | | 20 | <input type="checkbox"/> | | | 2 |

Distance: 156.3 ft. Grade: 2
Condition: Water Level Sag
Remarks: N/A

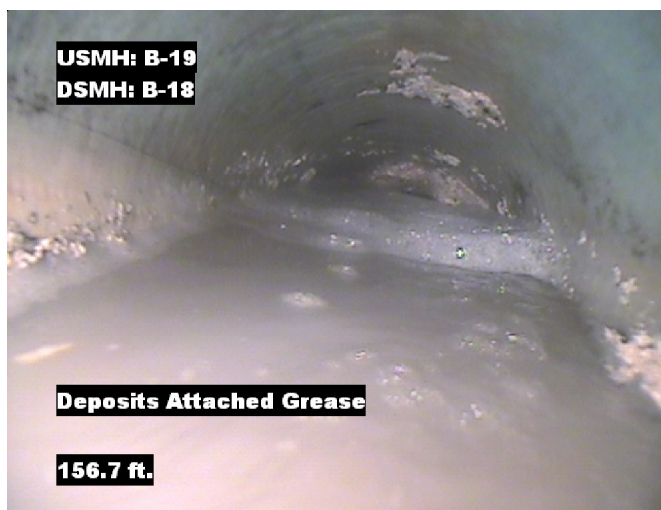
| Distance | Condition | Cont. Dfct. | Values | | | Joint | Clock Position | | Grade |
|---|---|---|---|---|---|---|---|---|---|
| 156.7 ft. | Deposits Attached Grease | | | | 5 | <input type="checkbox"/> | 9 | 3 | 2 |

Distance: 156.7 ft. Grade: 2
Condition: Deposits Attached Grease
Remarks: N/A

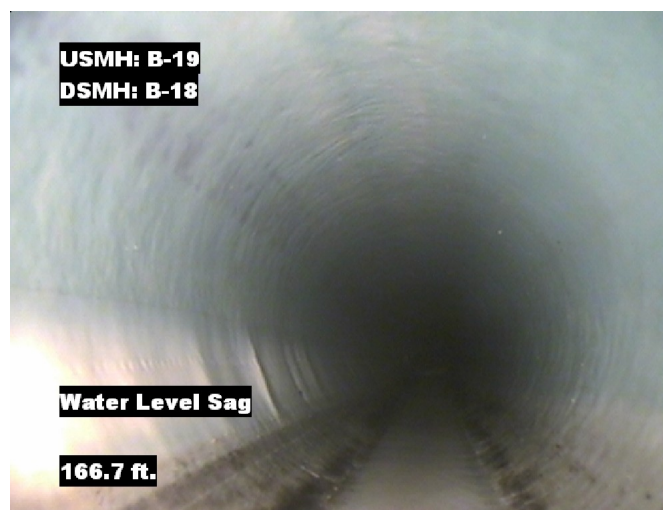
| Distance | Condition | Cont. Dfct. | Values | | | Joint | Clock Position | | Grade |
|---|---|---|---|---|---|---|---|---|---|
| 166.7 ft. | Water Level Sag | | | | 10 | <input type="checkbox"/> | | | 2 |

Distance: 166.7 ft. Grade: 2
Condition: Water Level Sag
Remarks: N/A

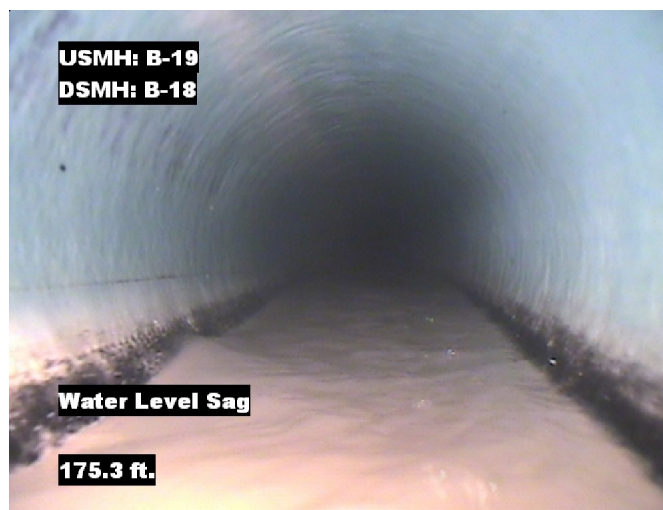
| Distance | Condition | Cont. Dfct. | Values | | | Joint | Clock Position | | Grade |
|---|---|---|---|---|---|---|---|---|---|
| 175.3 ft. | Water Level Sag | | | | 10 | <input type="checkbox"/> | | | 2 |

Distance: 175.3 ft. Grade: 2
Condition: Water Level Sag
Remarks: N/A

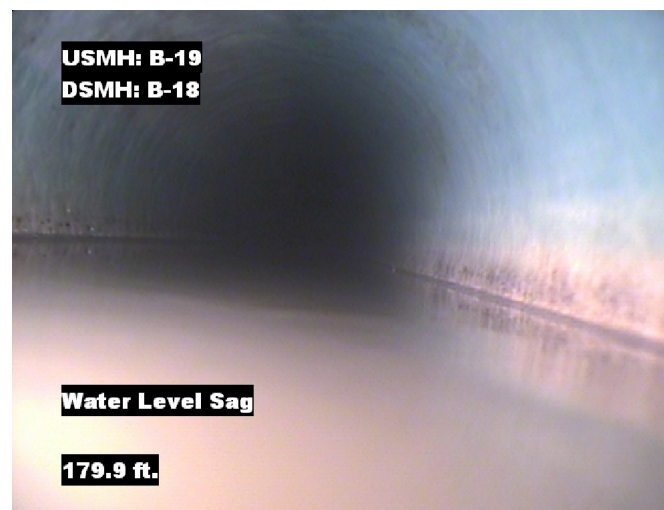
| Distance | Condition | Cont. Dfct. | Values | | | Joint | Clock Position | | Grade |
|---|---|---|---|---|---|---|---|---|---|
| 179.9 ft. | Water Level Sag | | | | 15 | <input type="checkbox"/> | | | 2 |

Distance: 179.9 ft. Grade: 2
Condition: Water Level Sag
Remarks: N/A

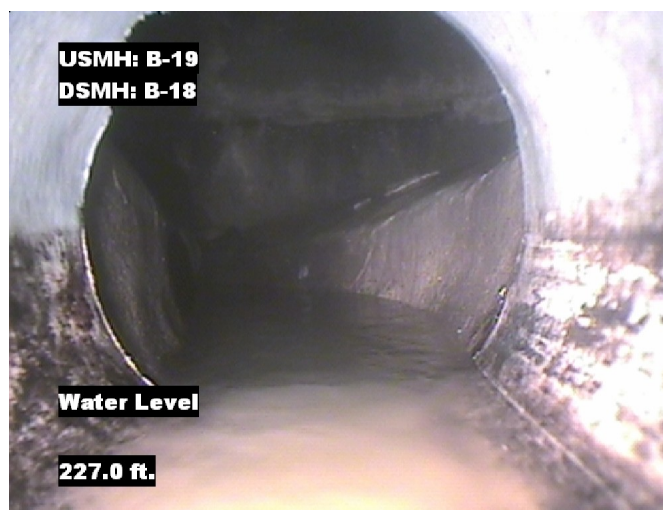
Distance: 227.0 ft. Grade: 0
Condition: Water Level
Remarks: N/A
