Defect Listing

Pipe Segment Refere... B-2_B-1	City Oliver Springs	Street Old Harriman hwy	Material Fibreglass Reinforc...	Location C... Easement/R...	Sewer Use Sanitary
Upstream MH B-2	Total Length 319.3	Year Laid	Shape Circular	Location Details	
DS Manhole B-1	Length surveyed 319.3	Year Renewed	Height 10	Width 10	Pipe Joint... N/A

Image Report 4/Page

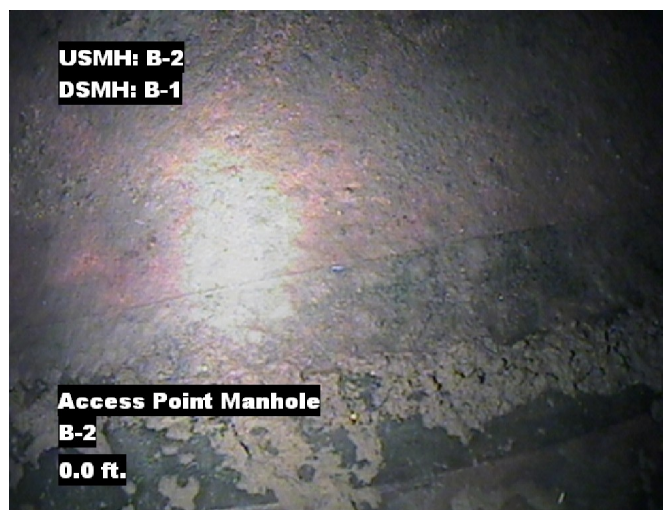
Distance: 0.0 ft. Grade: 0
Condition: Access Point Manhole
Remarks: B-2

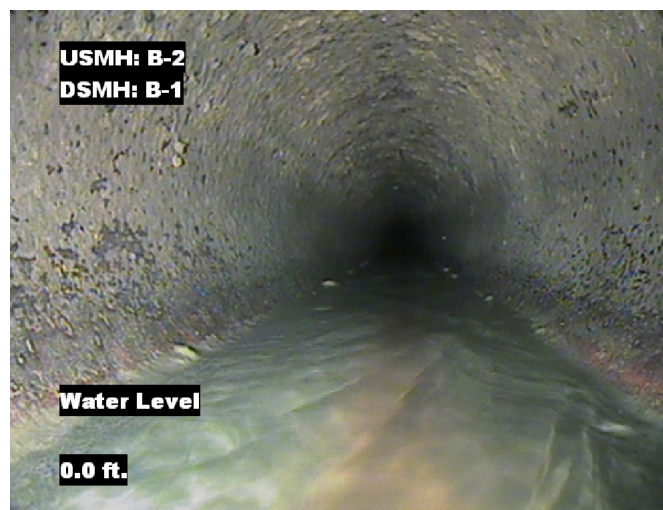
Distance: 0.0 ft. Grade: 0
Condition: Water Level
Remarks: N/A

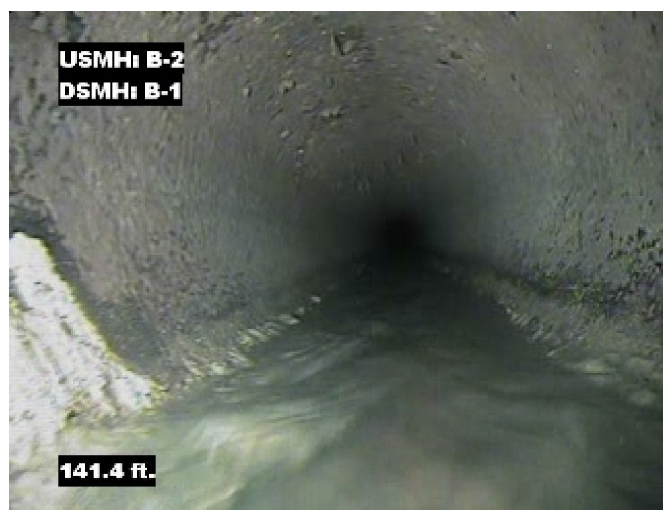
Distance: 141.4 ft. Grade: 2
Condition: Deposits Attached Grease
Remarks: N/A

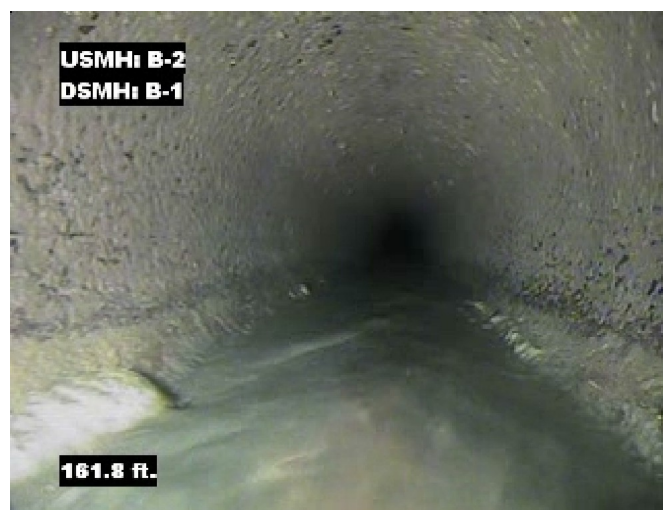
Distance: 161.8 ft. Grade: 2
Condition: Deposits Attached Grease
Remarks: N/A

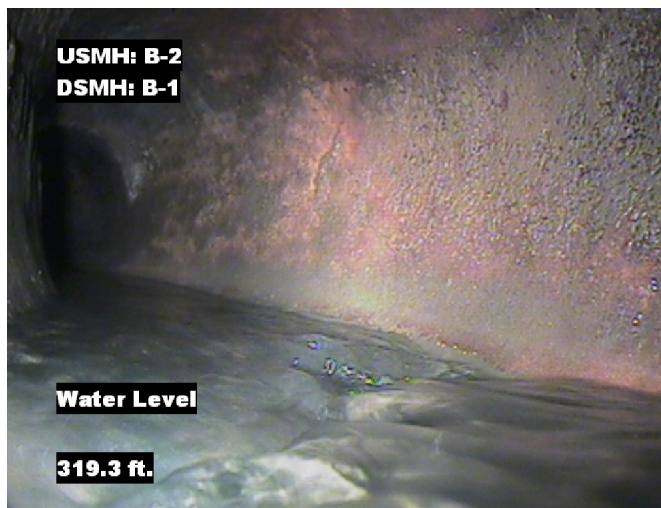
Distance: 319.3 ft. Grade: 0
Condition: Water Level
Remarks: N/A

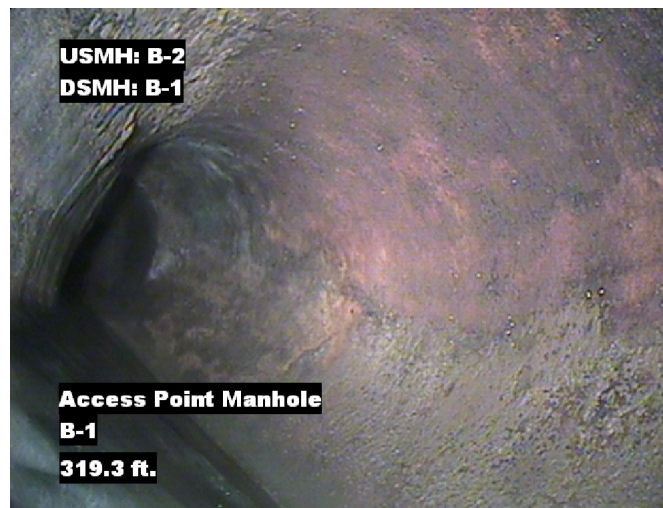
Distance: 319.3 ft. Grade: 0
Condition: Access Point Manhole
Remarks: B-1
