Defect Listing

Pipe Segment Refere... B-20_B-19	City Oliver springs	Street Cemtery Rd	Material Fibreglass Reinforc...	Location C... Light High...	Sewer Use Sanitary
Upstream MH B-20	Total Length 331.6	Year Laid	Shape Circular	Location Details	
DS Manhole B-19	Length surveyed 331.6	Year Renewed	Height 8	Width 8	Pipe Joint... N/A

SPR N/A	MPR N/A	PO Number 4397-03	Customer GRW
SPRI N/A	MPRI N/A	Work Order 4397-02	Purpose Pre-Rehabilitation Survey
QSR N/A	QMR N/A		
OPR N/A	Surveyed By Charlie Gordon	Direction Downstream	Date 20150908
OPRI N/A	Certificate Number U-615-07000491	Pre-Cleaning Jetting	Time 07:46
	Date Cleaned 20150908	End Time 08:05	Weather Dry
			Additional Info

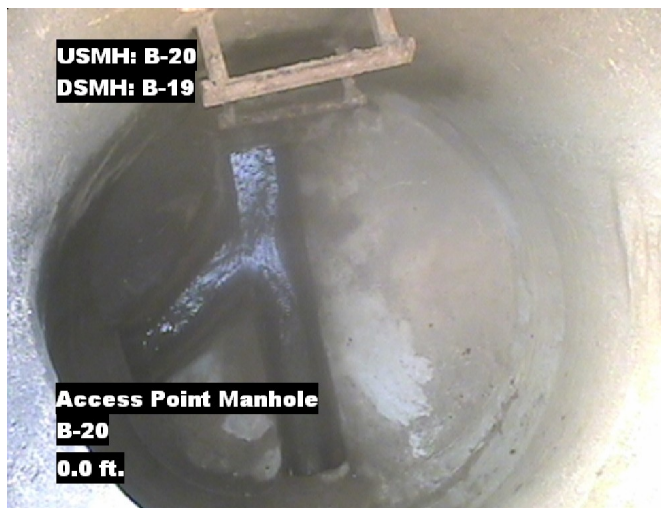
Distance: 0.0 ft. Grade: 0
Condition: Access Point Manhole
Remarks: B-20

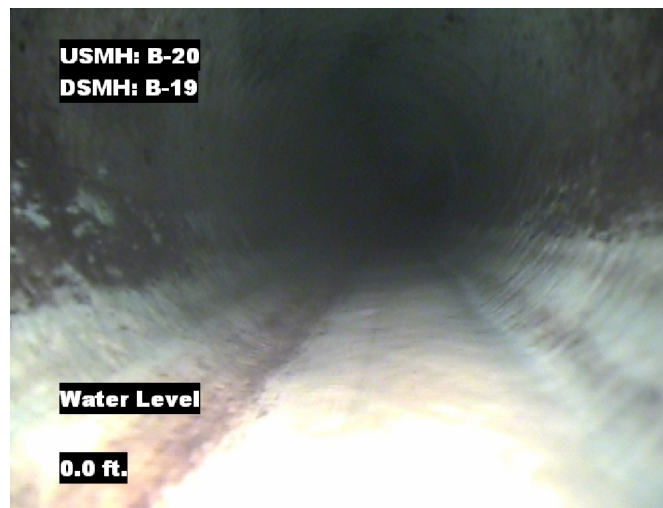
Distance: 0.0 ft. Grade: 0
Condition: Water Level
Remarks: N/A

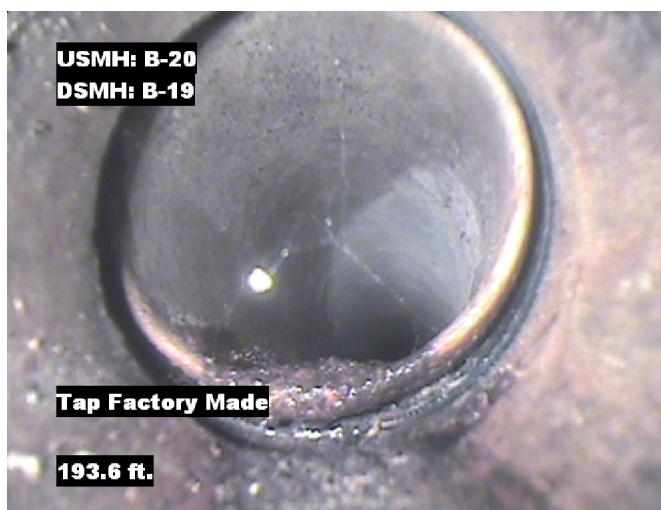
Distance: 193.6 ft. Grade: 0
Condition: Tap Factory Made
Remarks: N/A

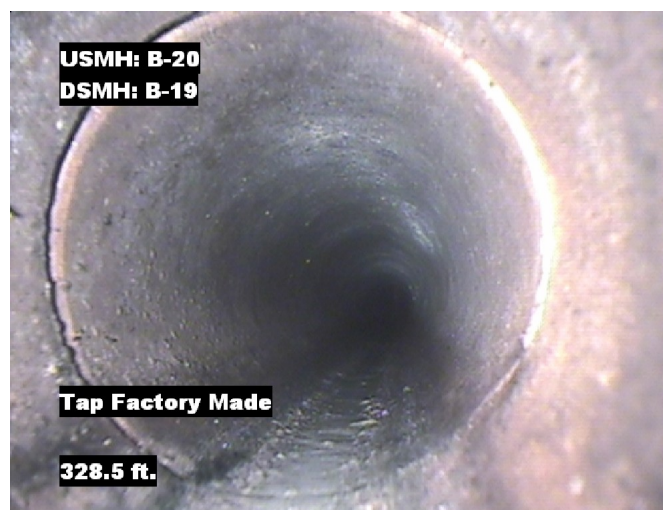
Distance: 328.5 ft. Grade: 0
Condition: Tap Factory Made
Remarks: N/A

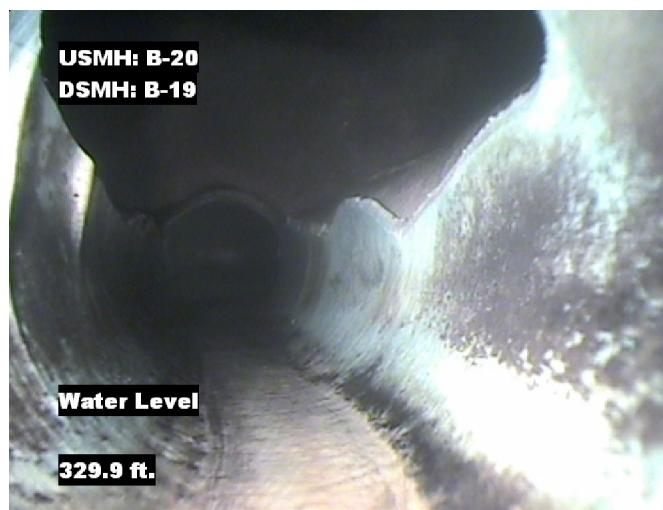
Distance: 329.9 ft. Grade: 0
Condition: Water Level
Remarks: N/A

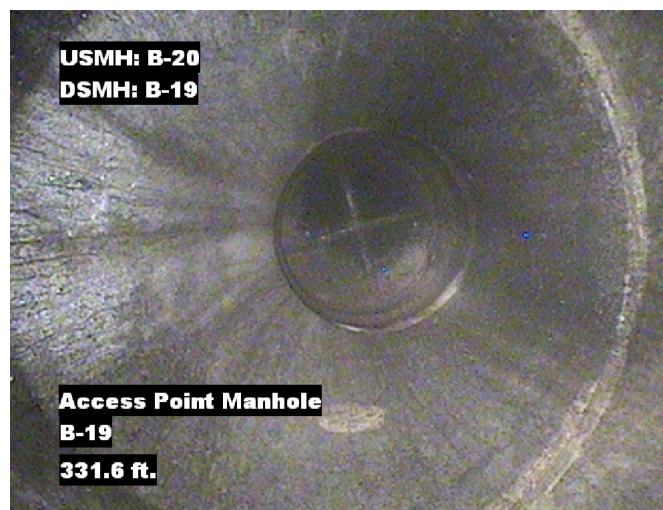
Distance: 331.6 ft. Grade: 0
Condition: Access Point Manhole
Remarks: B-19
