Defect Listing

Pipe Segment Refere... B-22_B-21	City Oliver Springs	Street cemetery Rd	Material Concrete Pipe (non-...	Location C... Light High...	Sewer Use Sanitary
Upstream MH B-22	Total Length 172.2	Year Laid	Shape Circular	Location Details	
DS Manhole B-21	Length surveyed 172.2	Year Renewed	Height 8	Width 8	Pipe Joint... 4

SPR N/A	MPR N/A	PO Number 4397-03		Customer GRW	
SPRI N/A	MPRI N/A	Work Order 4397-02		Purpose Pre-Rehabilitation Survey	
QSR N/A	QMR N/A				
OPR N/A	Surveyed By Charlie Gordon	Direction Downstream	Date 20150903	Media label	
OPRI N/A	Certificate Number U-615-07000491	Pre-Cleaning Jetting	Time 14:54	Weather Dry	
Date Cleaned 20150903			End Time 14:56	Additional Info

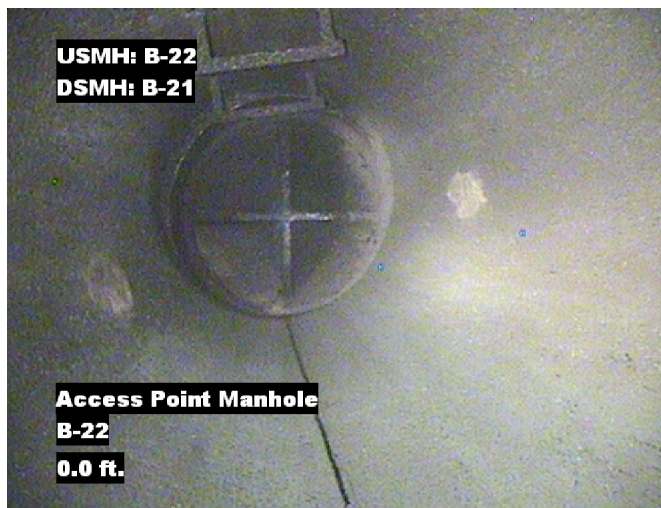
Distance: 0.0 ft. Grade: 0
Condition: Access Point Manhole
Remarks: B-22

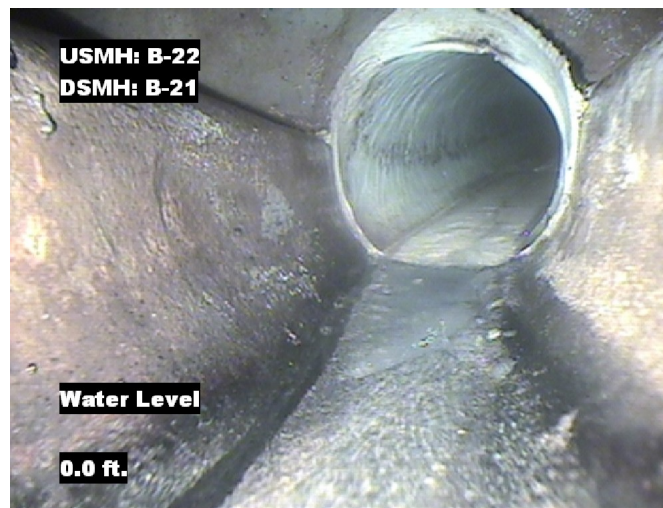
Distance: 0.0 ft. Grade: 0
Condition: Water Level
Remarks: N/A

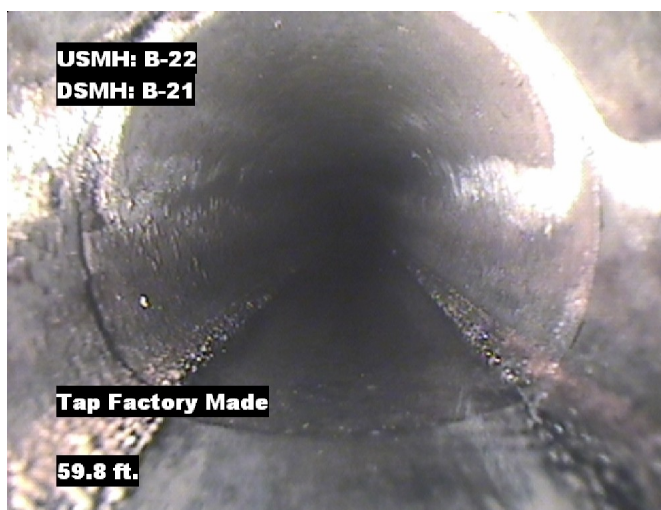
Distance: 59.8 ft. Grade: 0
Condition: Tap Factory Made
Remarks: N/A

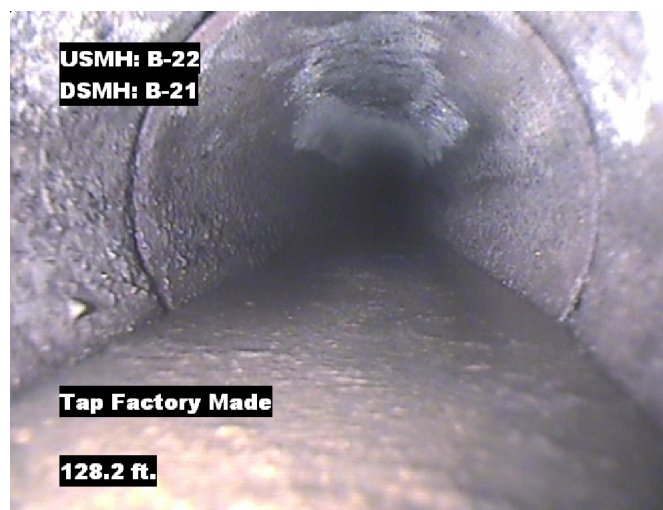
Distance: 128.2 ft. Grade: 0
Condition: Tap Factory Made
Remarks: N/A

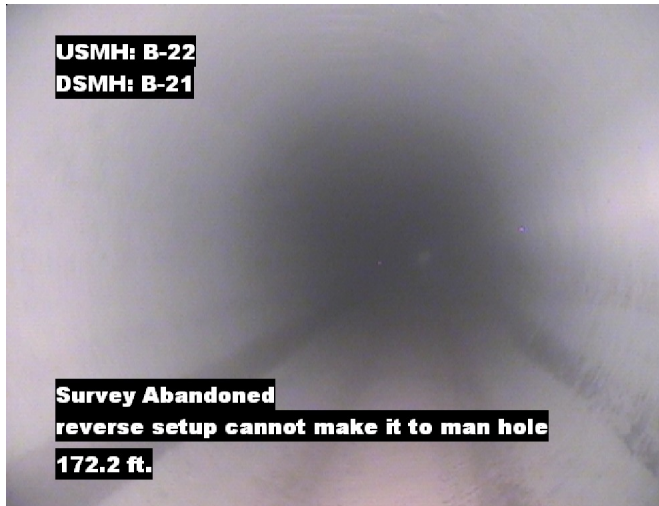
Distance: 172.2 ft. Grade: 0
Condition: Survey Abandoned
Remarks: reverse setup cannot make it to man hole
