Defect Listing

Pipe Segment Refere... B-23_B-22	City Oliver Springs	Street pride rd	Material Concrete Pipe (non-...	Location C... Light High...	Sewer Use Sanitary
Upstream MH B-23	Total Length 126.3	Year Laid	Shape Circular	Location Details	
DS Manhole B-22	Length surveyed 55.3	Year Renewed	Height 8	Width 8	Pipe Joint... 4

SPR 7	MPR N/A	PO Number 4397-03	Customer GRW
SPRI 3.5	MPRI N/A	Work Order 4397-02	Purpose Pre-Rehabilitation Survey
QSR 4131	QMR N/A		
OPR 7	Surveyed By Charlie Gordon	Direction Upstream	Date 20150903
OPRI 3.5	Certificate Number U-615-07000491	Pre-Cleaning Jetting	Time 15:07
	Date Cleaned 20150910	End Time 15:14	Weather Dry
		Additional Info

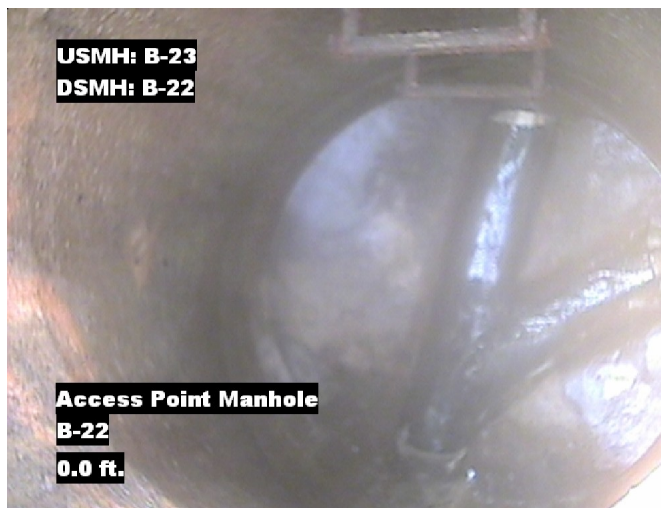
Distance: 0.0 ft. Grade: 0
Condition: Access Point Manhole
Remarks: B-22

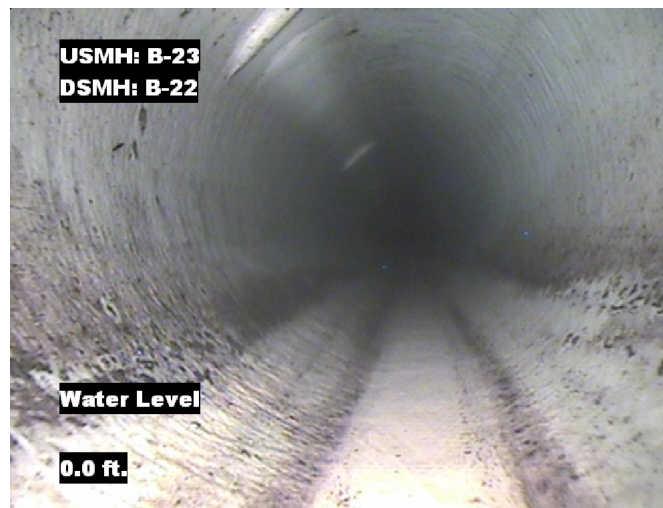
Distance: 0.0 ft. Grade: 0
Condition: Water Level
Remarks: N/A

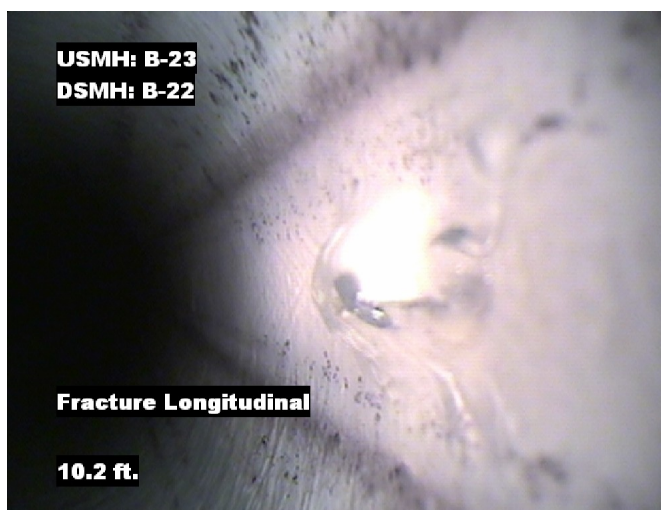
Distance: 10.2 ft. Grade: 3
Condition: Fracture Longitudinal
Remarks: N/A

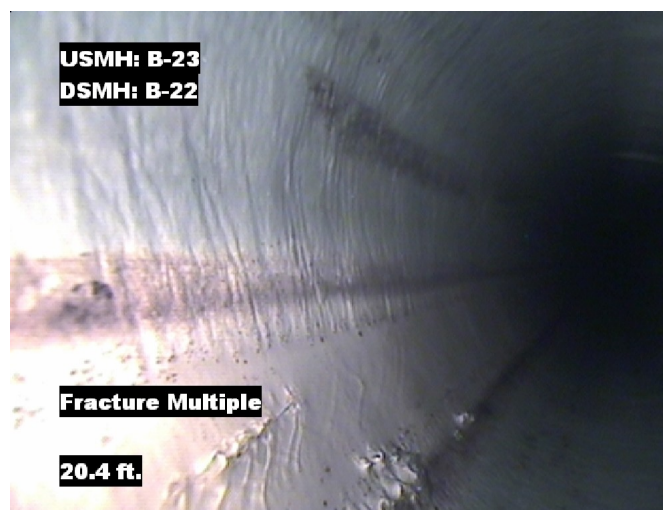
Distance: 20.4 ft. Grade: 4
Condition: Fracture Multiple
Remarks: N/A

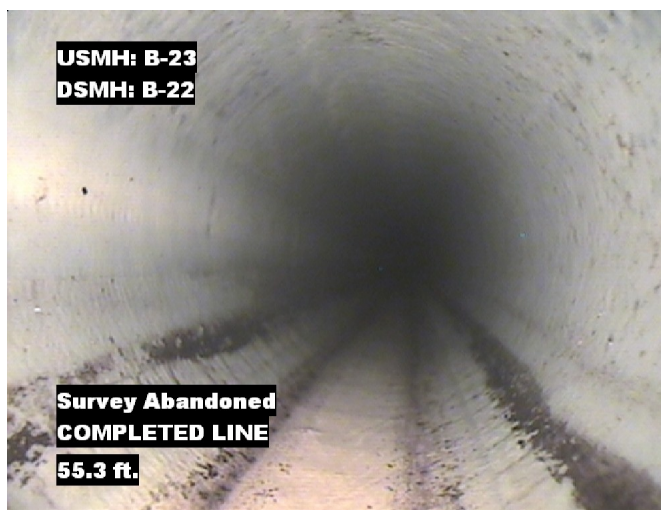
Distance: 55.3 ft. Grade: 0
Condition: Survey Abandoned
Remarks: COMPLETED LINE
