Defect Listing

Pipe Segme	ent Refere	С	ity	Street	Mat	erial	Location C	Sewer Use		
B-24	_B-23	Oliver	Springs	Pride Rd	Concrete F	Pipe (non	Light High	Sanitary		
Upstre	am MH	Total I	_ength	Year Laid	Sh	ape	Location Deta			
B-	24	35	1.3		Circ	Circular				
DS Ma	anhole	Length s	surveyed	Year Renewed	Height Width		Height Width Pipe Jo		Width Pipe Joint 8 4	
B-	23	35	1.3		8	8				
SPR	N/A	MPR	2	PO Number			Customer			
0001	-	MDDI		4397-03 Work Order		GRW				
SPRI	N/A	MPRI	2			Purpose				
QSR	N/A	QMR	2100	4397-02		Pre-	-Rehabilitation Survey			
Ol	PR	Surve	yed By	Direction	Da	ate	Media	alabel		
2	2	Charlie_	Gordon	Downstream	2015	0903				
OF	PRI	Certificat	e Number	Pre-Cleaning	Tir	me	Weather			
:	2		7000491	Jetting	13	:13	Dry			
		Date C	leaned	Er		End Time		Additional Info		
		2015	0903		13:38

Image Report 4/Page

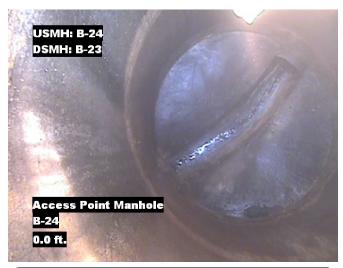
Distance: 0.0 ft. Grade: 0

Condition: Access Point Manhole

Remarks: B-24

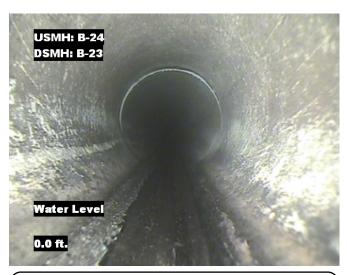
Distance: 0.0 ft. Grade: 0

Condition: Water Level

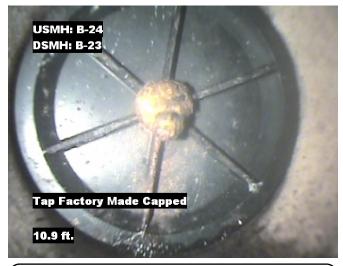
Distance: 10.9 ft. **Grade**: 0 **Condition**: Tap Factory Made Capped

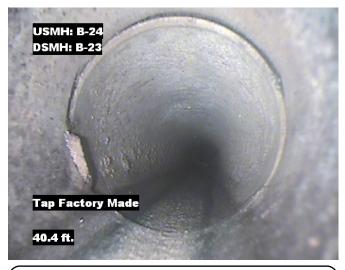
Distance: 40.4 ft. Grade: 0

Condition: Tap Factory Made

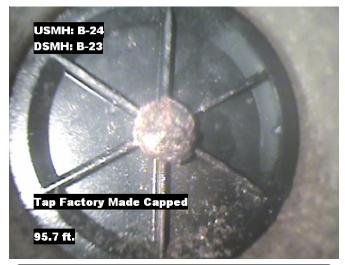
Distance: 95.7 ft. Grade: Condition:

Tap Factory Made Capped

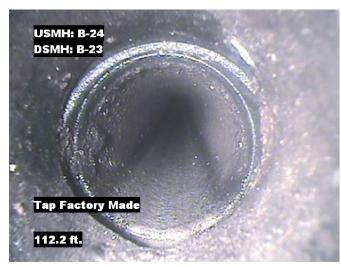
Distance: 112.2 ft. Grade:

Condition: Tap Factory Made

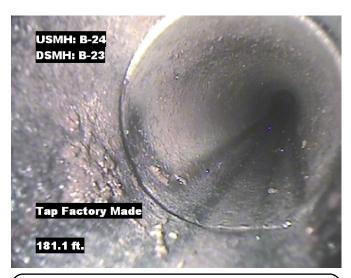
Distance: 181.1 ft. Grade: 0

Condition: Tap Factory Made

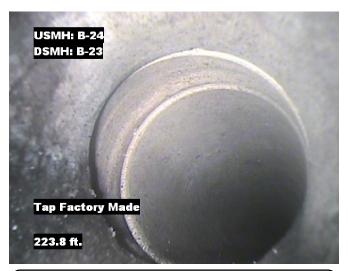
Distance: 223.8 ft. Grade: 0

Condition: Tap Factory Made

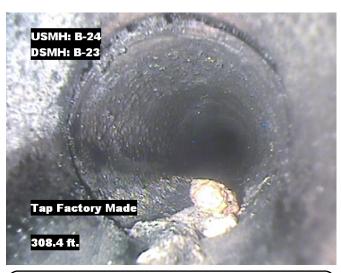
Distance: 308.4 ft. Grade: 0

Condition: Tap Factory Made

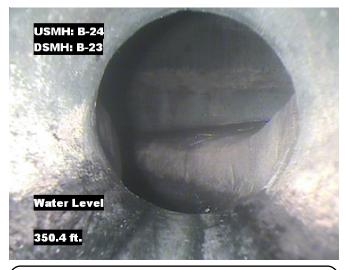
Distance: 350.4 ft. Grade: 0

Condition: Water Level

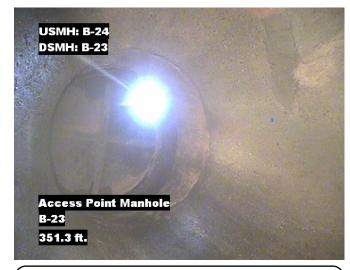
Distance: 351.3 ft. Grade: 0

Condition: Access Point Manhole

Remarks: B-23
