## Defect Listing

Pipe Segment Refere... <b>B-25_B-24</b>	City <b>Oliver Springs</b>	Street <b>Pride Rd</b>	Material <b>Concrete Pipe (non-...</b>	Location C... <b>Light High...</b>	Sewer Use <b>Sanitary</b>
Upstream MH <b>B-25</b>	Total Length <b>213.7</b>	Year Laid	Shape <b>Circular</b>	Location Details	
DS Manhole <b>B-24</b>	Length surveyed <b>213.7</b>	Year Renewed	Height <b>8</b>	Width <b>8</b>	Pipe Joint... <b>4</b>

SPR <b>N/A</b>	MPR <b>N/A</b>	PO Number <b>4397-03</b>		Customer <b>GRW</b>	
SPRI <b>N/A</b>	MPRI <b>N/A</b>	Work Order <b>4397-02</b>		Purpose <b>Pre-Rehabilitation Survey</b>	
QSR <b>N/A</b>	QMR <b>N/A</b>				
OPR <b>N/A</b>	Surveyed By <b>Charlie Gordon</b>	Direction <b>Upstream</b>	Date <b>20150903</b>	Media label	
OPRI <b>N/A</b>	Certificate Number <b>U-615-07000491</b>	Pre-Cleaning <b>Jetting</b>	Time <b>12:51</b>	Weather <b>Dry</b>	
Date Cleaned <b>20150903</b>			End Time <b>13:07</b>	Additional Info

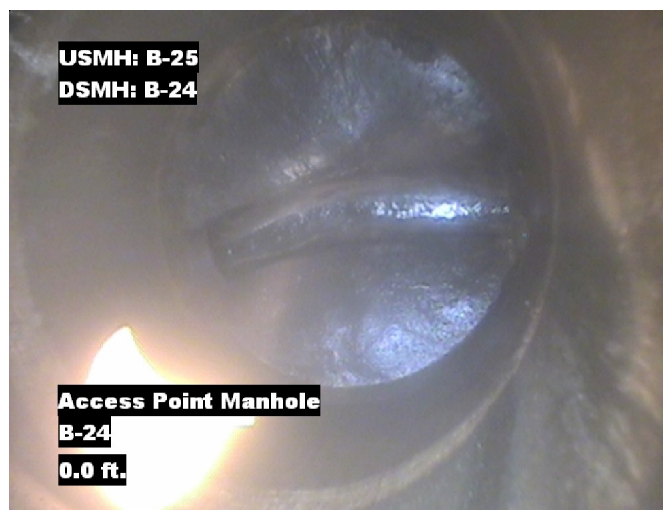
Distance: 0.0 ft. Grade: 0  
Condition: Access Point Manhole  
Remarks: B-24

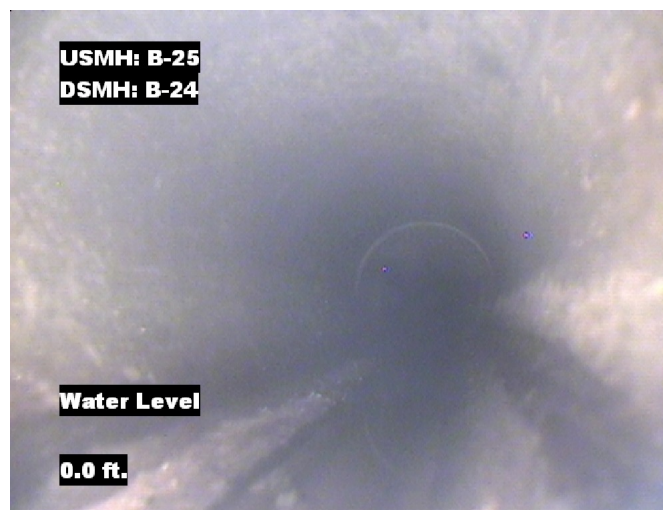
Distance: 0.0 ft. Grade: 0  
Condition: Water Level  
Remarks: N/A

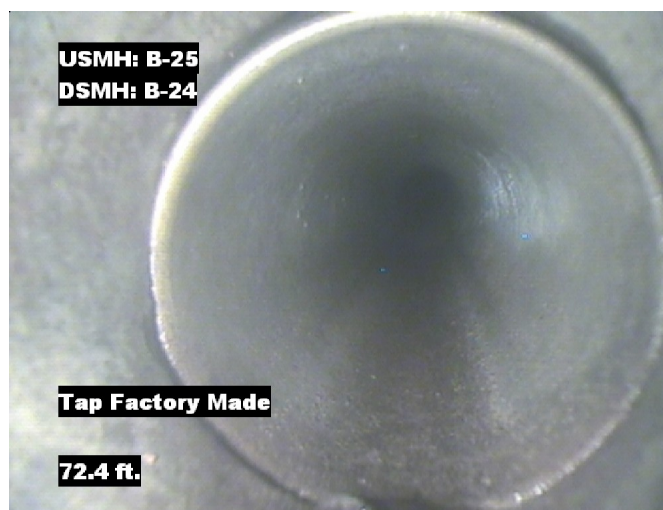
Distance: 72.4 ft. Grade: 0  
Condition: Tap Factory Made  
Remarks: N/A

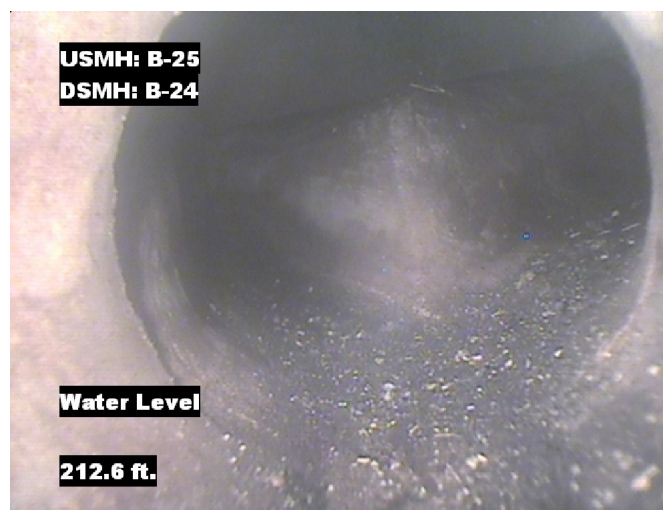
Distance: 212.6 ft. Grade: 0  
Condition: Water Level  
Remarks: N/A

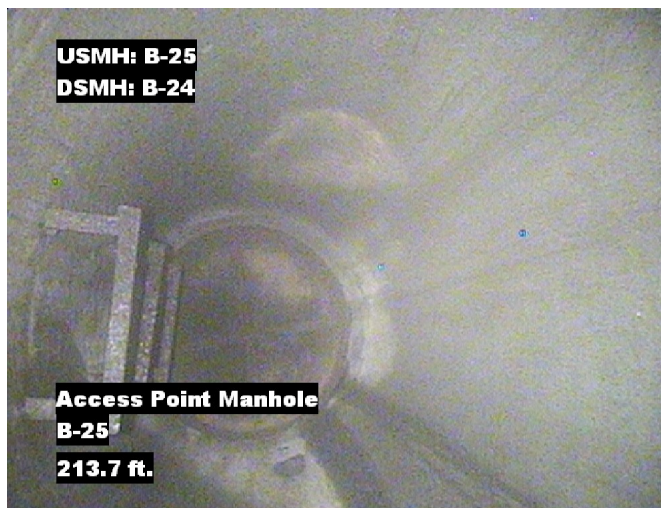
Distance: 213.7 ft. Grade: 0  
Condition: Access Point Manhole  
Remarks: B-25
