Defect Listing

Pipe Segment Refere... B-3_B-2	City Oliver Springs	Street Old Harriman hwy	Material Fibreglass Reinforc...	Location C... Easement/R...	Sewer Use Sanitary
Upstream MH B-3	Total Length 284.6	Year Laid	Shape Circular	Location Details	
DS Manhole B-2	Length surveyed 284.6	Year Renewed	Height 10	Width 10	Pipe Joint... N/A

SPR N/A	MPR 2	PO Number 4397-03		Customer GRW	
SPRI N/A	MPRI 2	Work Order 4397-02		Purpose Pre-Rehabilitation Survey	
QSR N/A	QMR 2100				
OPR 2	Surveyed By Charlie Gordon	Direction Downstream	Date 20150916	Media label	
OPRI 2	Certificate Number U-615-07000491	Pre-Cleaning No Pre-Cleaning	Time 07:50	Weather Damp	
Date Cleaned			End Time 08:07	Additional Info Liner through mh B-...

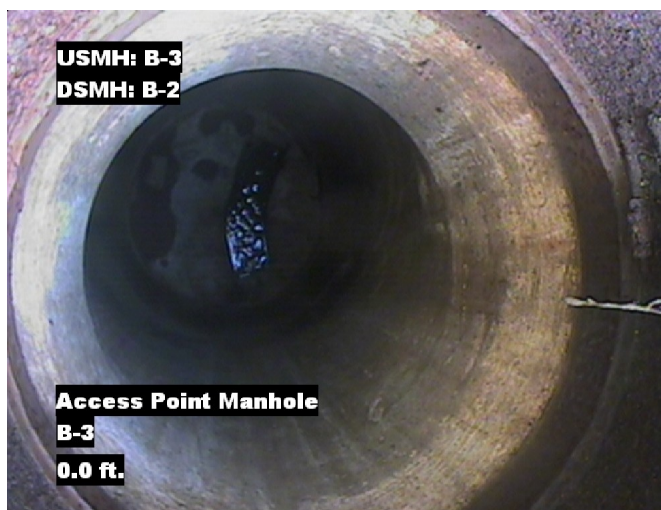
Distance: 0.0 ft. Grade: 0
Condition: Access Point Manhole
Remarks: B-3

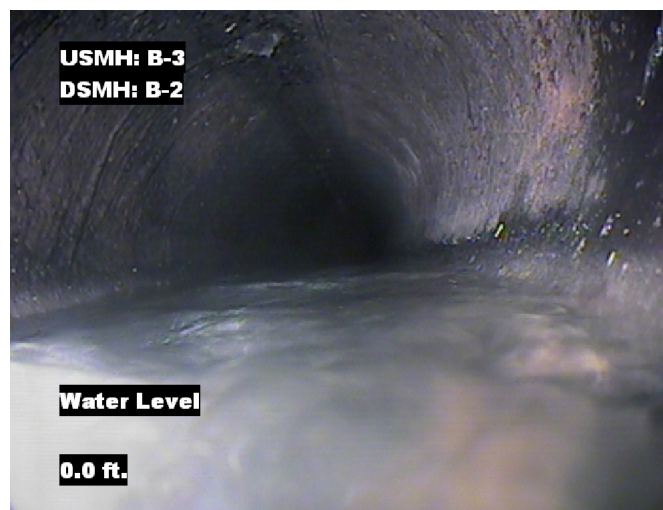
Distance: 0.0 ft. Grade: 0
Condition: Water Level
Remarks: N/A

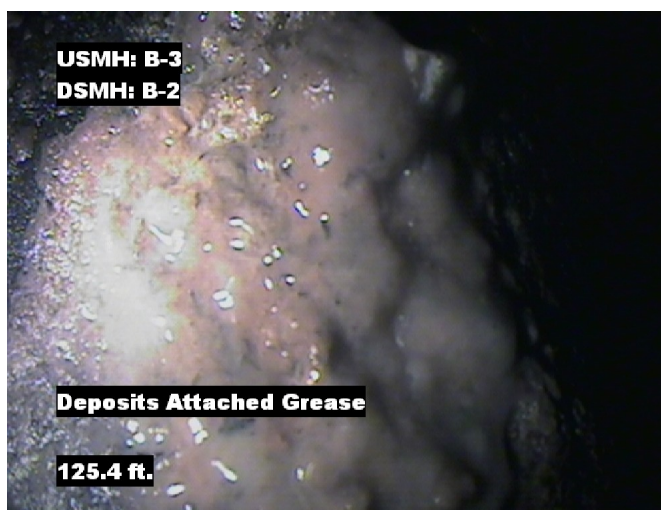
Distance: 125.4 ft. Grade: 2
Condition: Deposits Attached Grease
Remarks: N/A

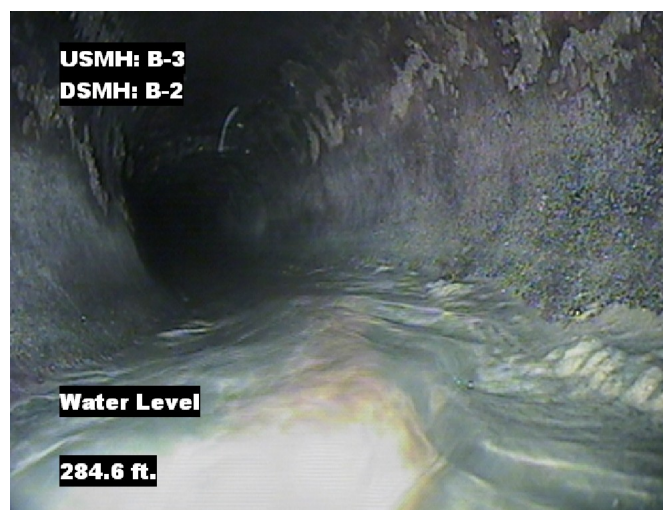
Distance: 284.6 ft. Grade: 0
Condition: Water Level
Remarks: N/A

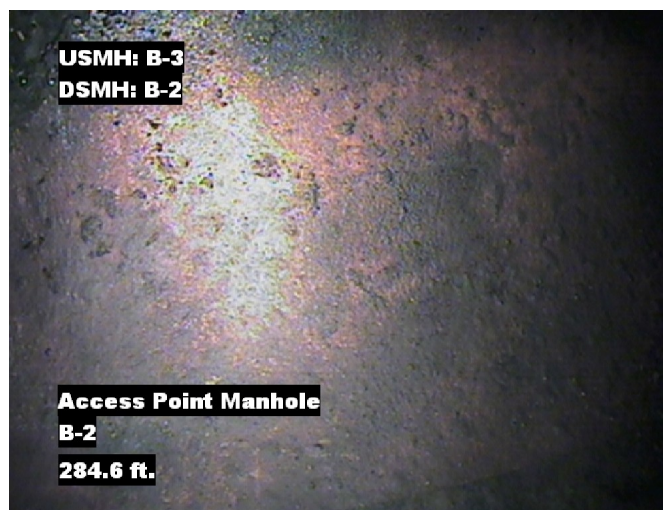
Distance: 284.6 ft. Grade: 0
Condition: Access Point Manhole
Remarks: B-2
