Defect Listing

Pipe Segment Refere... B-4_B-3	City Oliver Springs	Street Old harriman Hwy	Material Fibreglass Reinforc...	Location C... Light High...	Sewer Use Sanitary
Upstream MH B-4	Total Length 270	Year Laid	Shape Circular	Location Details	
DS Manhole B-3	Length surveyed 270	Year Renewed	Height 10	Width 10	Pipe Joint... N/A

SPR 6	MPR 8	PO Number 4397-03		Customer GRW	
SPRI 3	MPRI 2.7	Work Order 4397-02		Purpose Pre-Rehabilitation Survey	
QSR 3200	QMR 4122				
OPR 14	Surveyed By Charlie Gordon	Direction Downstream	Date 20150915	Media label	
OPRI 2.8	Certificate Number U-615-07000491	Pre-Cleaning Jetting	Time 13:56	Weather Dry	
Date Cleaned 20150915			End Time 14:10	Additional Info

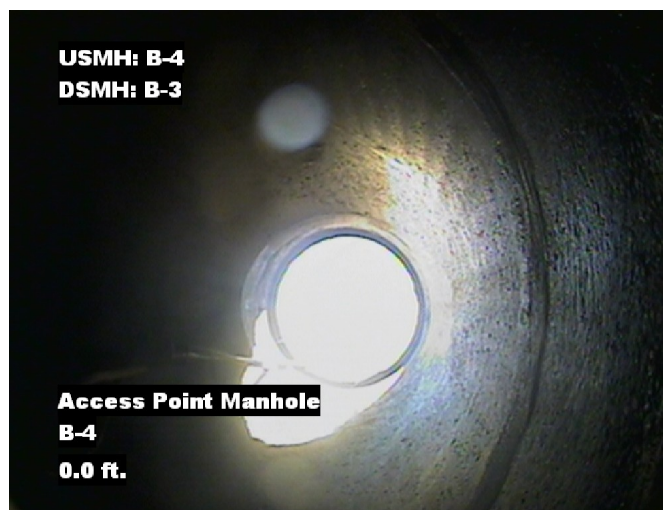
Distance: 0.0 ft. Grade: 0
Condition: Access Point Manhole
Remarks: B-4

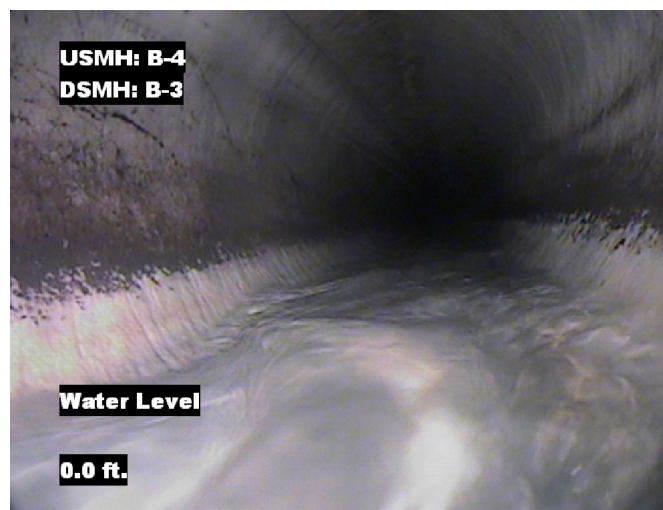
Distance: 0.0 ft. Grade: 0
Condition: Water Level
Remarks: N/A

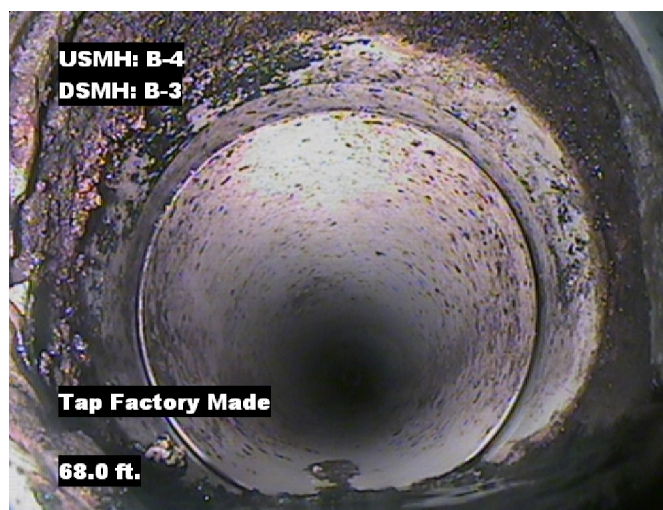
Distance: 68.0 ft. Grade: 0
Condition: Tap Factory Made
Remarks: N/A

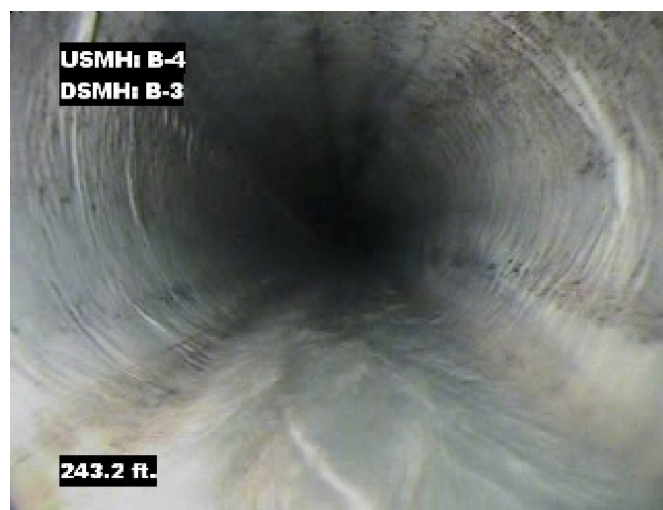
Distance: 243.1 ft. Grade: 3
Condition: Lining Failure Wrinkled
Remarks: N/A

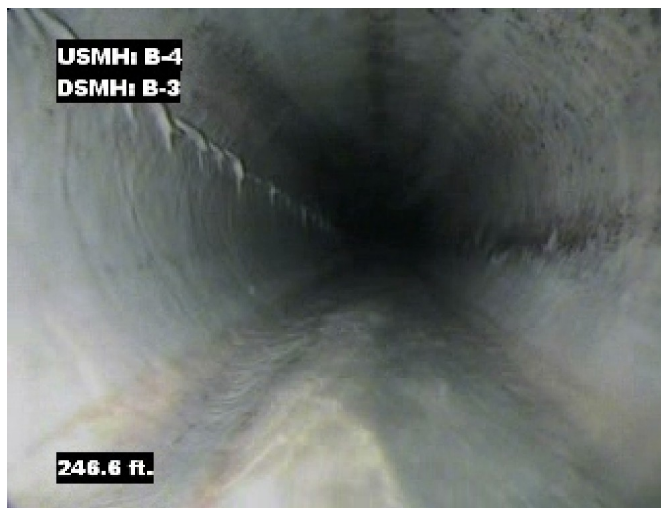
Distance: 246.7 ft. Grade: 3
Condition: Lining Failure Wrinkled
Remarks: THIS IS A CONTINUOUS DEFECT

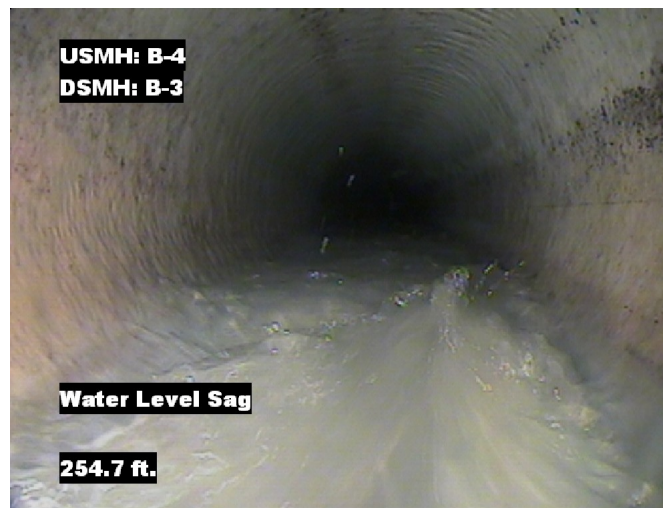
Distance: 254.7 ft. Grade: 2
Condition: Water Level Sag
Remarks: N/A

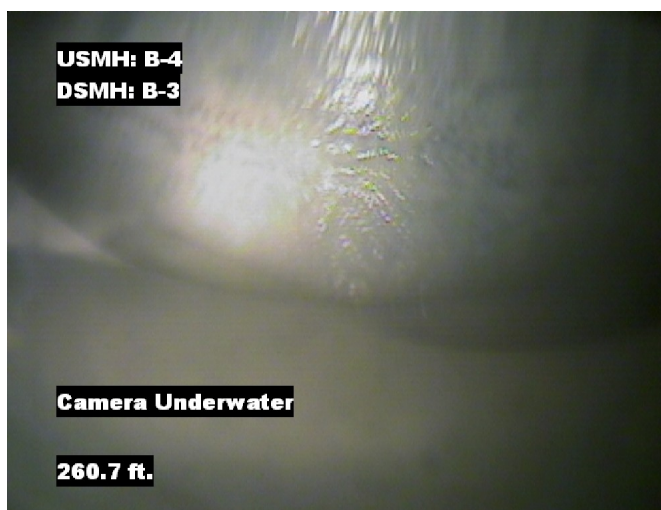
Distance: 260.7 ft. Grade: 4
Condition: Camera Underwater
Remarks: N/A

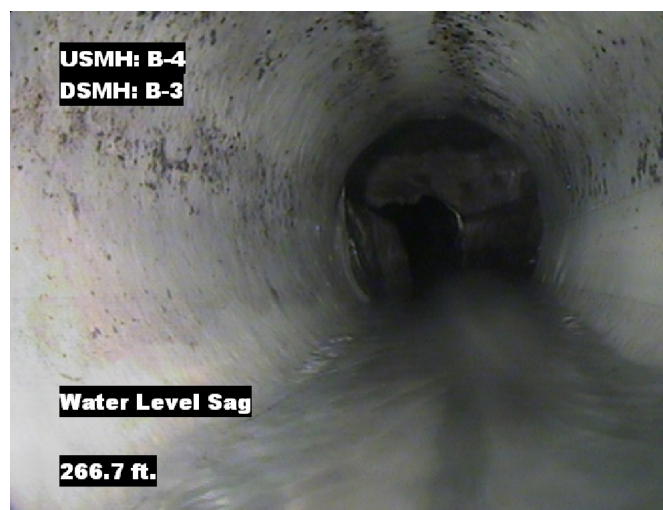
Distance: 266.7 ft. Grade: 2
Condition: Water Level Sag
Remarks: N/A

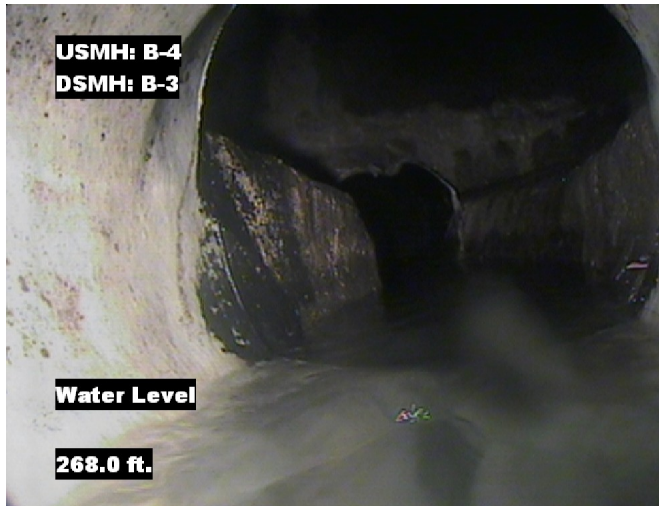
Distance: 268.0 ft. Grade: 0
Condition: Water Level
Remarks: N/A

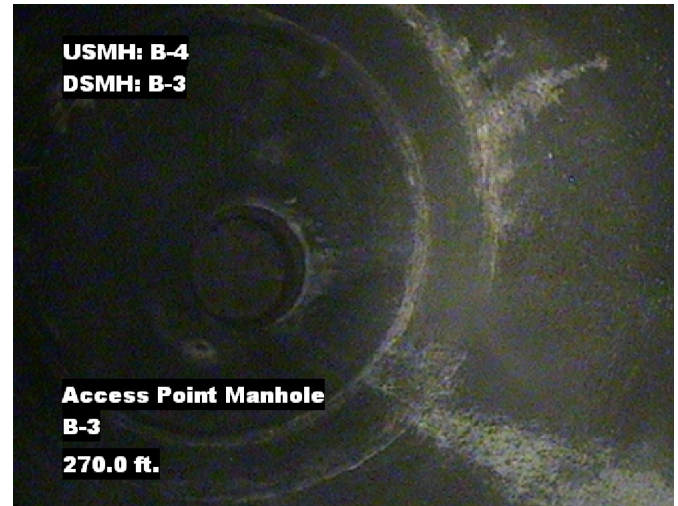
Distance: 270.0 ft. Grade: 0
Condition: Access Point Manhole
Remarks: B-3
