Defect Listing

Pipe Segment Refere		С	ty	Street	Mat	erial	Location C	Sewer Use		
B-5_	_B-4	Oliver	Springs	Old Harriman Hwy	Fibreglass	Reinforc	einforc Light High Sa			
Upstream MH		Total I	_ength	Year Laid	Shape		Location	Details		
В	-5	32	9.2		Circ	ular	ular			
DS Ma	anhole	Length s	surveyed	Year Renewed	Height	Width				
B	-4	32	9.2		10	10	N/A			
SPR	N/A	MPR	18	PO Number	PO Number			Customer		
0001	-			4397-03	GRW					
SPRI	N/A	MPRI	2	Work Order		Purpose				
QSR	N/A	QMR	2900	4397-02		Pre-Rehabilitation Survey				
OF	PR	Surve	ed By	Direction	Da	ate	Media	label		
1	8	Charlie_	Gordon	Upstream	2015	0915				
OF	PRI	Certificate Number		Pre-Cleaning	Time		Weather			
2		U-615-07000491		Jetting	14:48		Dry			
		Date C	leaned	End Time		Additional Info				
		2015	0915		15	:01

Image Report 4/Page

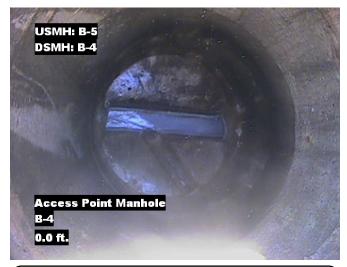
Distance: 0.0 ft. Grade: (

Condition: Access Point Manhole

Remarks: B-4

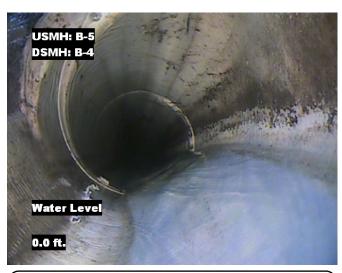
Distance: 0.0 ft. Grade: 0

Condition: Water Level

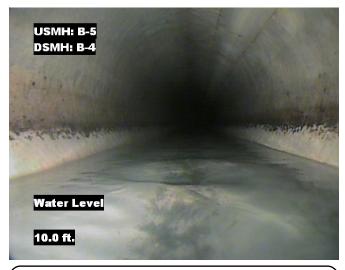
Distance: 10.0 ft. Grade: 0

Condition: Water Level

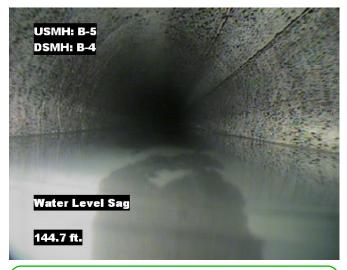
Distance: 144.7 ft. Grade: 2

Condition: Water Level Sag

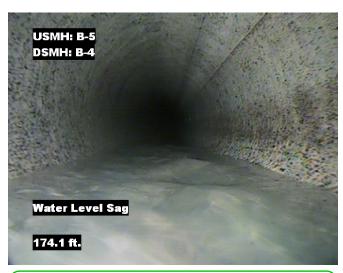
Distance: 173.9 ft. Grade: 2

Condition: Water Level Sag

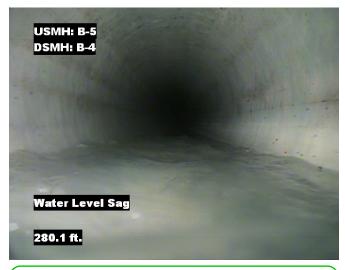
Distance: 279.9 ft. Grade: 2

Condition: Water Level Sag

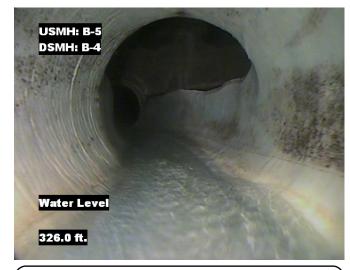
Distance: 326.0 ft. Grade: 0

Condition: Water Level

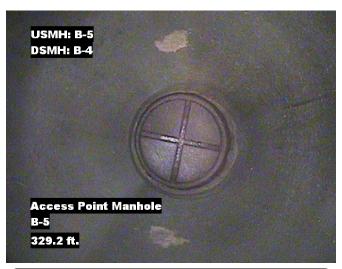
Distance: 329.2 ft. Grade: 0

Condition: Access Point Manhole

Remarks: B-5
