Defect Listing

Pipe Segment Refere... B-6_B-5	City Oliver Springs	Street Old Harriman HWY	Material Fibreglass Reinforc...	Location C... Yard	Sewer Use Sanitary
Upstream MH B-6	Total Length 331.3	Year Laid	Shape Circular	Location Details	
DS Manhole B-5	Length surveyed 331.3	Year Renewed	Height 10	Width 10	Pipe Joint... N/A

Image Report 4/Page

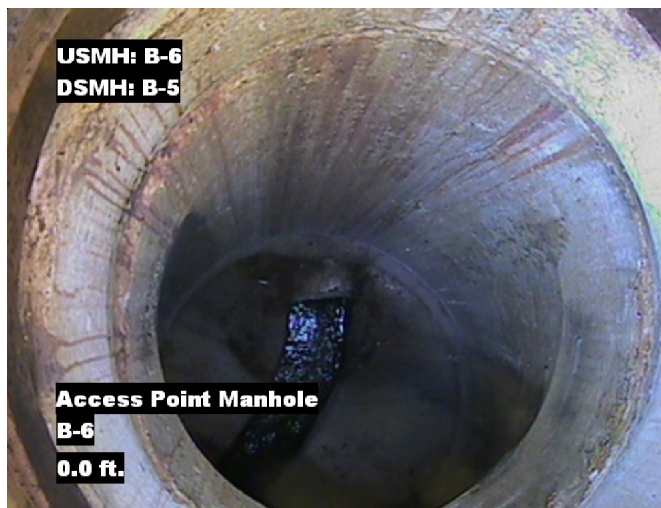
Distance: 0.0 ft. Grade: 0
Condition: Access Point Manhole
Remarks: B-6

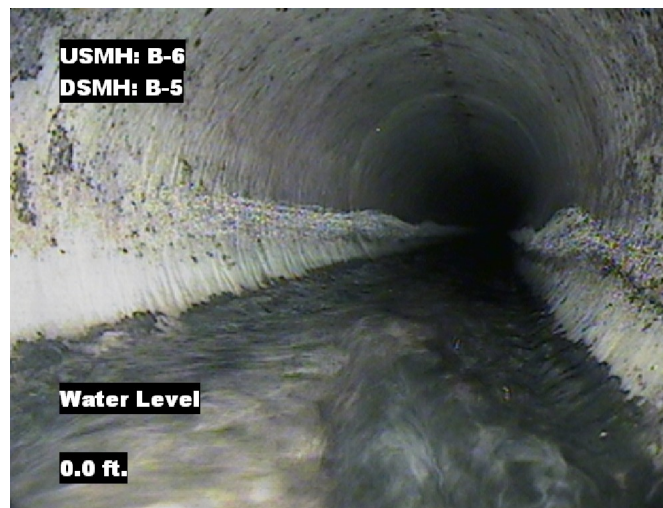
Distance: 0.0 ft. Grade: 0
Condition: Water Level
Remarks: N/A

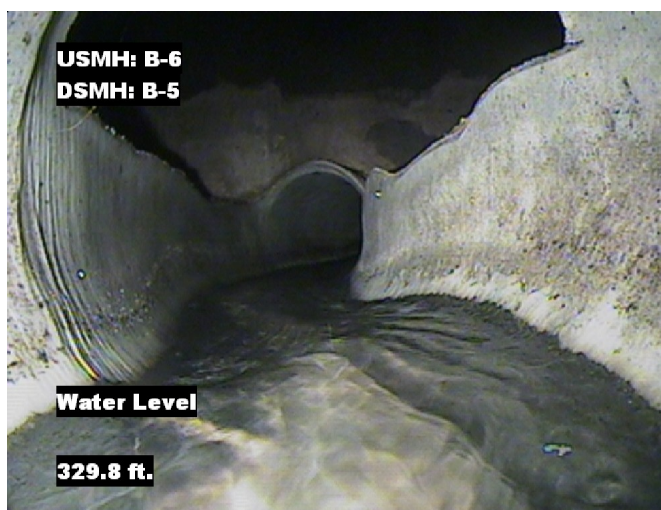
Distance: 329.8 ft. Grade: 0
Condition: Water Level
Remarks: N/A

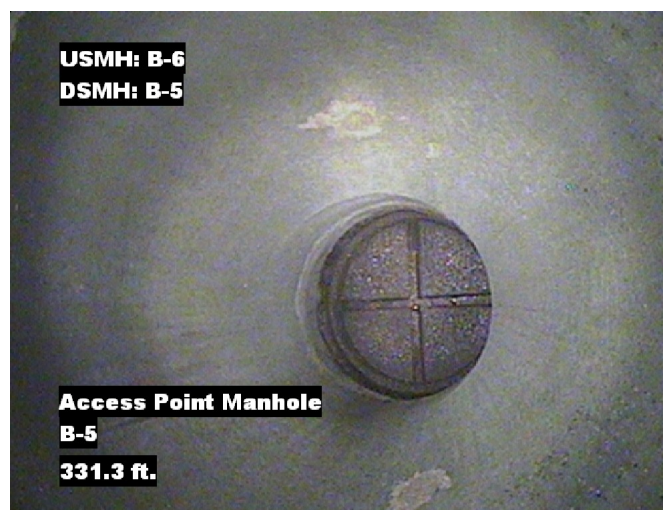
Distance: 331.3 ft. Grade: 0
Condition: Access Point Manhole
Remarks: B-5
