Defect Listing

Pipe Segment Refere... B-8_B-7	City Oliver Springs	Street Old Harriman Hwy	Material Fibreglass Reinforc...	Location C... Easement/R...	Sewer Use Sanitary
Upstream MH B-8	Total Length 315.1	Year Laid	Shape Circular	Location Details	
DS Manhole B-7	Length surveyed 315.1	Year Renewed	Height 10	Width 10	Pipe Joint... N/A

SPR N/A	MPR 8	PO Number 4397-03	Customer GRW
SPRI N/A	MPRI 2	Work Order 4397-02	Purpose Pre-Rehabilitation Survey
QSR N/A	QMR 2400		
OPR 8	Surveyed By Charlie Gordon	Direction Downstream	Date 20150915
OPRI 2	Certificate Number U-615-07000491	Pre-Cleaning Jetting	Time 10:09
	Date Cleaned 20150915	End Time 10:29	Weather Damp
			Additional Info

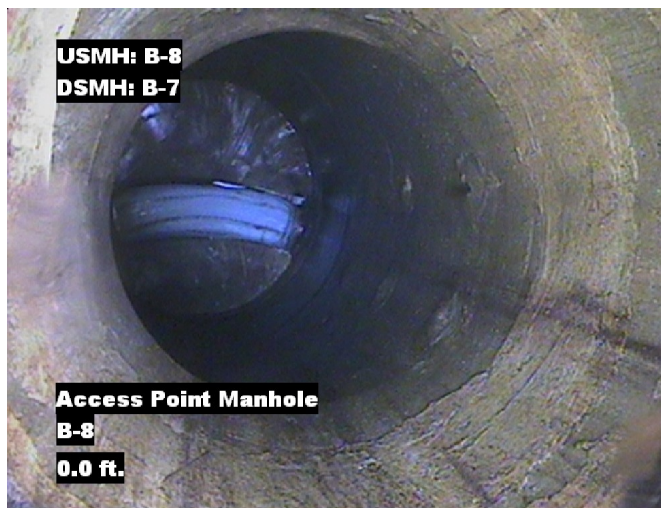
Distance: 0.0 ft. Grade: 0
Condition: Access Point Manhole
Remarks: B-8

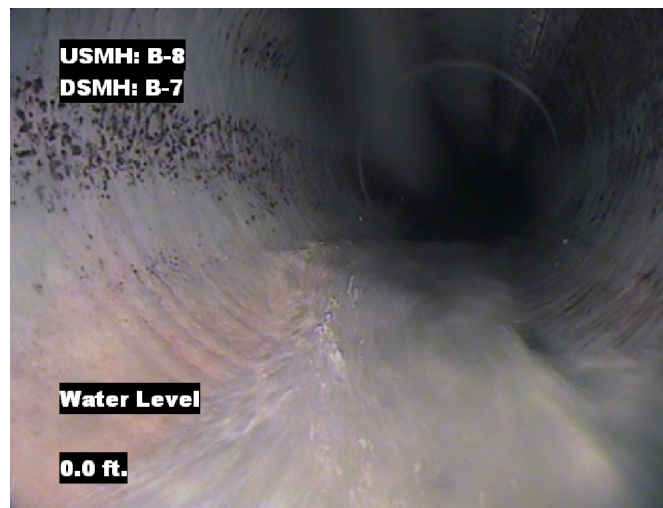
Distance: 0.0 ft. Grade: 0
Condition: Water Level
Remarks: N/A

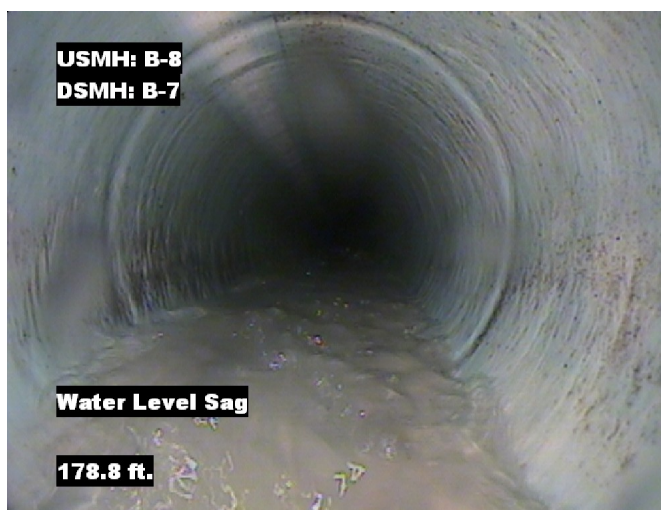
Distance: 178.8 ft. Grade: 2
Condition: Water Level Sag
Remarks: N/A

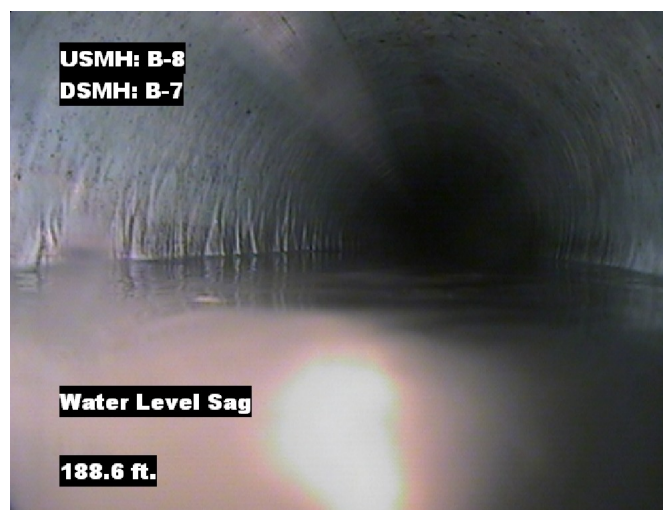
Distance: 188.6 ft. Grade: 2
Condition: Water Level Sag
Remarks: N/A

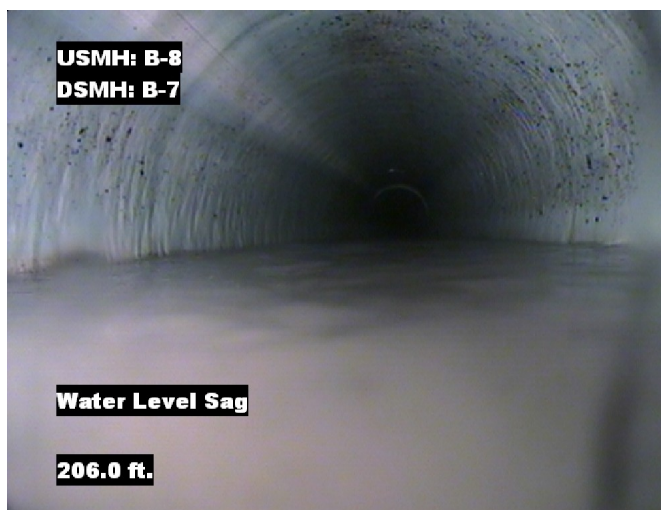
Distance: 206.0 ft. Grade: 2
Condition: Water Level Sag
Remarks: N/A

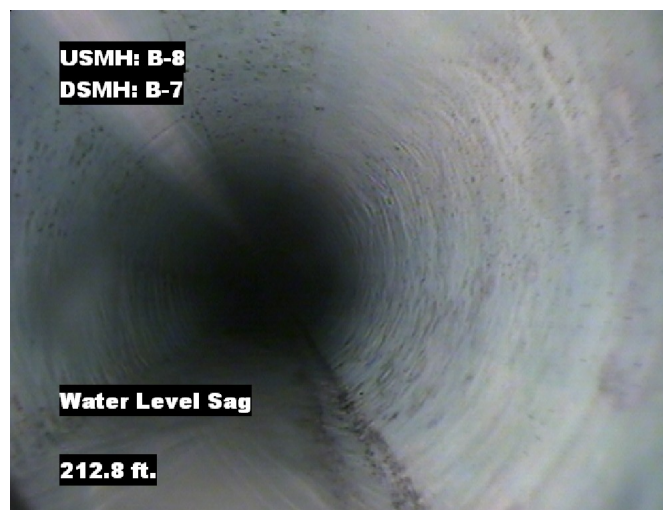
Distance: 212.6 ft. Grade: 2
Condition: Water Level Sag
Remarks: N/A

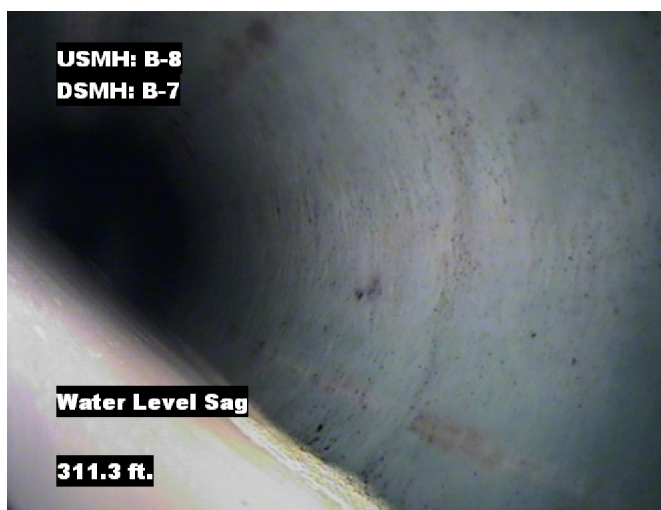
Distance: 311.3 ft. Grade: 2
Condition: Water Level Sag
Remarks: N/A

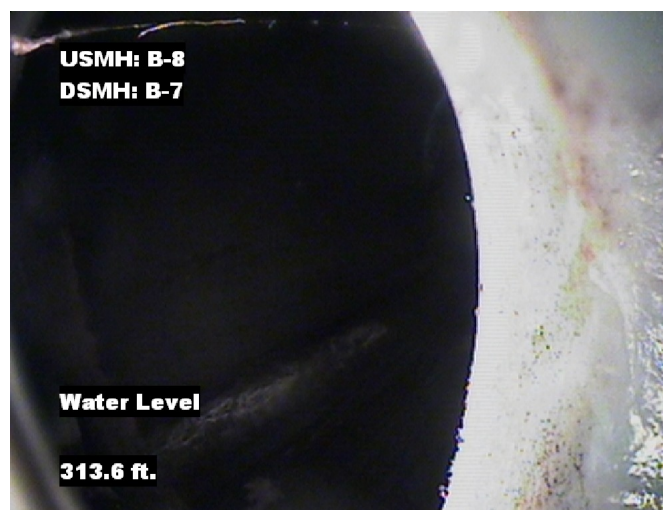
Distance: 313.6 ft. Grade: 0
Condition: Water Level
Remarks: N/A

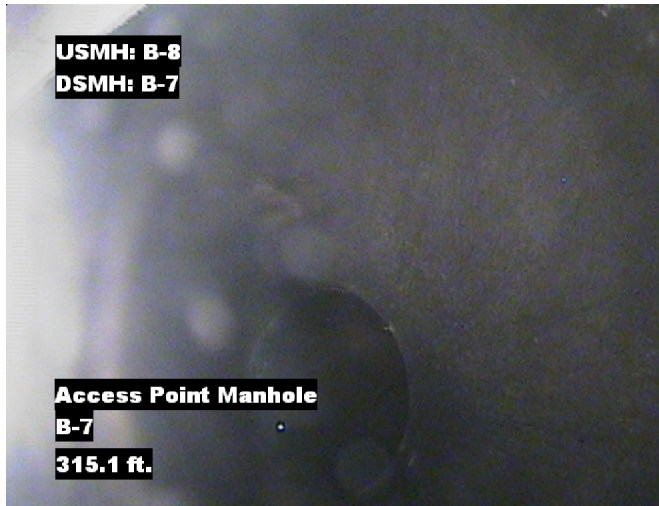
Distance: 315.1 ft. Grade: 0
Condition: Access Point Manhole
Remarks: B-7
