Defect Listing

Pipe Segment Refere... B-9_B-8	City Oliver Springs	Street Cemetery Rd	Material Fibreglass Reinforc...	Location C... Easement/R...	Sewer Use Sanitary
Upstream MH B-9	Total Length 408.1	Year Laid	Shape Circular	Location Details	
DS Manhole B-8	Length surveyed 408.1	Year Renewed	Height 10	Width 10	Pipe Joint... N/A

SPR N/A	MPR 54	PO Number 4397-03	Customer GRW
SPRI N/A	MPRI 2.2	Work Order 4397-02	Purpose Pre-Rehabilitation Survey
QSR N/A	QMR 422C		
OPR 54	Surveyed By Charlie Gordon	Direction Downstream	Date 20150915
OPRI 2.2	Certificate Number U-615-07000491	Pre-Cleaning Jetting	Time 08:12
	Date Cleaned 20150915	End Time 08:37	Weather Damp
			Media label
			Additional Info

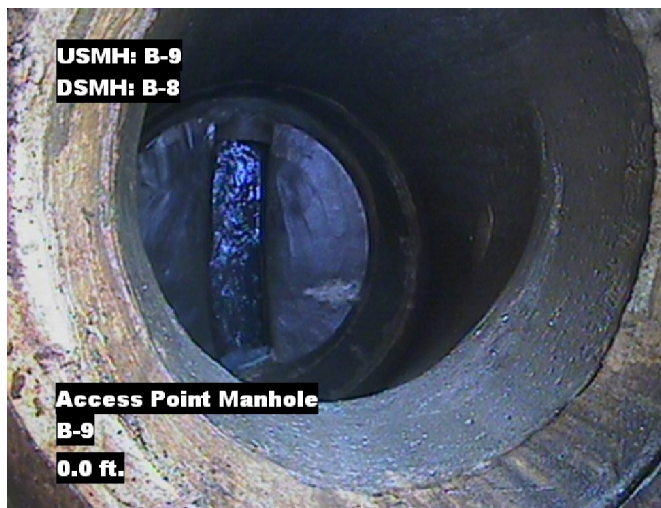
Distance: 0.0 ft. Grade: 0
Condition: Access Point Manhole
Remarks: B-9

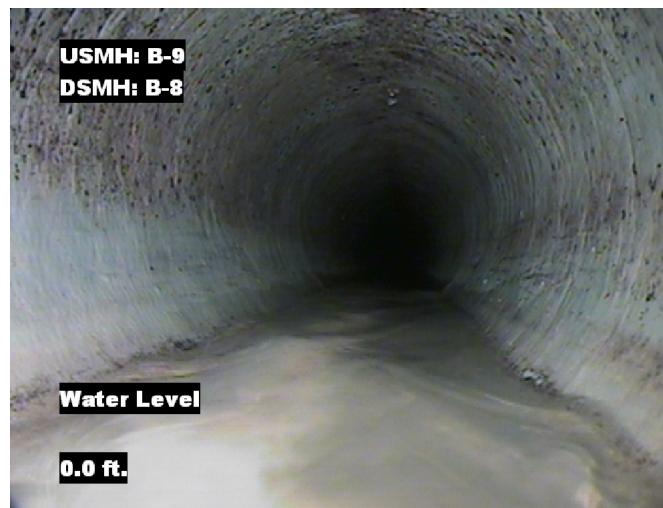
Distance: 0.0 ft. Grade: 0
Condition: Water Level
Remarks: N/A

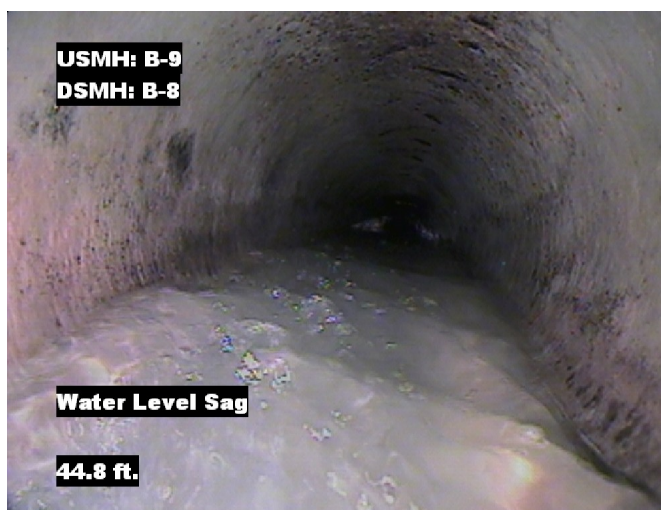
Distance: 44.8 ft. Grade: 2
Condition: Water Level Sag
Remarks: N/A

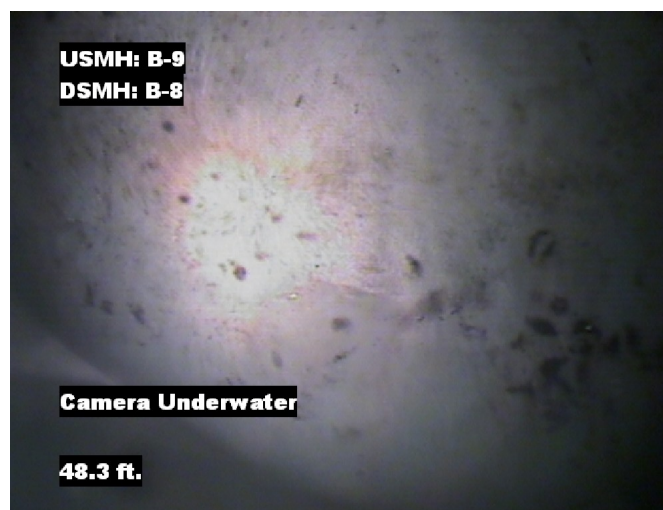
Distance: 48.3 ft. Grade: 4
Condition: Camera Underwater
Remarks: N/A

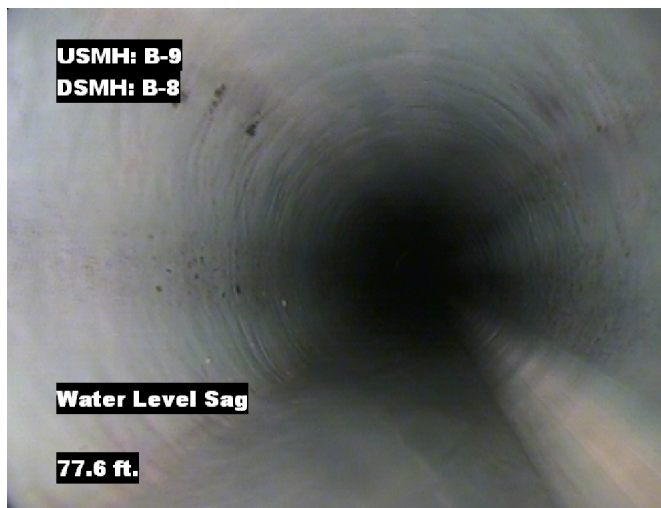
Distance: 77.4 ft. Grade: 2
Condition: Water Level Sag
Remarks: N/A

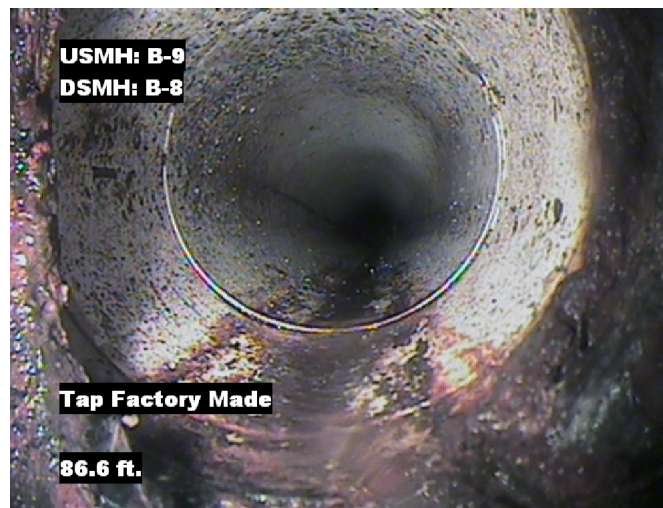
Distance: 86.6 ft. Grade: 0
Condition: Tap Factory Made
Remarks: N/A

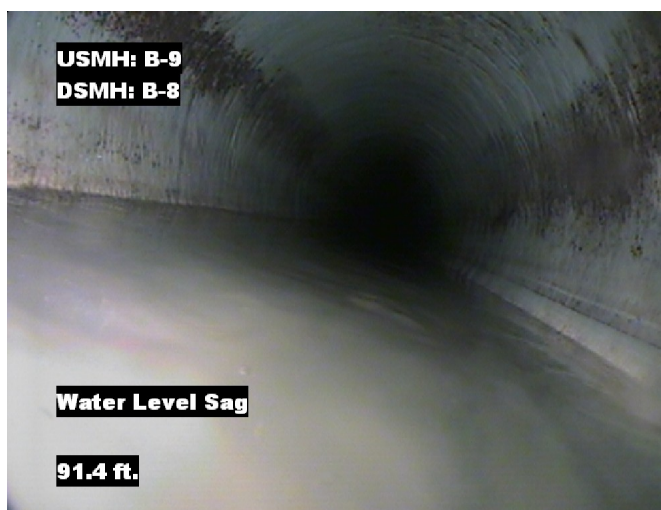
Distance: 91.4 ft. Grade: 2
Condition: Water Level Sag
Remarks: N/A

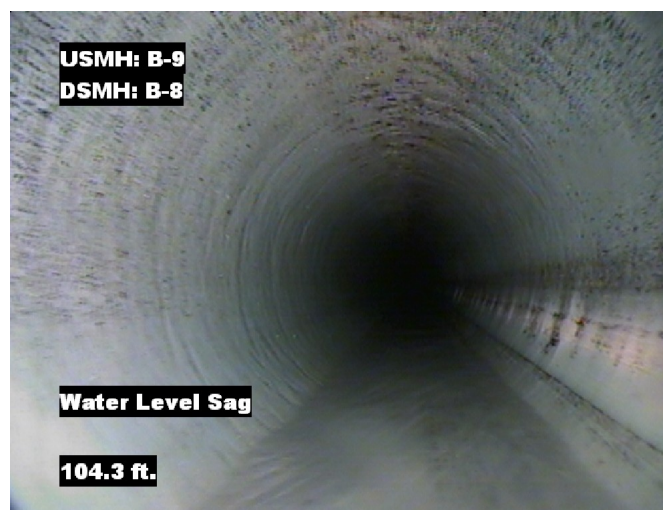
Distance: 103.9 ft. Grade: 2
Condition: Water Level Sag
Remarks: N/A

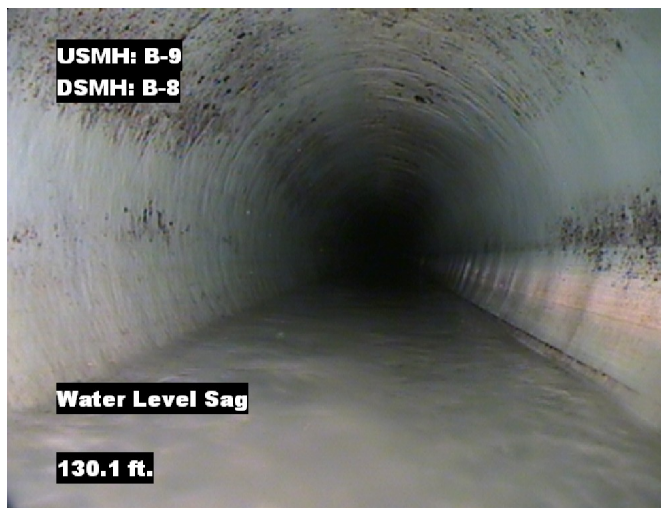
Distance: 130.1 ft. Grade: 2
Condition: Water Level Sag
Remarks: N/A

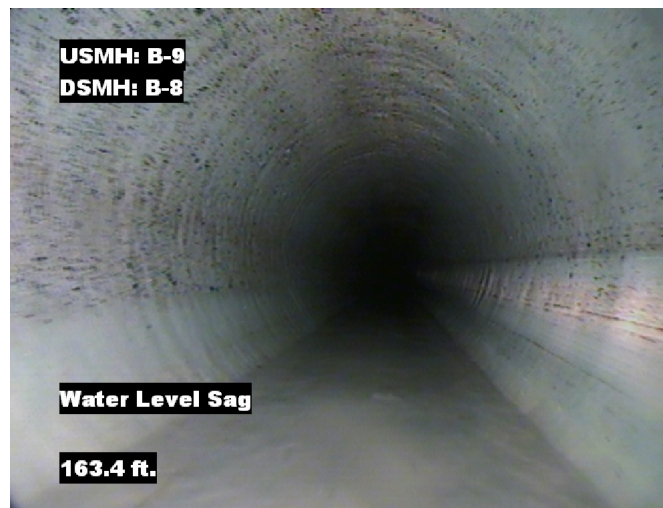
Distance: 163.0 ft. Grade: 2
Condition: Water Level Sag
Remarks: N/A

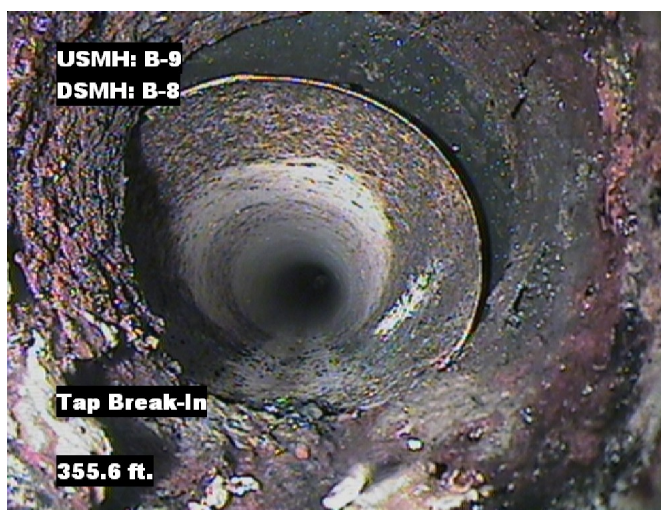
Distance: 355.6 ft. Grade: 0
Condition: Tap Break-In
Remarks: N/A

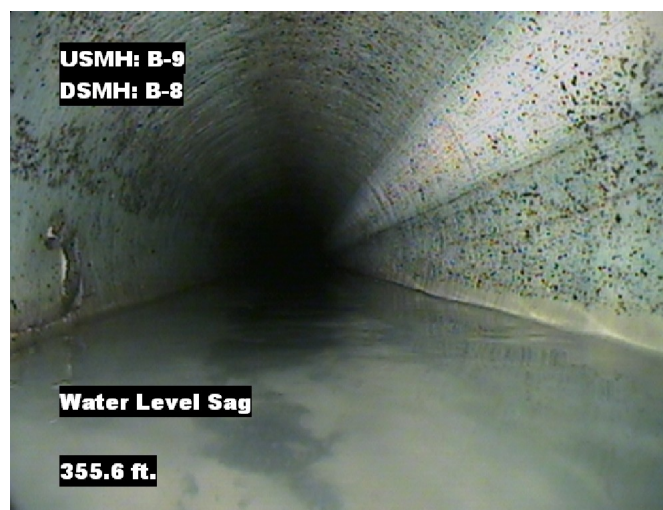
Distance: 355.6 ft. Grade: 2
Condition: Water Level Sag
Remarks: N/A

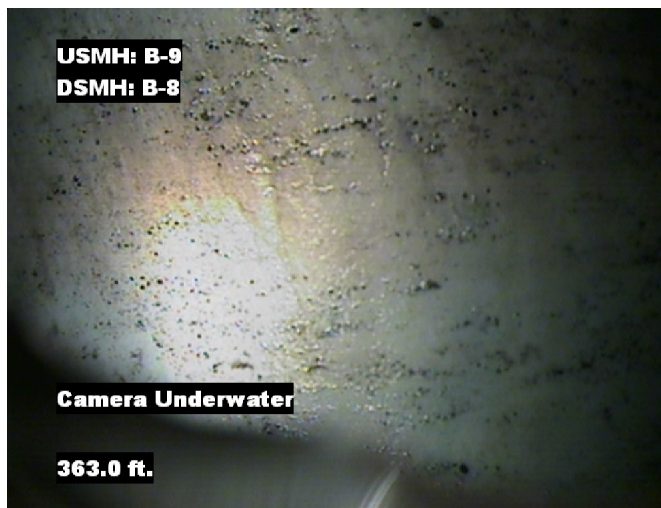
Distance: 363.0 ft. Grade: 4
Condition: Camera Underwater
Remarks: N/A

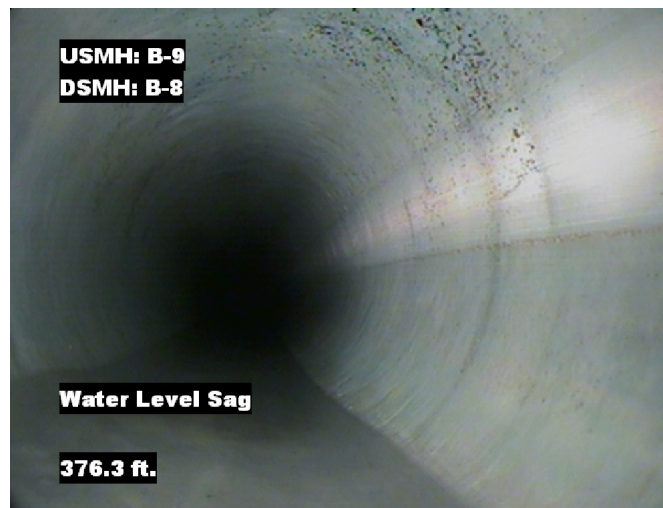
Distance: 376.3 ft. Grade: 2
Condition: Water Level Sag
Remarks: N/A

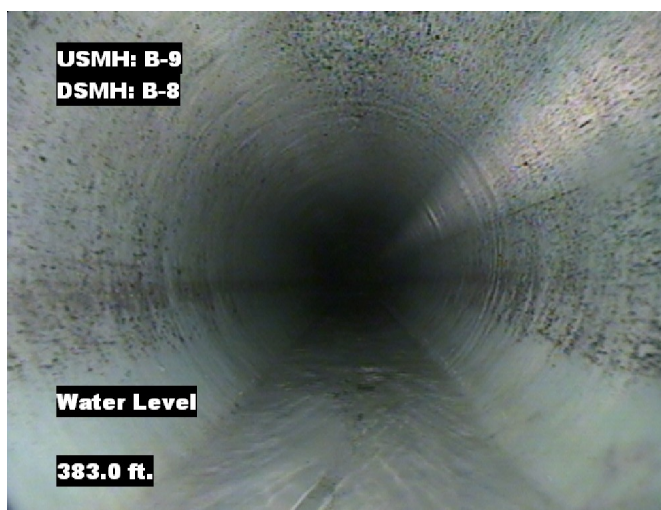
Distance: 383.0 ft. Grade: 0
Condition: Water Level
Remarks: N/A

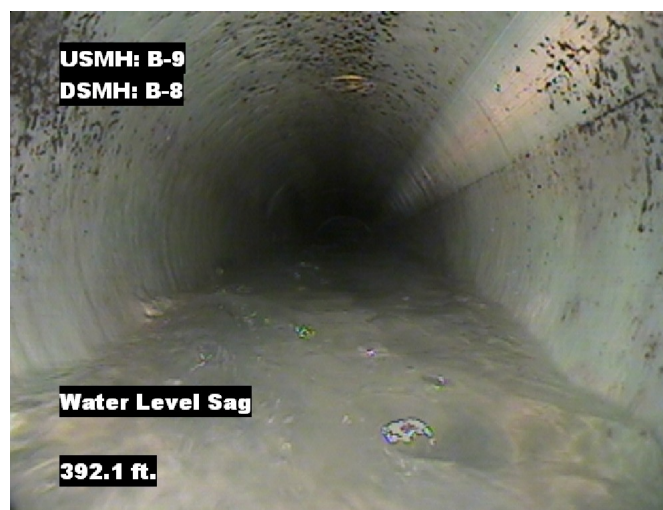
Distance: 392.1 ft. Grade: 2
Condition: Water Level Sag
Remarks: N/A

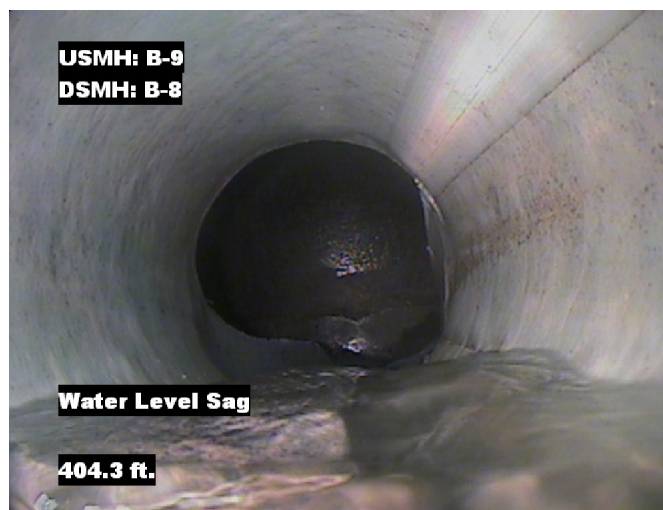
Distance: 404.3 ft. Grade: 2
Condition: Water Level Sag
Remarks: N/A

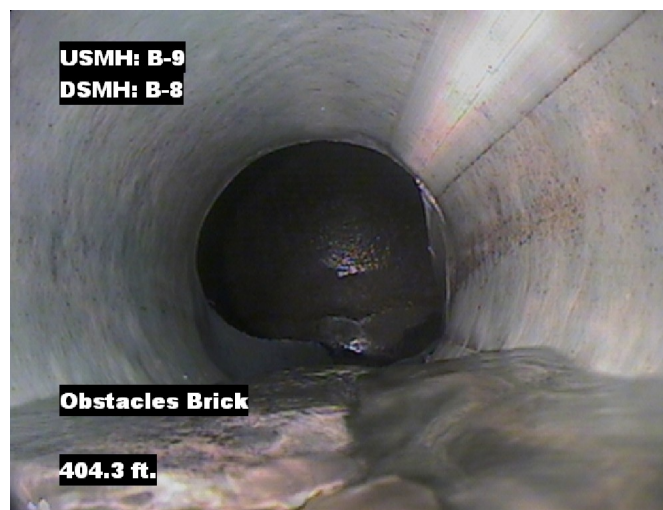
Distance: 404.3 ft. Grade: 2
Condition: Obstacles Brick
Remarks: N/A

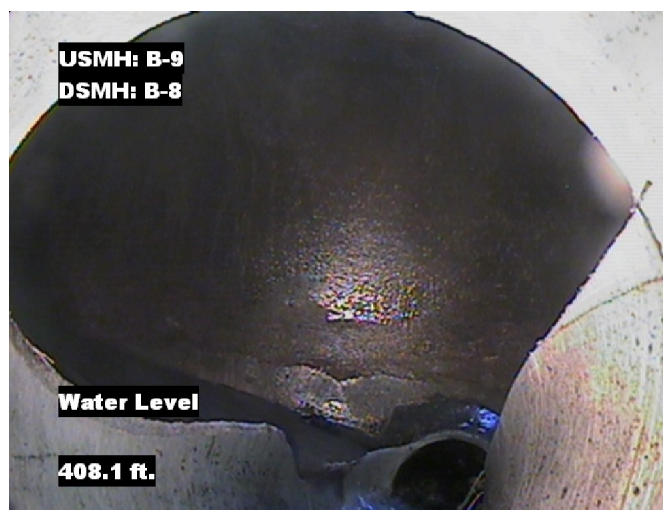
Distance: 408.1 ft. Grade: 0
Condition: Water Level
Remarks: N/A

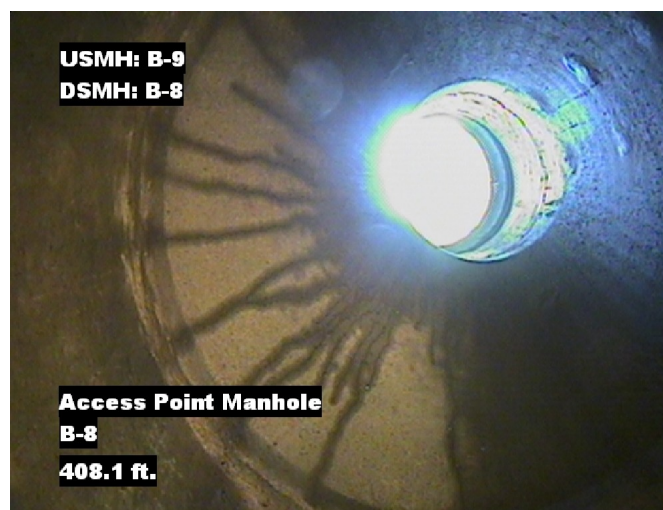
Distance: 408.1 ft. Grade: 0
Condition: Access Point Manhole
Remarks: B-8
