Defect Listing

Pipe Segment Refere... B1-1_B-11	City Oliver Springs	Street Cemetery Rd	Material Fibreglass Reinforc...	Location C... Easement/R...	Sewer Use Sanitary
Upstream MH B1-1	Total Length	Year Laid	Shape Circular	Location Details	
DS Manhole B-11	Length surveyed 328.4	Year Renewed	Height 8	Width 8	Pipe Joint... N/A

Image Report 4/Page

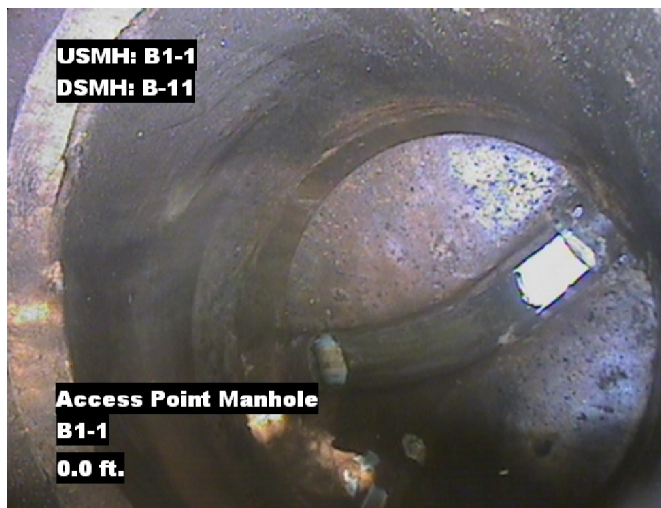
Distance: 0.0 ft. Grade: 0
Condition: Access Point Manhole
Remarks: B1-1

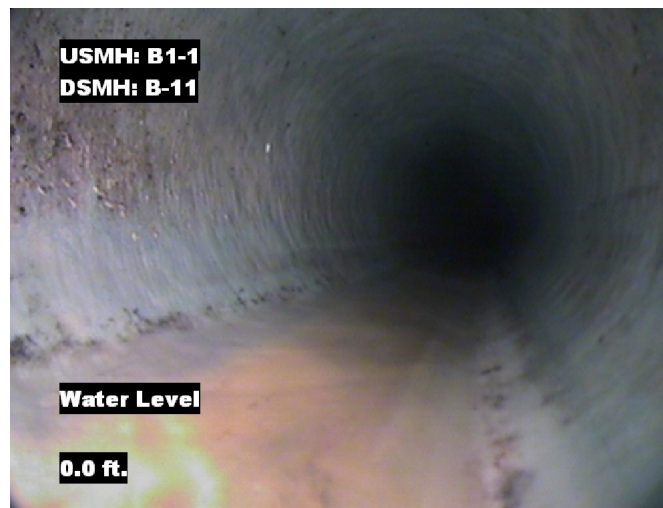
Distance: 0.0 ft. Grade: 0
Condition: Water Level
Remarks: N/A

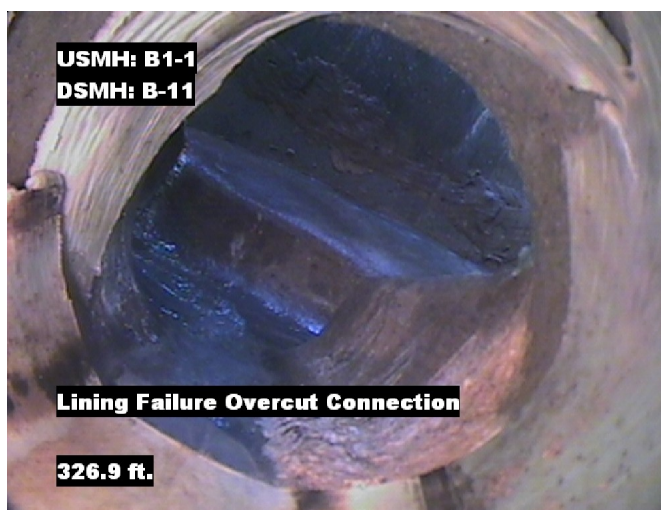
Distance: 326.9 ft. Grade: 3
Condition: Lining Failure Overcut Connection
Remarks: N/A

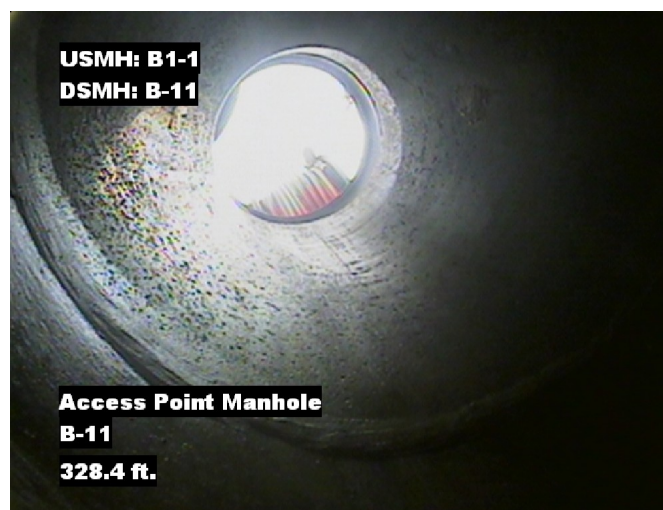
Distance: 328.4 ft. Grade: 0
Condition: Access Point Manhole
Remarks: B-11
