Defect Listing

Pipe Segment Refere... B1-2 B1-1	City Oliver Springs	Street Cemetery Rd	Material Fibreglass Reinforc...	Location C... Light High...	Sewer Use Sanitary
Upstream MH B1-2	Total Length 303.1	Year Laid	Shape Circular	Location Details	
DS Manhole B1-1	Length surveyed 303.1	Year Renewed	Height 8	Width 8	Pipe Joint... N/A

SPR N/A	MPR 12	PO Number 4397-03	Customer GRW
SPRI N/A	MPRI 2	Work Order 4397-02	Purpose Pre-Rehabilitation Survey
QSR N/A	QMR 2600		
OPR 12	Surveyed By Charlie Gordon	Direction Downstream	Date 20150911
OPRI 2	Certificate Number U-615-07000491	Pre-Cleaning Jetting	Time 06:45
	Date Cleaned 20150911	End Time 07:01	Weather Damp
			Media label
			Additional Info

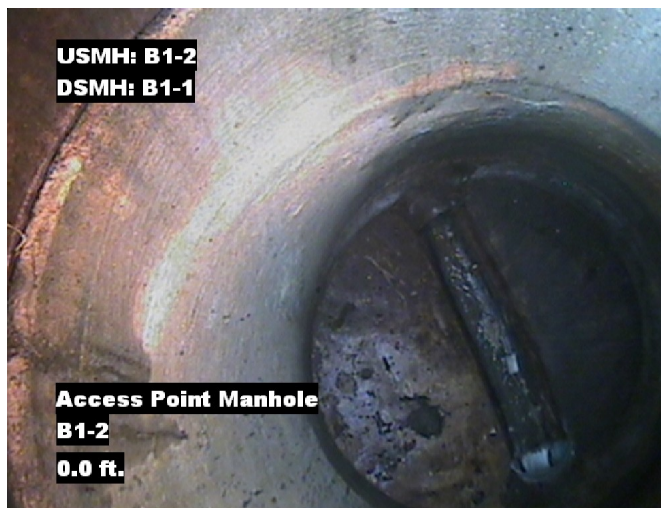
Distance: 0.0 ft. Grade: 0
Condition: Access Point Manhole
Remarks: B1-2

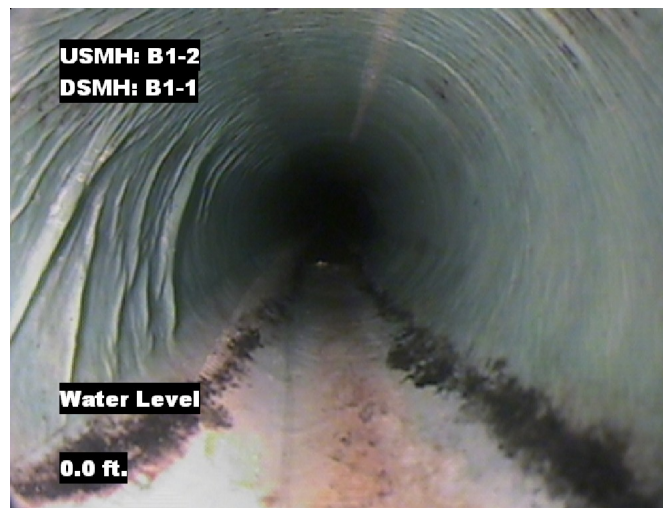
Distance: 0.0 ft. Grade: 0
Condition: Water Level
Remarks: N/A

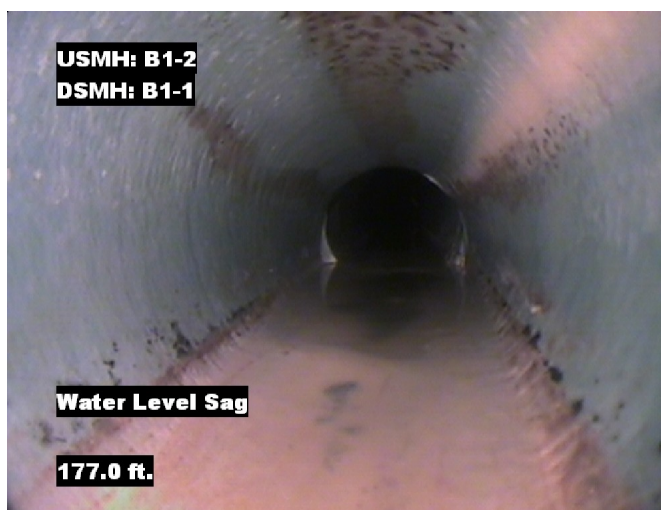
Distance: 177.0 ft. Grade: 2
Condition: Water Level Sag
Remarks: N/A

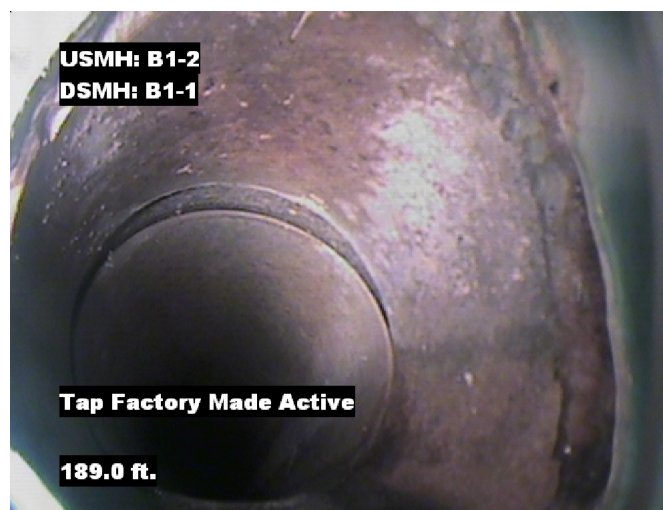
Distance: 189.0 ft. Grade: 0
Condition: Tap Factory Made Active
Remarks: N/A

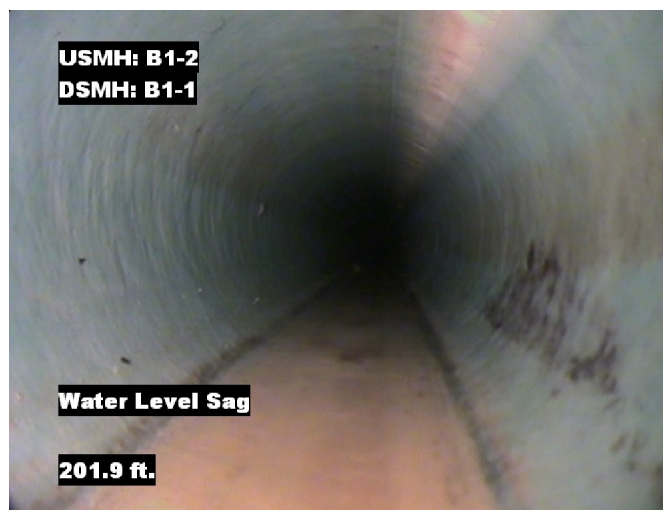
Distance: 201.9 ft. Grade: 2
Condition: Water Level Sag
Remarks: N/A

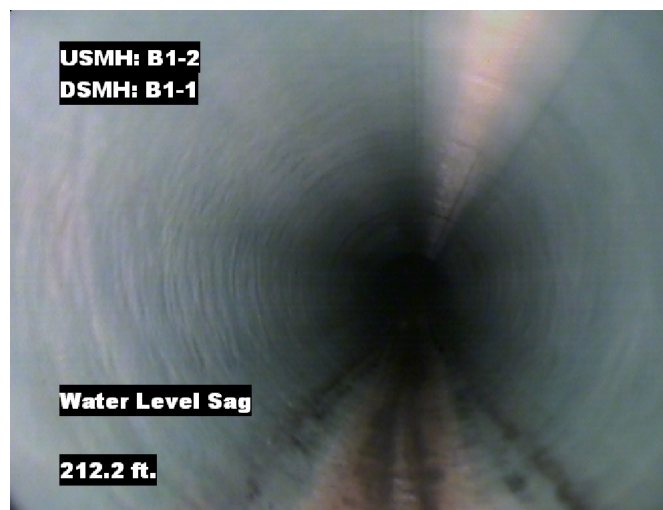
Distance: 211.9 ft. Grade: 2
Condition: Water Level Sag
Remarks: N/A

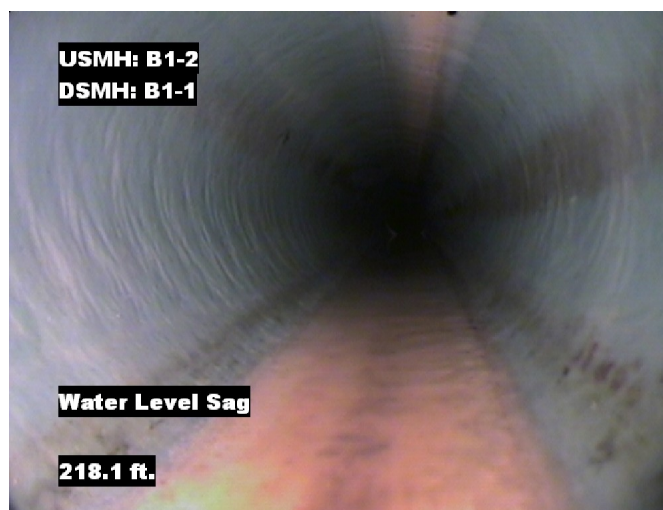
Distance: 218.1 ft. Grade: 2
Condition: Water Level Sag
Remarks: N/A

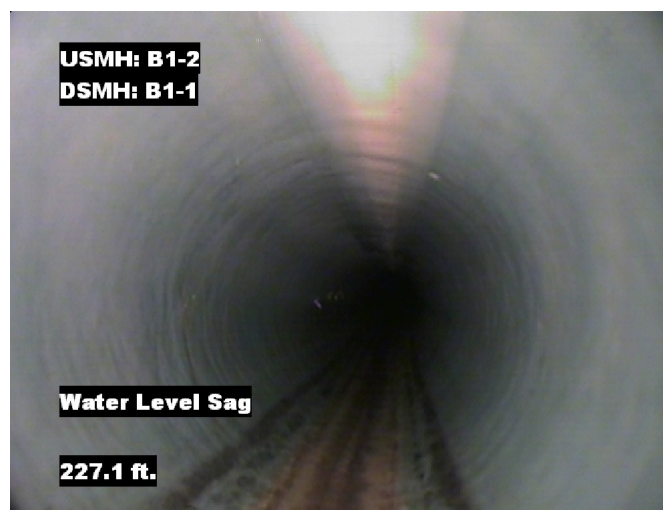
Distance: 226.8 ft. Grade: 2
Condition: Water Level Sag
Remarks: N/A

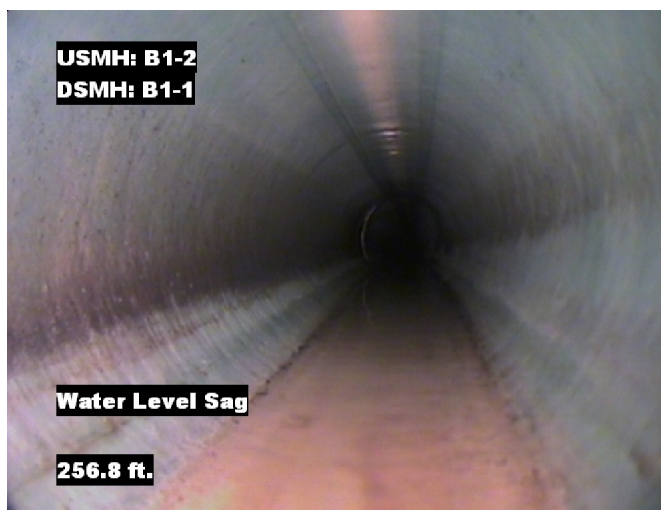
Distance: 256.8 ft. Grade: 2
Condition: Water Level Sag
Remarks: N/A

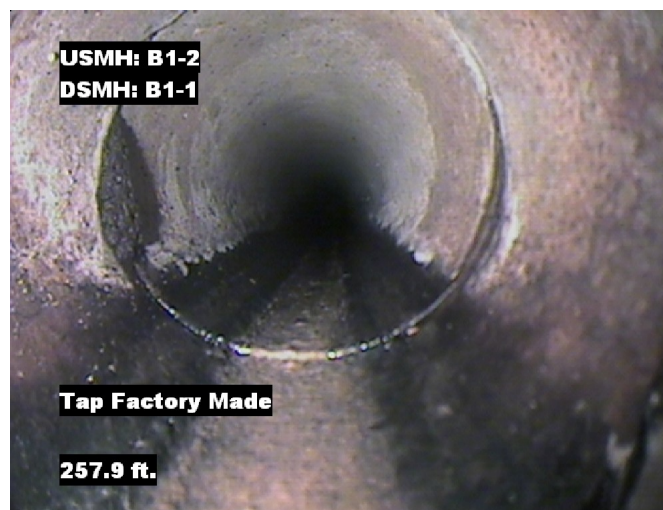
Distance: 257.9 ft. Grade: 0
Condition: Tap Factory Made
Remarks: N/A

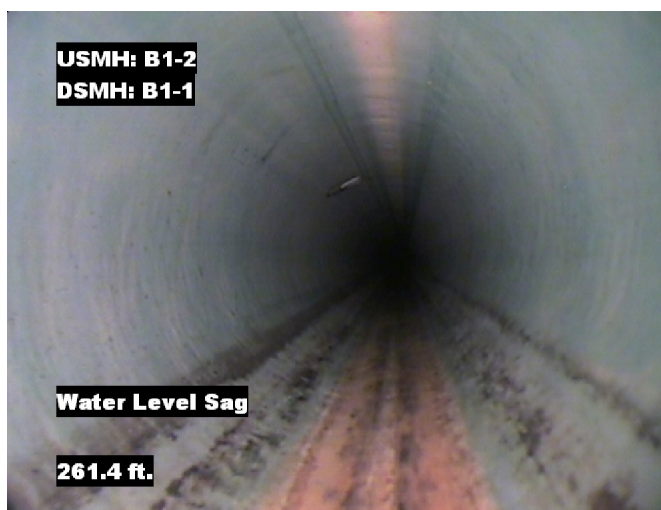
Distance: 261.4 ft. Grade: 2
Condition: Water Level Sag
Remarks: N/A

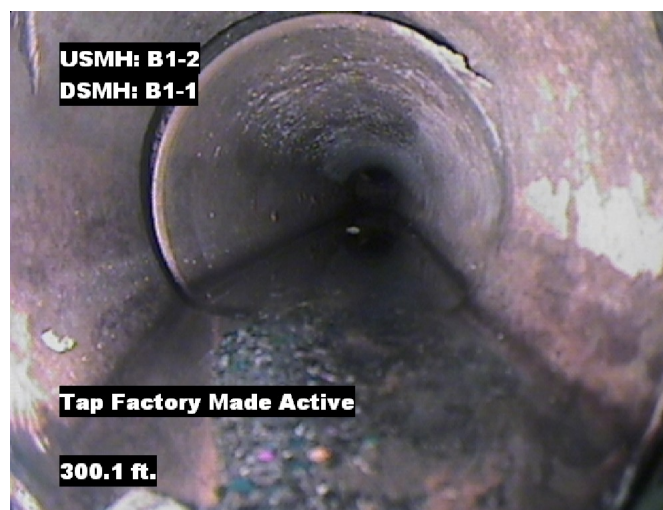
Distance: 300.1 ft. Grade: 0
Condition: Tap Factory Made Active
Remarks: N/A

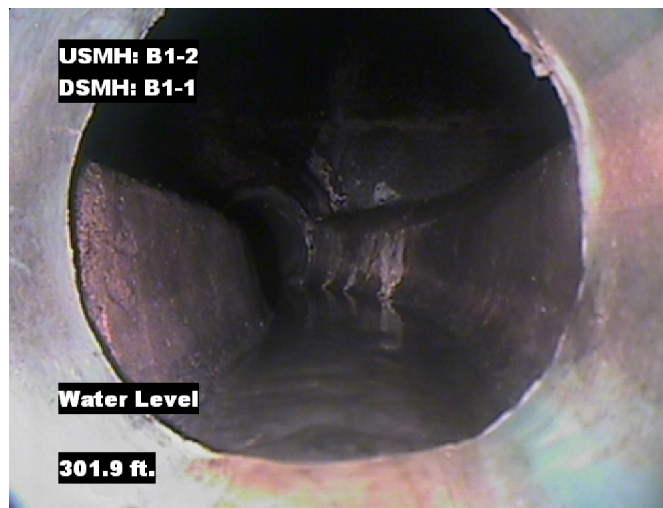
Distance: 301.9 ft. Grade: 0
Condition: Water Level
Remarks: N/A

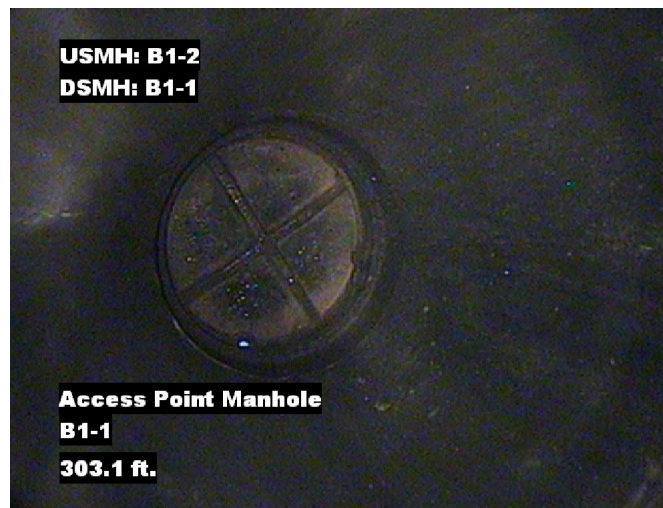
Distance: 303.1 ft. Grade: 0
Condition: Access Point Manhole
Remarks: B1-1
