## Defect Listing

Pipe Segment Refere... <b>B1-3_B1-2</b>	City <b>Oliver Springs</b>	Street <b>Cemetery Rd</b>	Material <b>Concrete Pipe (non-...</b>	Location C... <b>Light High...</b>	Sewer Use <b>Sanitary</b>
Upstream MH <b>B1-3</b>	Total Length <b>313.2</b>	Year Laid	Shape <b>Circular</b>	Location Details	
DS Manhole <b>B1-2</b>	Length surveyed <b>2</b>	Year Renewed	Height <b>8</b>	Width <b>8</b>	Pipe Joint... <b>4</b>

SPR <b>7</b>	MPR <b>N/A</b>	PO Number <b>4397-03</b>	Customer <b>GRW</b>
SPRI <b>3.5</b>	MPRI <b>N/A</b>	Work Order <b>4397-02</b>	Purpose <b>Pre-Rehabilitation Survey</b>
QSR <b>5121</b>	QMR <b>N/A</b>		
OPR <b>7</b>	Surveyed By <b>Charlie Gordon</b>	Direction <b>Upstream</b>	Date <b>20150910</b>
OPRI <b>3.5</b>	Certificate Number <b>U-615-07000491</b>	Pre-Cleaning <b>Jetting</b>	Time <b>14:31</b>
	Date Cleaned <b>20150910</b>	End Time <b>14:35</b>	Weather <b>Damp</b>
			Media label
			Additional Info

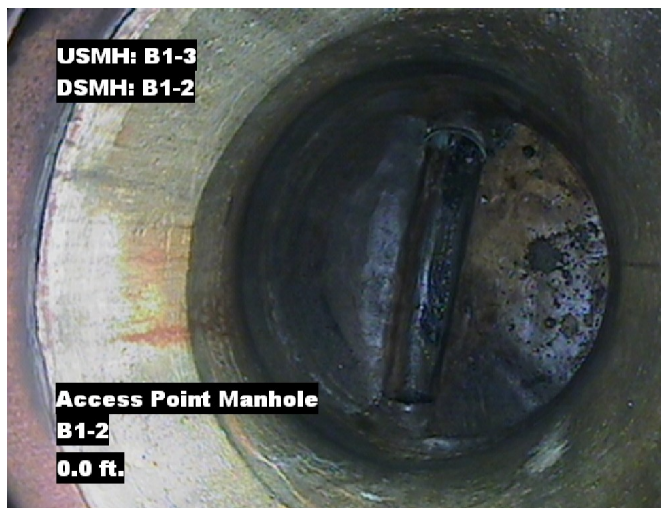
Distance: 0.0 ft. Grade: 0  
Condition: Access Point Manhole  
Remarks: B1-2

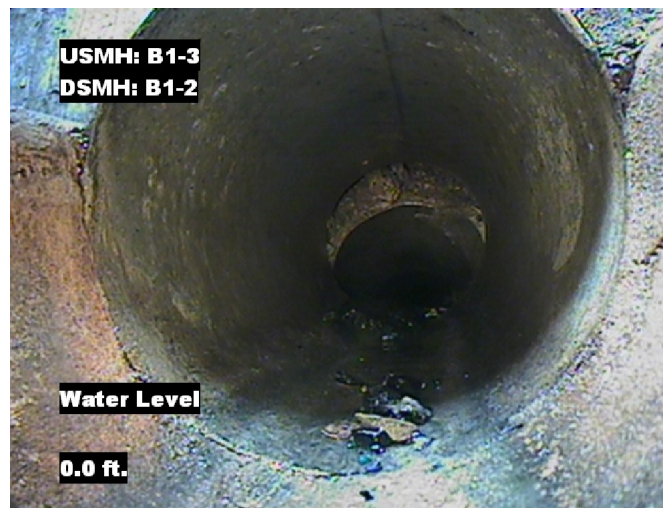
Distance: 0.0 ft. Grade: 0  
Condition: Water Level  
Remarks: N/A

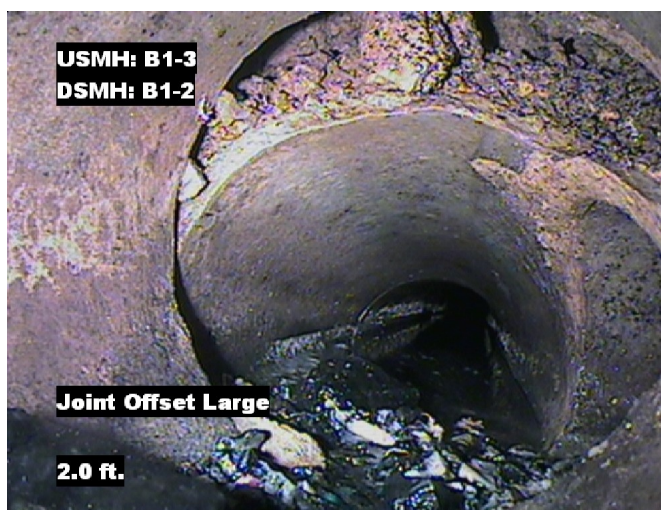
Distance: 2.0 ft. Grade: 2  
Condition: Joint Offset Large  
Remarks: N/A

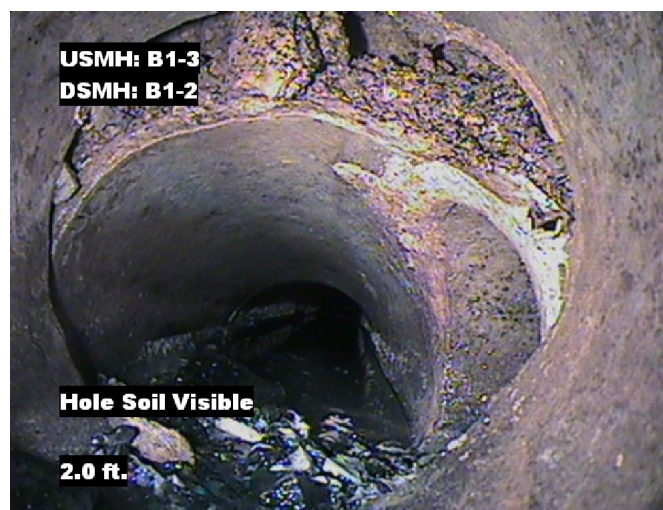
Distance: 2.0 ft. Grade: 5  
Condition: Hole Soil Visible  
Remarks: N/A

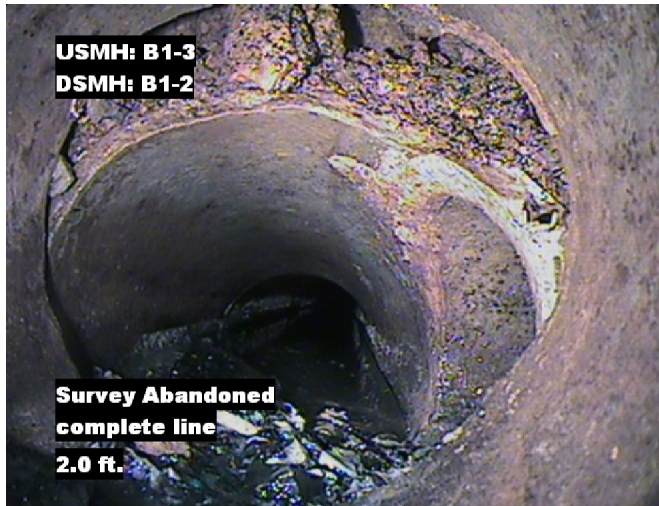
**USMH: B1-3**  
**DSMH: B1-2**

Distance: 2.0 ft.      Grade: 0  
Condition: Survey Abandoned  
Remarks: complete line
