Defect Listing

Pipe Segment Refere... B2-1_B-17	City Oliver springs	Street Cemtery Rd	Material Concrete Pipe (non-...	Location C... Woods	Sewer Use Sanitary
Upstream MH B2-1	Total Length 187.2	Year Laid	Shape Circular	Location Details	
DS Manhole B-17	Length surveyed 187.2	Year Renewed	Height 8	Width 8	Pipe Joint... 4

SPR 1	MPR 2	PO Number 4397-03	Customer GRW
SPRI 1	MPRI 1	Work Order 4397-02	Purpose Pre-Rehabilitation Survey
QSR 1100	QMR 1200		
OPR 3	Surveyed By Charlie Gordon	Direction Upstream	Date 20150910
OPRI 1	Certificate Number U-615-07000491	Pre-Cleaning Heavy Cleaning	Time 10:50
	Date Cleaned 20150910	End Time 10:53	Weather Light Rain
			Media label Used Root saw

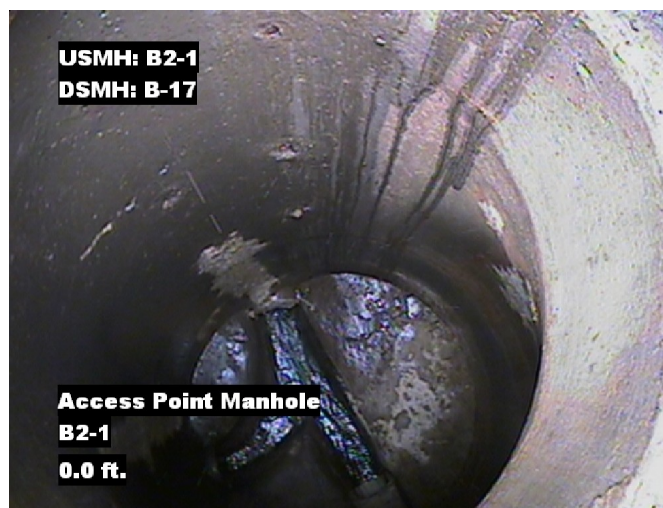
Distance: 0.0 ft. Grade: 0
Condition: Access Point Manhole
Remarks: B2-1

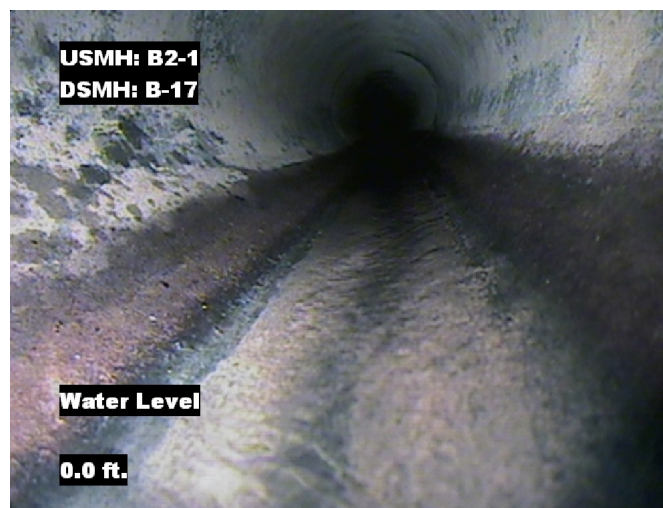
Distance: 0.0 ft. Grade: 0
Condition: Water Level
Remarks: N/A

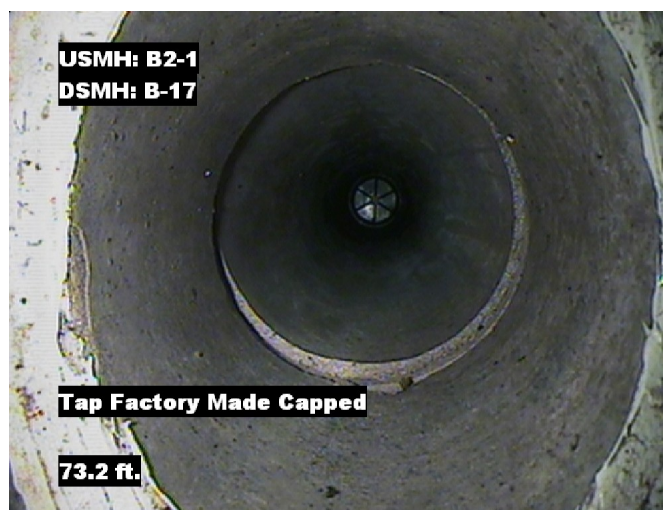
Distance: 73.2 ft. Grade: 0
Condition: Tap Factory Made Capped
Remarks: N/A

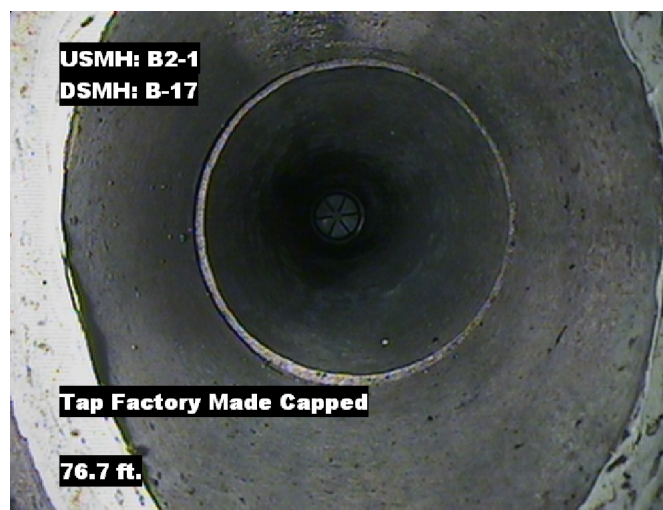
Distance: 76.7 ft. Grade: 0
Condition: Tap Factory Made Capped
Remarks: N/A

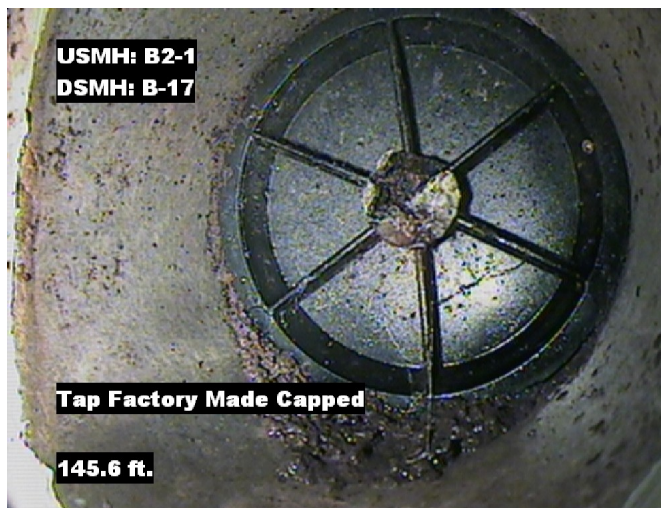
Distance: 145.6 ft. Grade: 0
Condition: Tap Factory Made Capped
Remarks: N/A

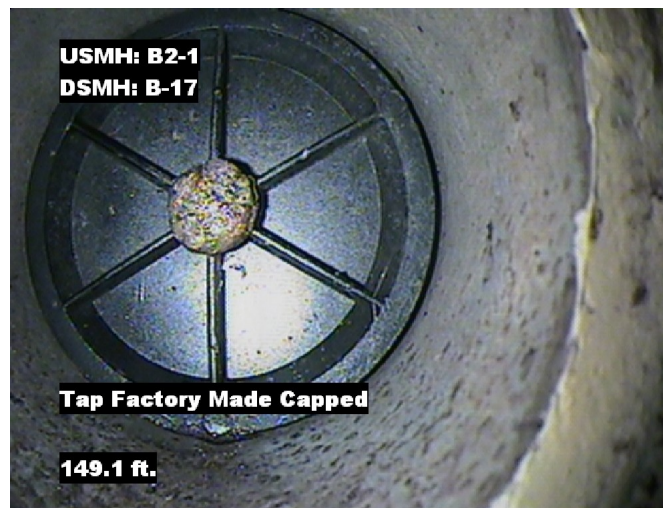
Distance: 149.1 ft. Grade: 0
Condition: Tap Factory Made Capped
Remarks: N/A

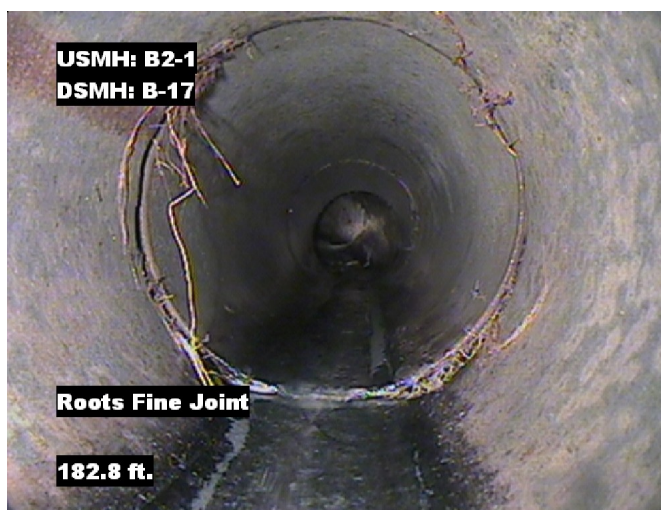
Distance: 182.8 ft. Grade: 1
Condition: Roots Fine Joint
Remarks: N/A

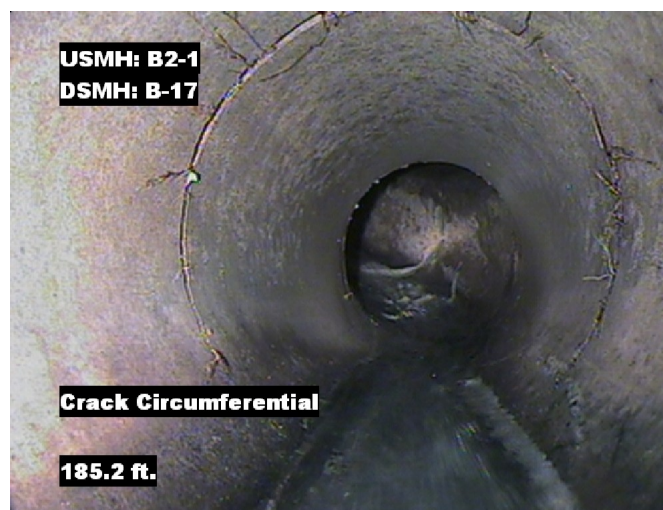
Distance: 185.2 ft. Grade: 1
Condition: Crack Circumferential
Remarks: N/A

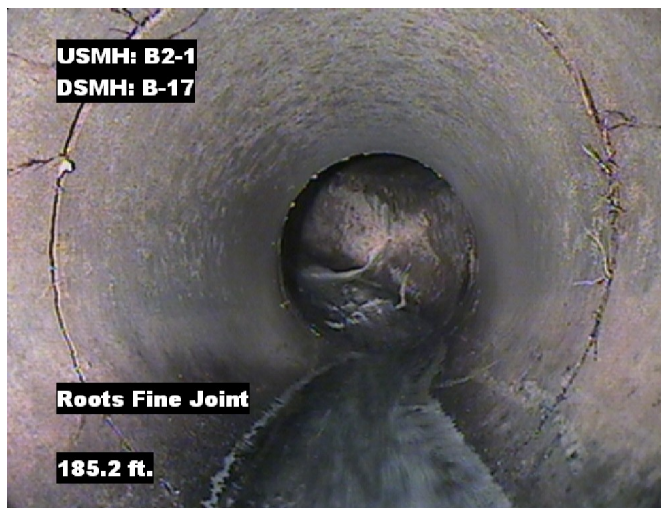
Distance: 185.2 ft. Grade: 1
Condition: Roots Fine Joint
Remarks: N/A

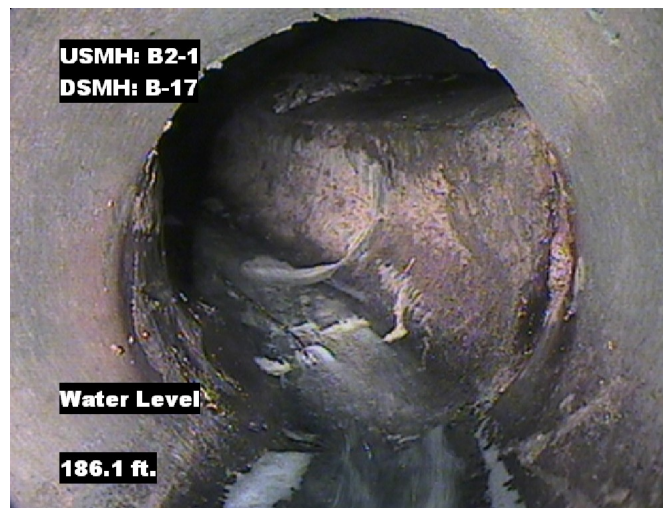
Distance: 186.1 ft. Grade: 0
Condition: Water Level
Remarks: N/A

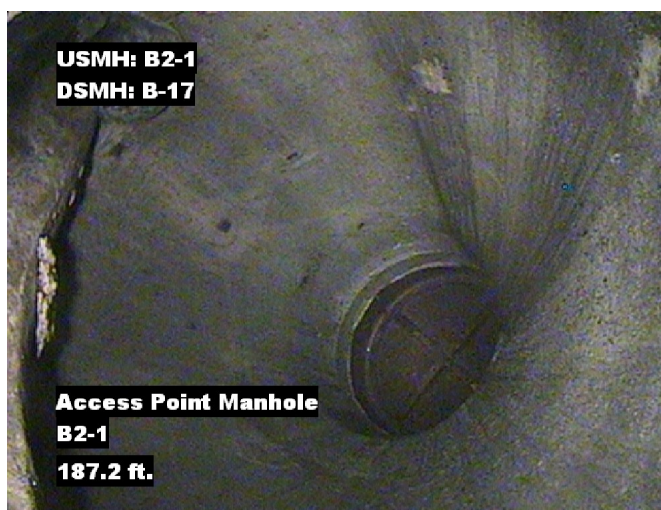
Distance: 187.2 ft. Grade: 0
Condition: Access Point Manhole
Remarks: B2-1
