Defect Listing

Pipe Segment Refere... B2-2 B2-1	City Oliver Springs	Street Kansas	Material Fibreglass Reinforc...	Location C... Woods	Sewer Use Sanitary
Upstream MH B2-2	Total Length 333.7	Year Laid	Shape Circular	Location Details	
DS Manhole B2-1	Length surveyed 333.7	Year Renewed	Height 8	Width 8	Pipe Joint... N/A

SPR N/A	MPR N/A	PO Number 4397-03	Customer GRW
SPRI N/A	MPRI N/A	Work Order 4397-02	Purpose Pre-Rehabilitation Survey
QSR N/A	QMR N/A		
OPR N/A	Surveyed By Charlie Gordon	Direction Downstream	Date 20150909
OPRI N/A	Certificate Number U-615-07000491	Pre-Cleaning Jetting	Time 08:25
	Date Cleaned 20150909	End Time 08:41	Weather Dry
		Additional Info

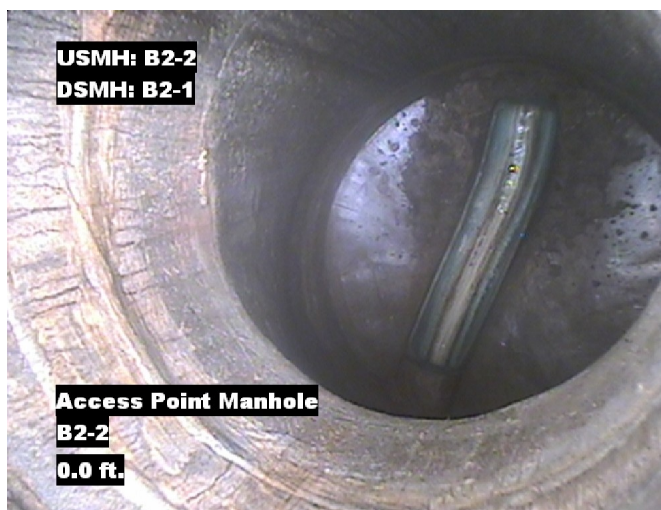
Distance: 0.0 ft. Grade: 0
Condition: Access Point Manhole
Remarks: B2-2

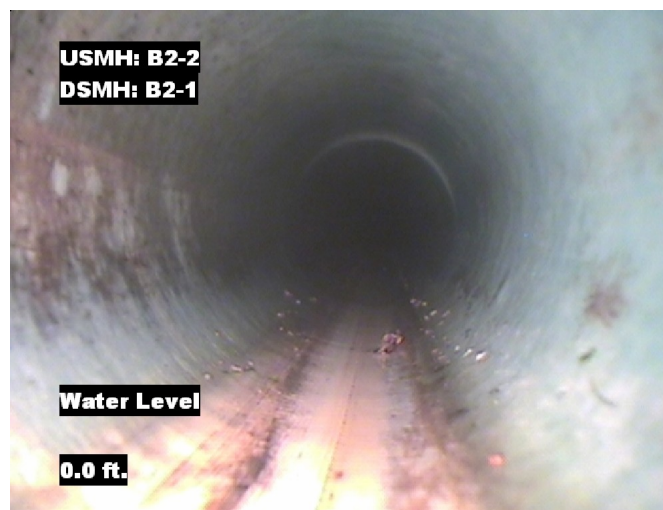
Distance: 0.0 ft. Grade: 0
Condition: Water Level
Remarks: N/A

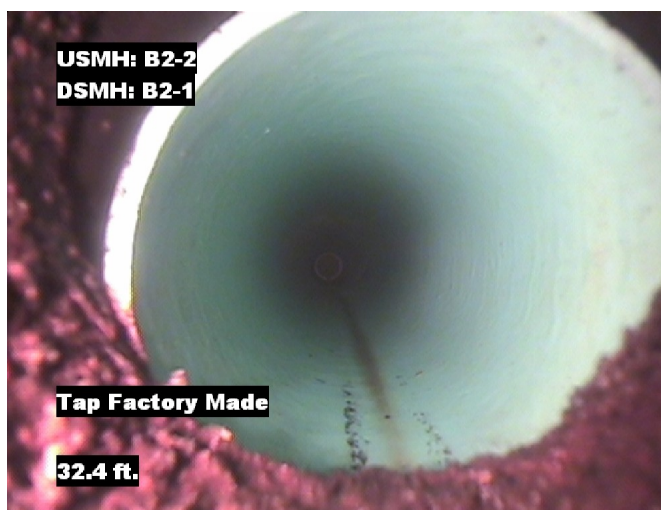
Distance: 32.4 ft. Grade: 0
Condition: Tap Factory Made
Remarks: N/A

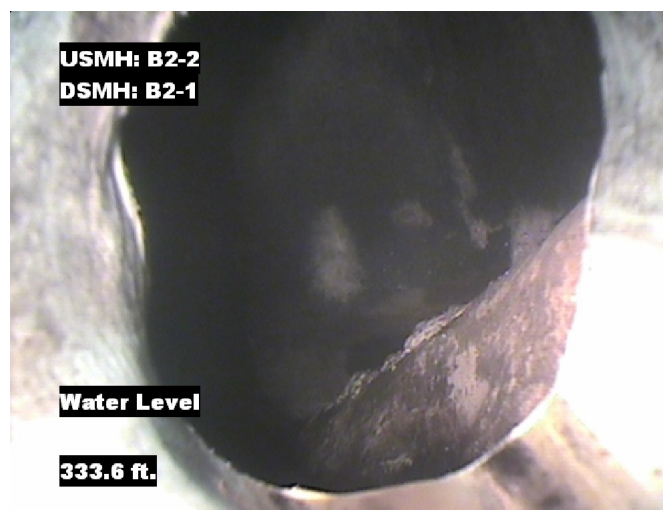
Distance: 333.6 ft. Grade: 0
Condition: Water Level
Remarks: N/A

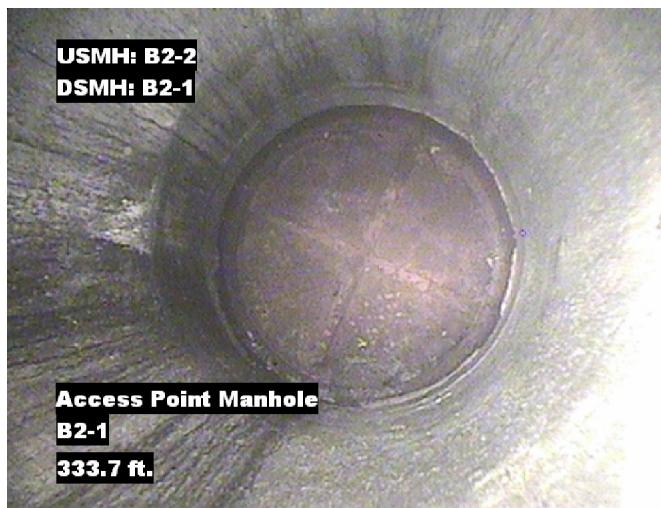
Distance: 333.7 ft. Grade: 0
Condition: Access Point Manhole
Remarks: B2-1
