Defect Listing

Pipe Segment Refere... B2-3_B2-2	City Oliver Springs	Street Kansas Ln	Material Fibreglass Reinforc...	Location C... Easement/R...	Sewer Use Sanitary
Upstream MH B2-3	Total Length 156.5	Year Laid	Shape Circular	Location Details	
DS Manhole B2-2	Length surveyed 156.5	Year Renewed	Height 8	Width 8	Pipe Joint... N/A

SPR N/A	MPR N/A	PO Number 4397-03	Customer GRW
SPRI N/A	MPRI N/A	Work Order 4397-02	Purpose Pre-Rehabilitation Survey
QSR N/A	QMR N/A		
OPR N/A	Surveyed By Charlie Gordon	Direction Upstream	Date 20150909
OPRI N/A	Certificate Number U-615-07000491	Pre-Cleaning Jetting	Time 07:55
	Date Cleaned 20150909	End Time 08:09	Weather Dry
		Additional Info

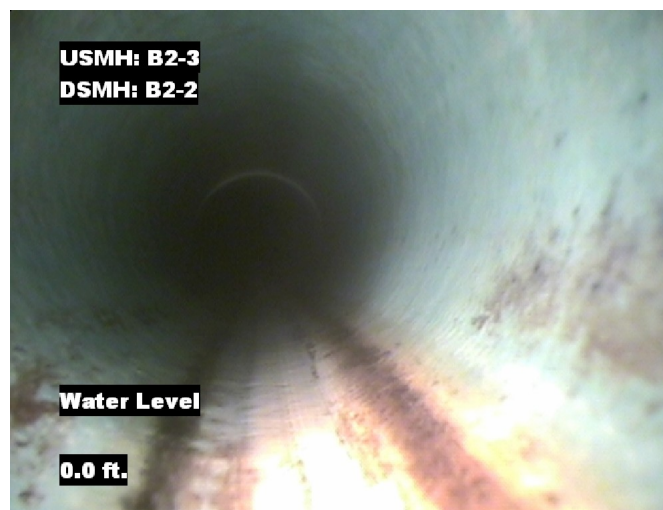
Distance: 0.0 ft. Grade: 0
Condition: Water Level
Remarks: N/A

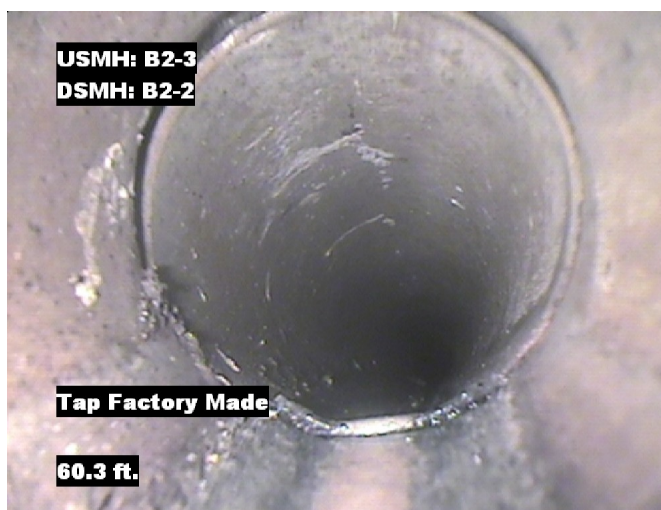
Distance: 60.3 ft. Grade: 0
Condition: Tap Factory Made
Remarks: N/A

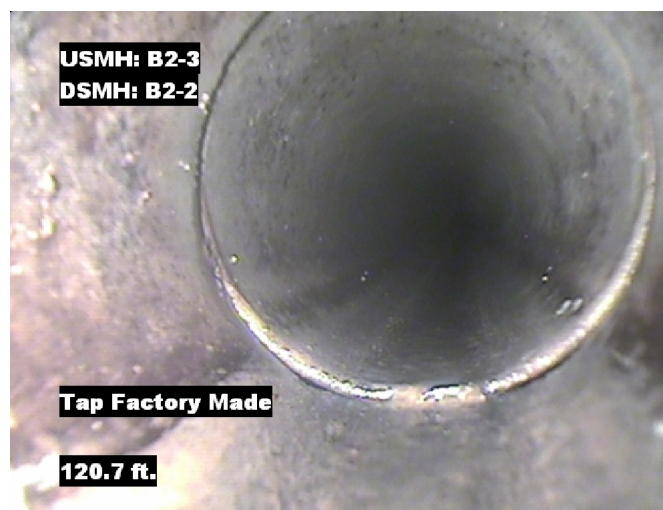
Distance: 120.7 ft. Grade: 0
Condition: Tap Factory Made
Remarks: N/A

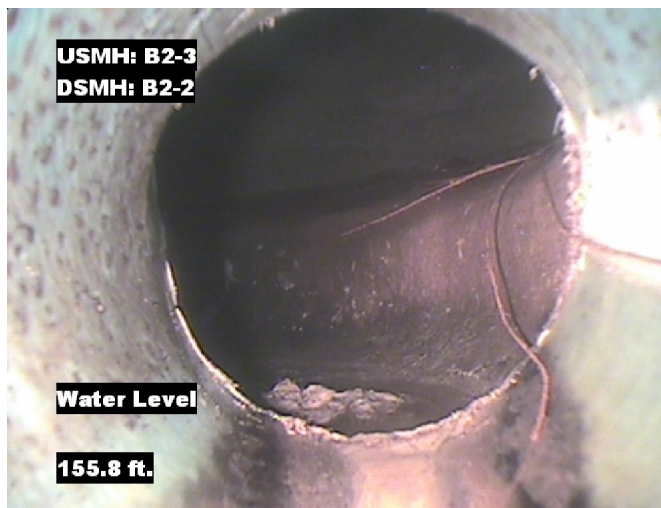
Distance: 155.6 ft. Grade: 0
Condition: Water Level
Remarks: N/A
