Defect Listing

Pipe Segment Refere...	City	Street	Material	Location C...	Sewer Use
B2-4_B2-3	Oliver springs	Kansas Ln	Concrete Pipe (non-...	Sidewalk	Sanitary
Upstream MH	Total Length	Year Laid	Shape	Location Details	
B2-4			Circular		
DS Manhole	Length surveyed	Year Renewed	Height	Width	Pipe Joint...
B2-3	150.9		8	8	4

SPR	5	MPR	10	PO Number	Customer
SPRI	5	MPRI	2	4397-03	GRW
QSR	5100	QMR	2500	Work Order	Purpose
				4397-02	Pre-Rehabilitation Survey
OPR		Surveyed By	Direction	Date	Media label
15		Charlie Gordon	Downstream	20150909	
OPRI		Certificate Number	Pre-Cleaning	Time	Weather
2.5		U-615-07000491	No Pre-Cleaning	07:02	Dry
		Date Cleaned		End Time	Additional Info
				07:23	CAMERA CAN NOT PASS...

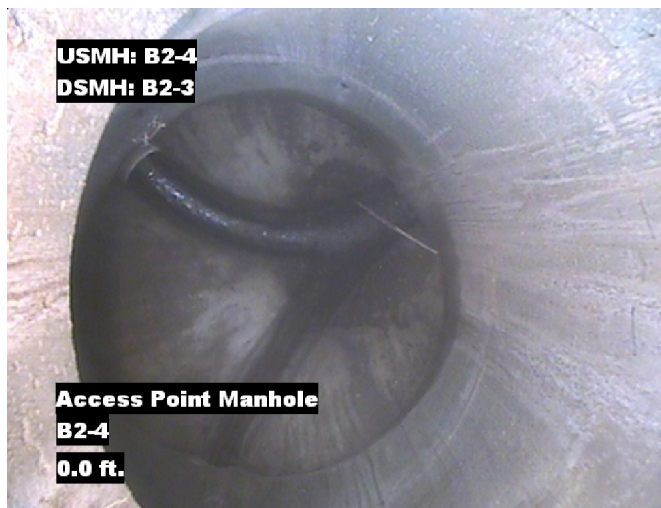
Distance: 0.0 ft. Grade: 0
Condition: Access Point Manhole
Remarks: B2-4

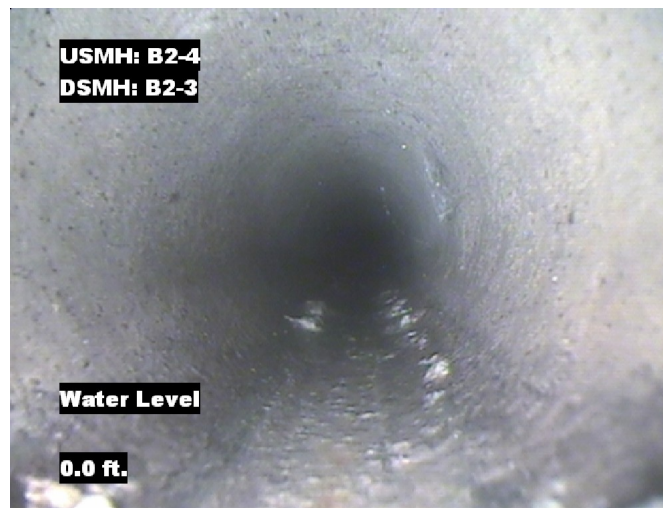
Distance: 0.0 ft. Grade: 0
Condition: Water Level
Remarks: N/A

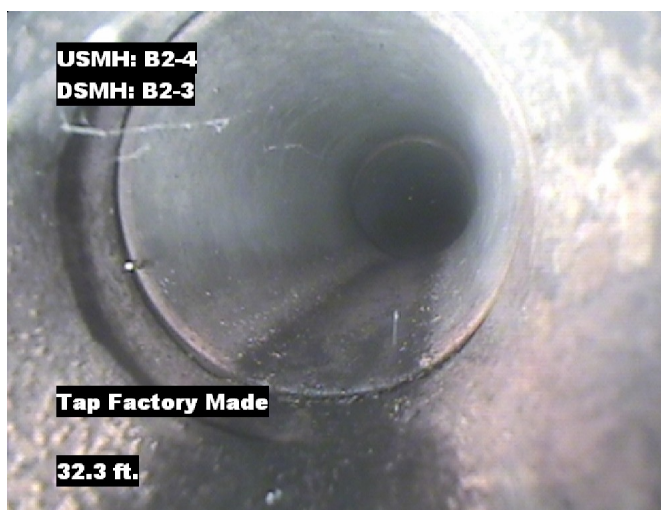
Distance: 32.3 ft. Grade: 0
Condition: Tap Factory Made
Remarks: N/A

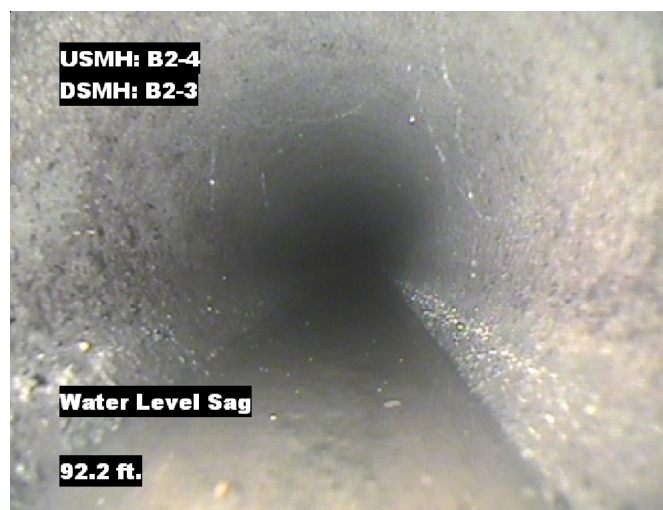
Distance: 92.2 ft. Grade: 2
Condition: Water Level Sag
Remarks: N/A

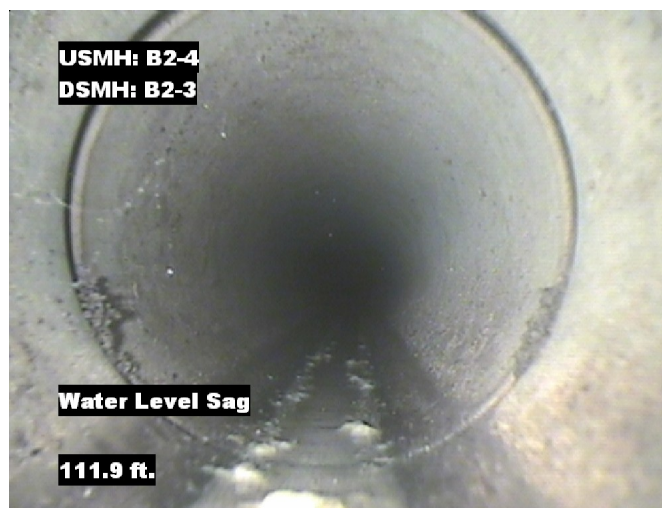
Distance: 111.9 ft. Grade: 2
Condition: Water Level Sag
Remarks: N/A

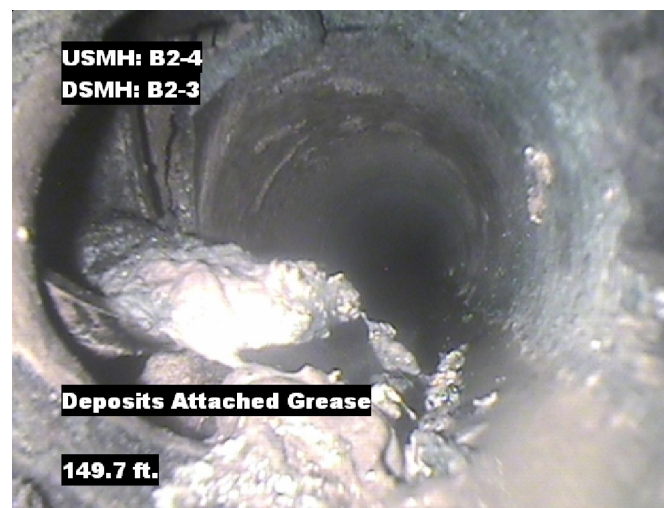
Distance: 149.7 ft. Grade: 2
Condition: Deposits Attached Grease
Remarks: N/A

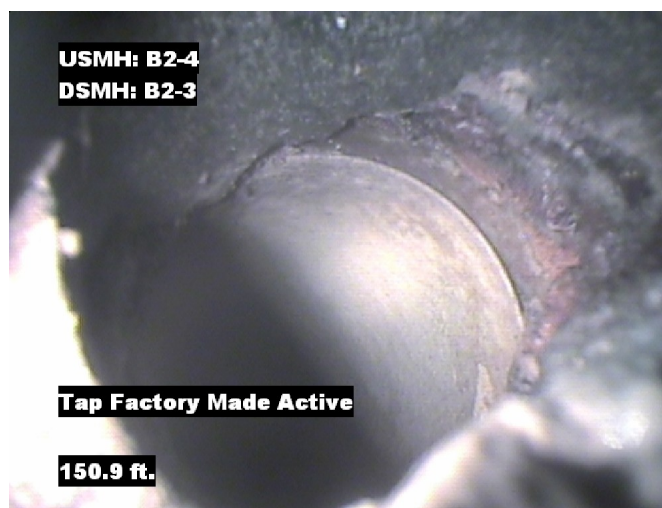
Distance: 150.9 ft. Grade: 0
Condition: Tap Factory Made Active
Remarks: N/A

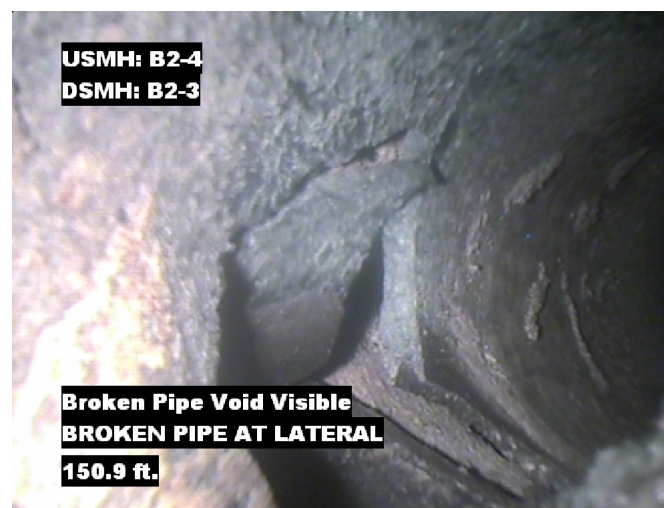
Distance: 150.9 ft. Grade: 5
Condition: Broken Pipe Void Visible
Remarks: BROKEN PIPE AT LATERAL

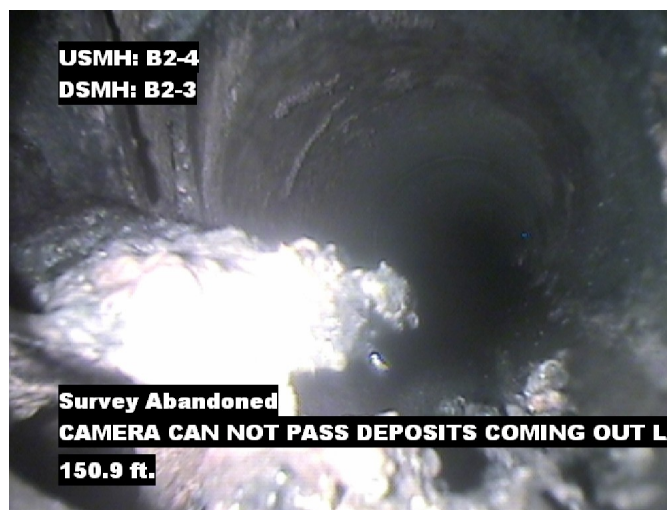
Distance: 150.9 ft. Grade: 0
Condition: Survey Abandoned
Remarks: CAMERA CAN NOT PASS DEPOSITS
COMING OUT LATERAL
