Defect Listing

Pipe Segment Refere... B3-2 B-18	City Oliver Springs	Street Kentucky St	Material Fibreglass Reinforc...	Location C... Light High...	Sewer Use Sanitary
Upstream MH B3-2	Total Length 225.2	Year Laid	Shape Circular	Location Details	
DS Manhole B-18	Length surveyed 225.2	Year Renewed	Height 8	Width 8	Pipe Joint... N/A

Image Report 4/Page

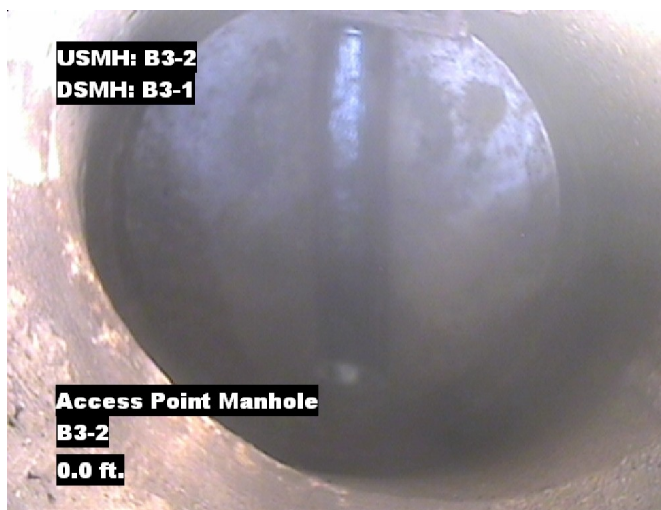
Distance: 0.0 ft. Grade: 0
Condition: Access Point Manhole
Remarks: B3-2

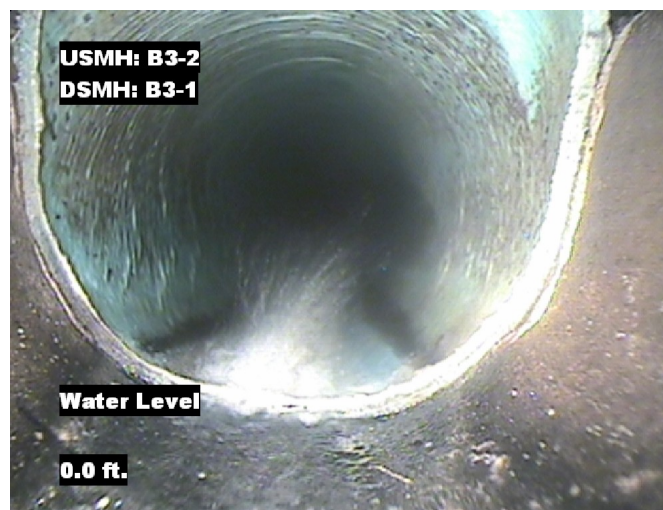
Distance: 0.0 ft. Grade: 0
Condition: Water Level
Remarks: N/A

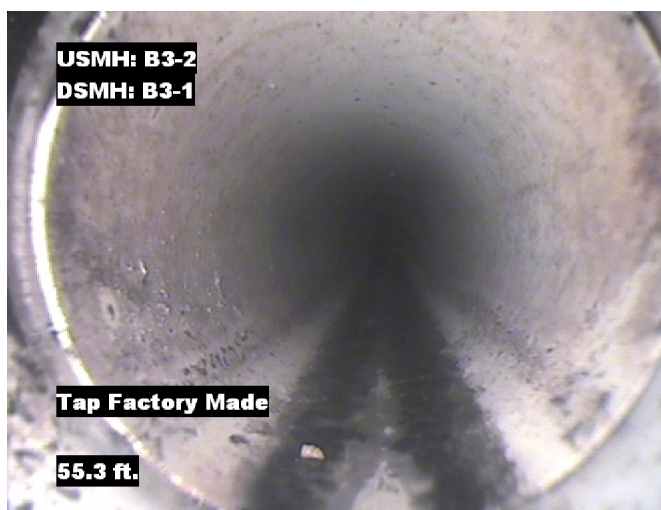
Distance: 55.3 ft. Grade: 0
Condition: Tap Factory Made
Remarks: N/A

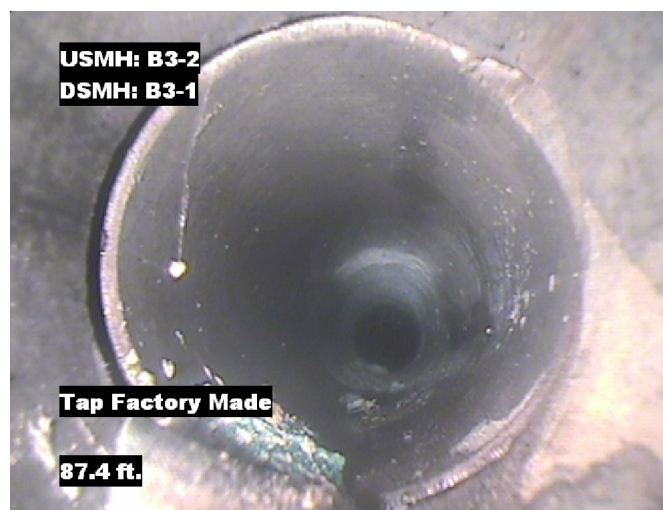
Distance: 87.4 ft. Grade: 0
Condition: Tap Factory Made
Remarks: N/A

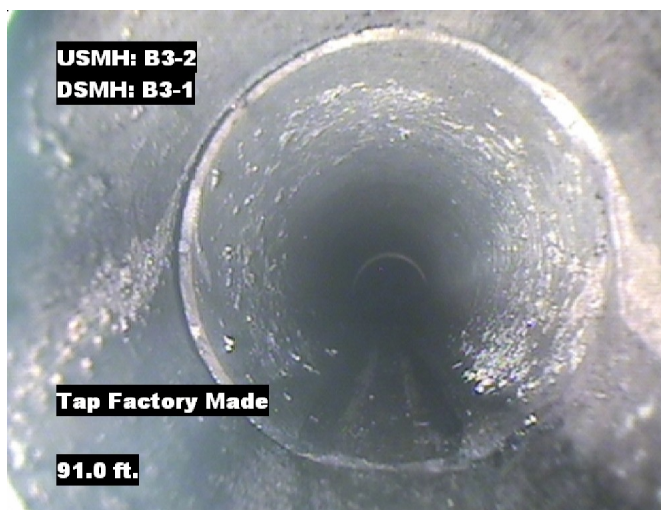
Distance: 91.0 ft. Grade: 0
Condition: Tap Factory Made
Remarks: N/A

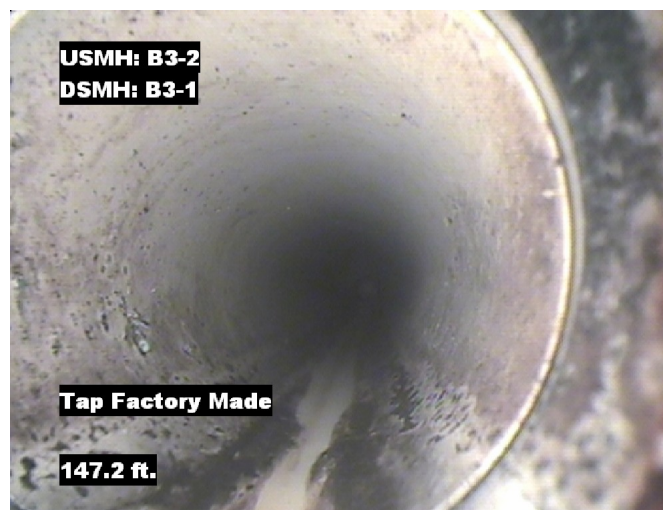
Distance: 147.2 ft. Grade: 0
Condition: Tap Factory Made
Remarks: N/A

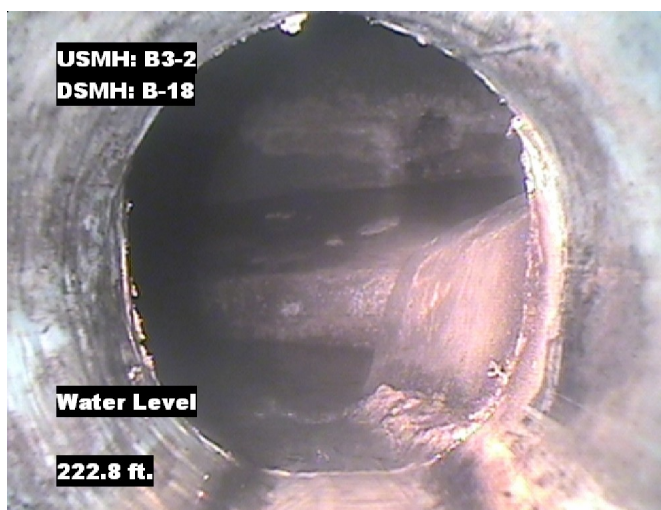
Distance: 222.8 ft. Grade: 0
Condition: Water Level
Remarks: N/A

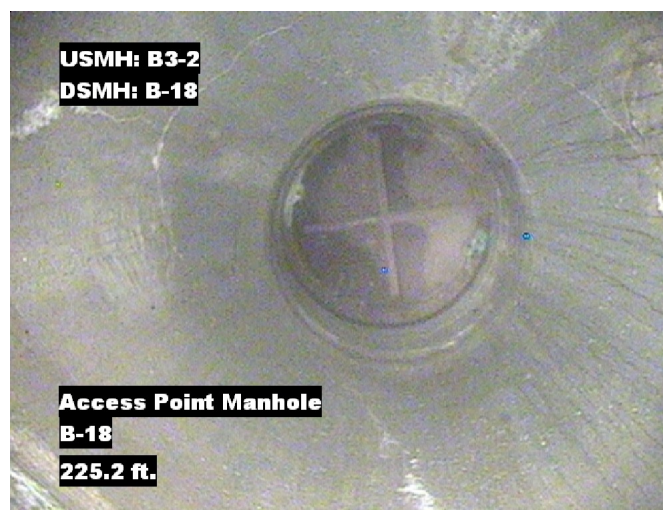
Distance: 225.2 ft. Grade: 0
Condition: Access Point Manhole
Remarks: B-18
