## Defect Listing

Pipe Segment Refere... <b>B3-3_B3-2</b>	City <b>Oliver Springs</b>	Street <b>Kentucky St</b>	Material <b>Concrete Pipe (non-...</b>	Location C... <b>Light High...</b>	Sewer Use <b>Sanitary</b>
Upstream MH <b>B3-3</b>	Total Length <b>167.7</b>	Year Laid	Shape <b>Circular</b>	Location Details	
DS Manhole <b>B3-2</b>	Length surveyed <b>167.7</b>	Year Renewed	Height <b>8</b>	Width <b>8</b>	Pipe Joint... <b>4</b>

SPR <b>3</b>	MPR <b>N/A</b>	PO Number <b>4397-03</b>	Customer <b>GRW</b>
SPRI <b>3</b>	MPRI <b>N/A</b>	Work Order <b>4397-02</b>	Purpose <b>Pre-Rehabilitation Survey</b>
QSR <b>3100</b>	QMR <b>N/A</b>		
OPR <b>3</b>	Surveyed By <b>Charlie Gordon</b>	Direction <b>Downstream</b>	Date <b>20150908</b>
OPRI <b>3</b>	Certificate Number <b>U-615-07000491</b>	Pre-Cleaning <b>Jetting</b>	Time <b>13:47</b>
	Date Cleaned <b>20150908</b>	End Time <b>13:54</b>	Weather <b>Dry</b>
			Media label
			Additional Info

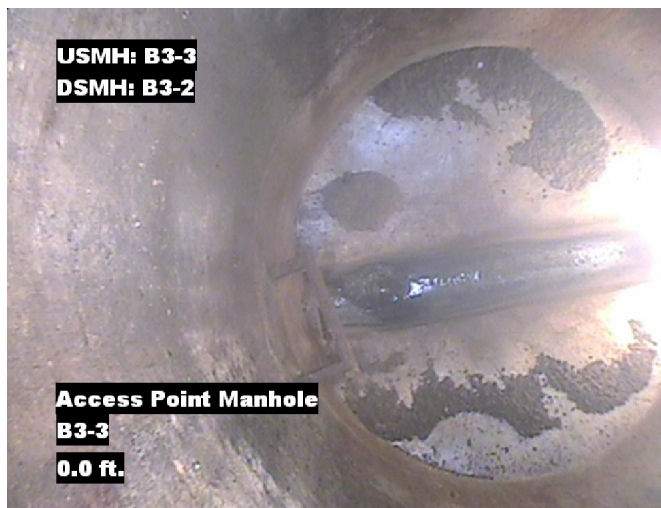
Distance: 0.0 ft. Grade: 0  
Condition: Access Point Manhole  
Remarks: B3-3

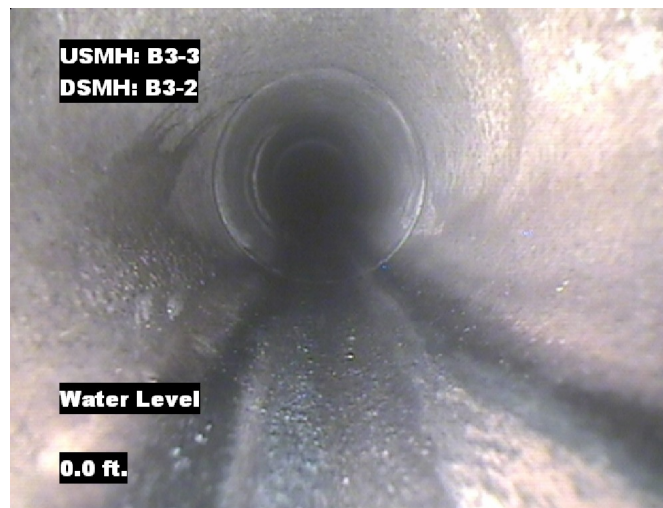
Distance: 0.0 ft. Grade: 0  
Condition: Water Level  
Remarks: N/A

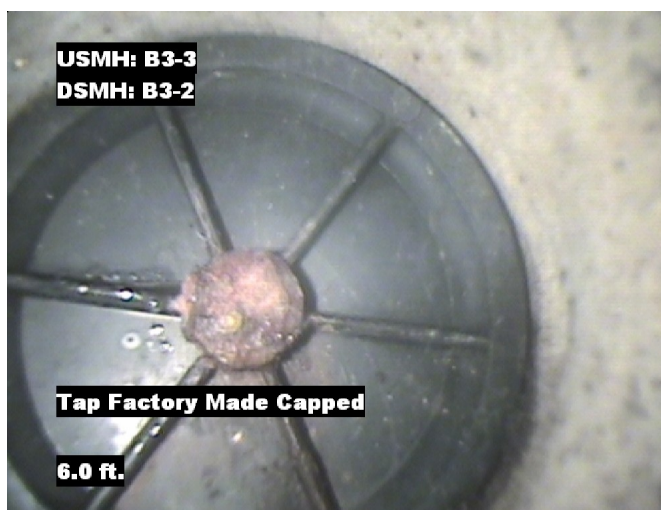
Distance: 6.0 ft. Grade: 0  
Condition: Tap Factory Made Capped  
Remarks: N/A

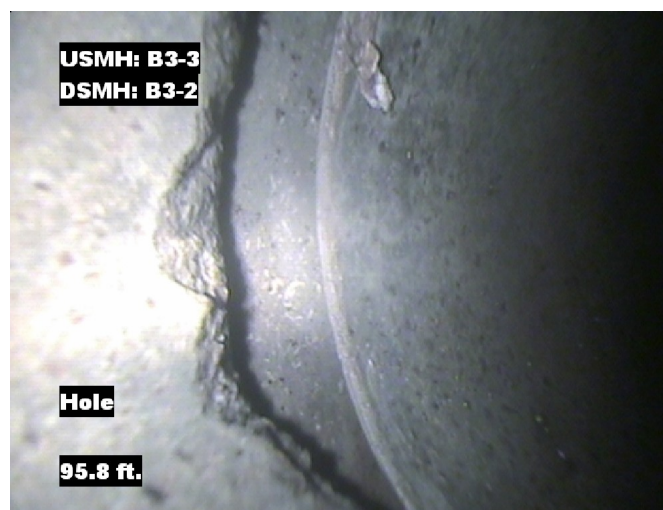
Distance: 95.8 ft. Grade: 3  
Condition: Hole  
Remarks: N/A

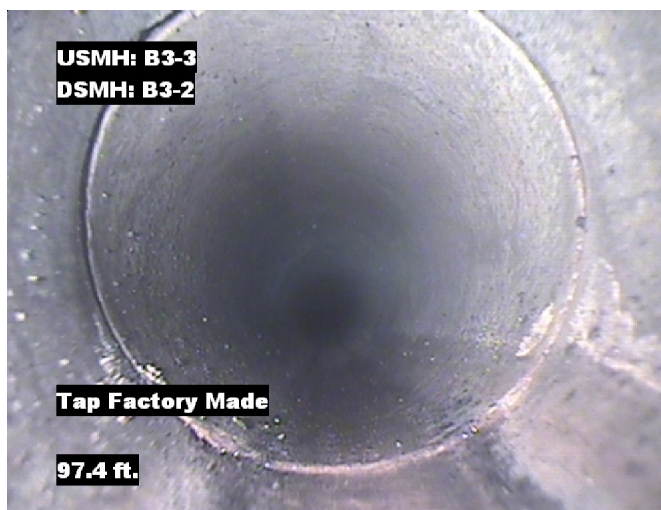
Distance: 97.4 ft. Grade: 0  
Condition: Tap Factory Made  
Remarks: N/A

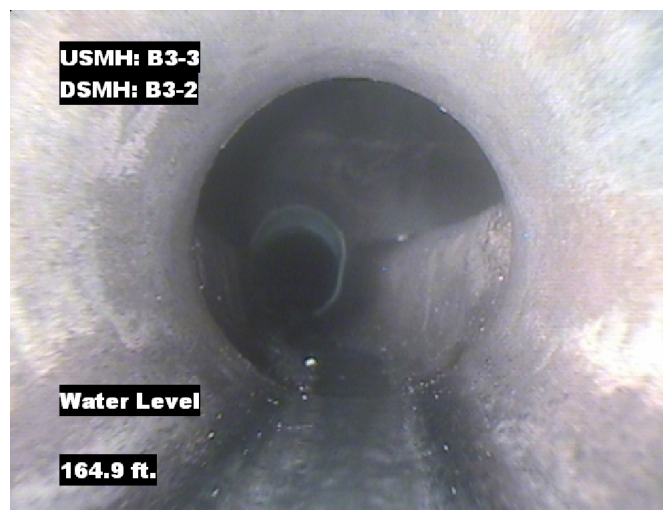
Distance: 164.8 ft. Grade: 0  
Condition: Water Level  
Remarks: N/A

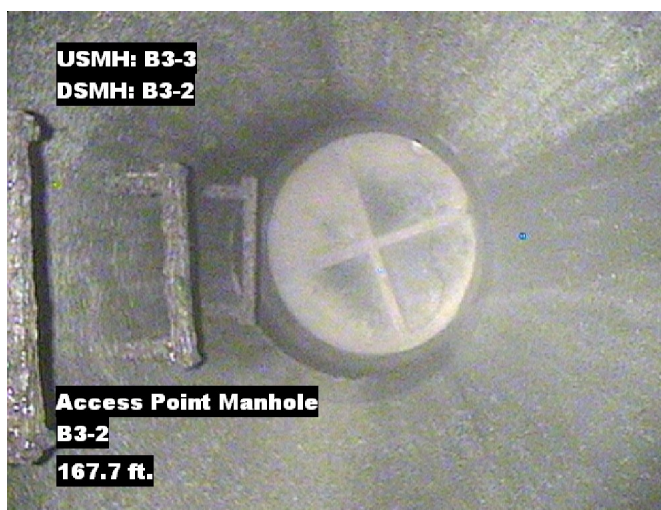
Distance: 167.7 ft. Grade: 0  
Condition: Access Point Manhole  
Remarks: B3-2
