Defect Listing

Pipe Segment Refere... B3-4_B3-3	City Oliver Springs	Street Kentucky St	Material Concrete Pipe (non-...	Location C... Light High...	Sewer Use Sanitary
Upstream MH B3-4	Total Length 235.1	Year Laid	Shape Circular	Location Details	
DS Manhole B3-3	Length surveyed 235.1	Year Renewed	Height 8	Width 8	Pipe Joint... 4

SPR N/A	MPR 2	PO Number 4397-03	Customer GRW
SPRI N/A	MPRI 2	Work Order 4397-02	Purpose Pre-Rehabilitation Survey
QSR N/A	QMR 2100		
OPR 2	Surveyed By Charlie Gordon	Direction Upstream	Date 20150908
OPRI 2	Certificate Number U-615-07000491	Pre-Cleaning Jetting	Time 13:08
	Date Cleaned 20150908	End Time 13:25	Weather Dry
		Additional Info

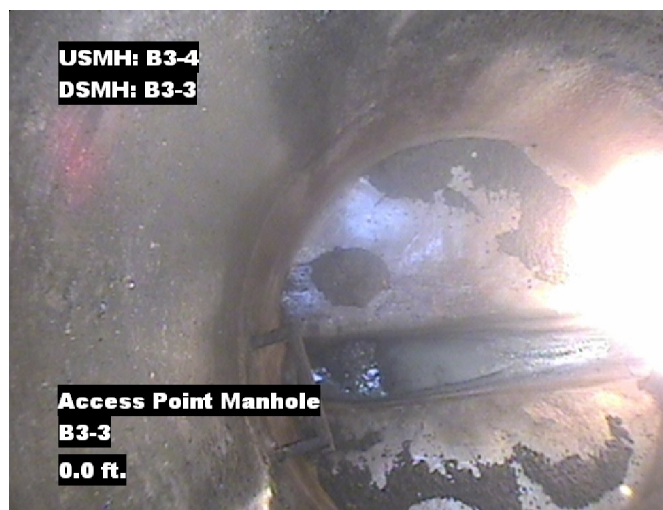
Distance: 0.0 ft. Grade: 0
Condition: Access Point Manhole
Remarks: B3-3

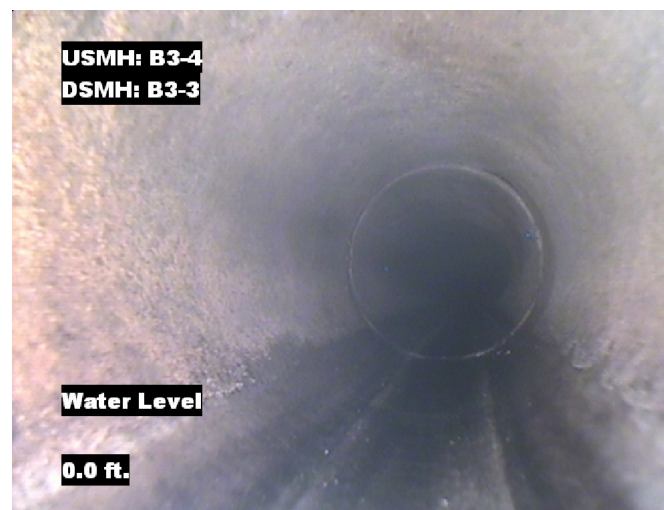
Distance: 0.0 ft. Grade: 0
Condition: Water Level
Remarks: N/A

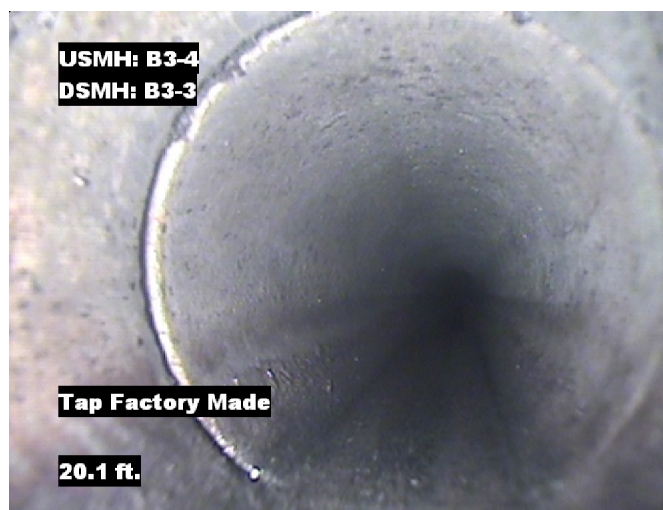
Distance: 20.1 ft. Grade: 0
Condition: Tap Factory Made
Remarks: N/A

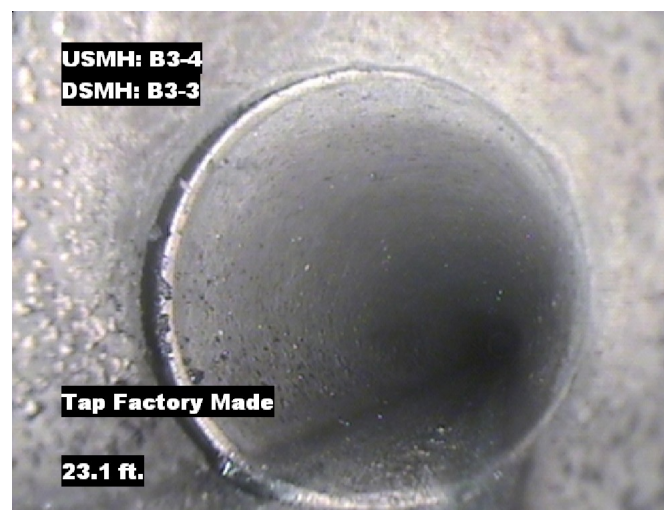
Distance: 23.1 ft. Grade: 0
Condition: Tap Factory Made
Remarks: N/A

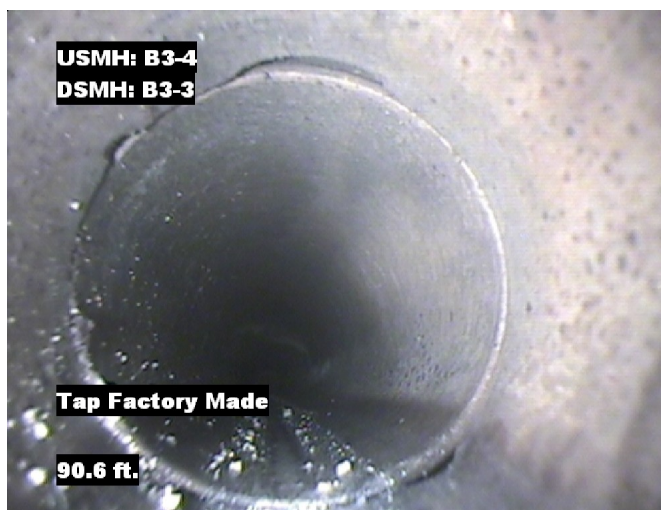
Distance: 90.6 ft. Grade: 0
Condition: Tap Factory Made
Remarks: N/A

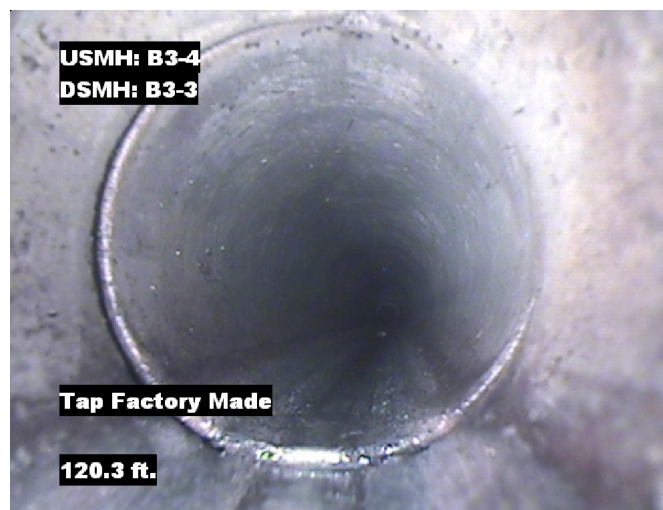
Distance: 120.3 ft. Grade: 0
Condition: Tap Factory Made
Remarks: N/A

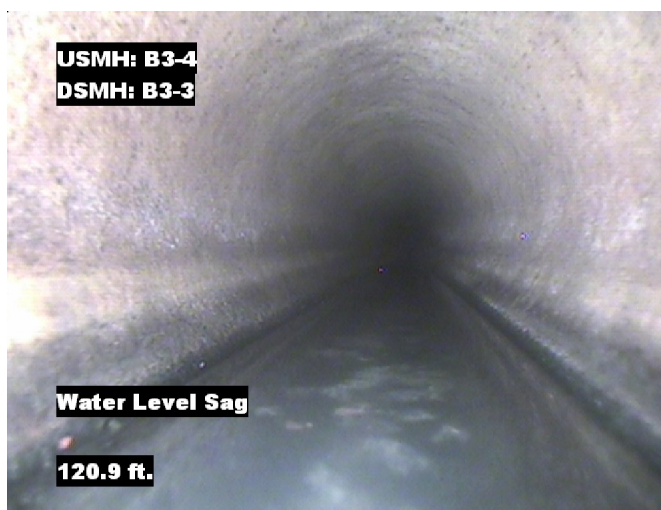
Distance: 120.9 ft. Grade: 2
Condition: Water Level Sag
Remarks: N/A

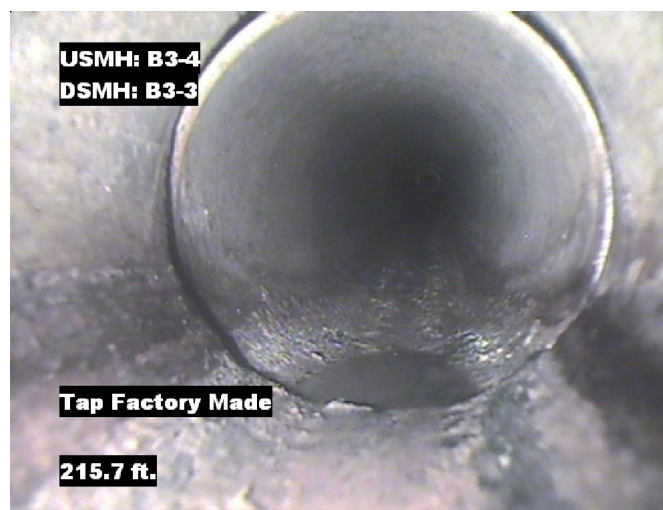
Distance: 215.7 ft. Grade: 0
Condition: Tap Factory Made
Remarks: N/A

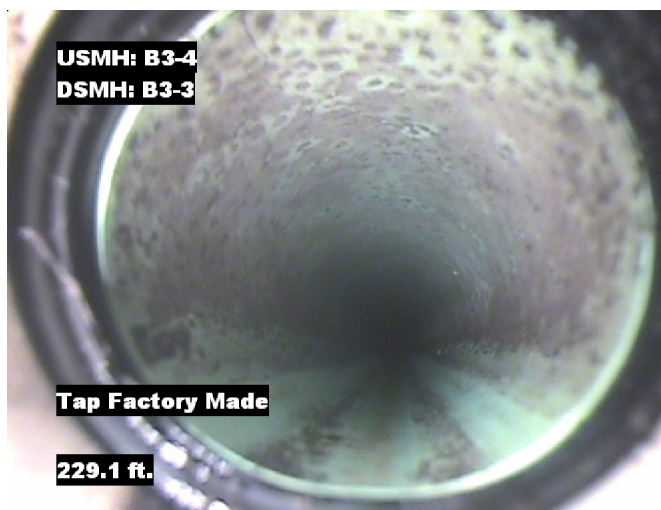
Distance: 229.1 ft. Grade: 0
Condition: Tap Factory Made
Remarks: N/A

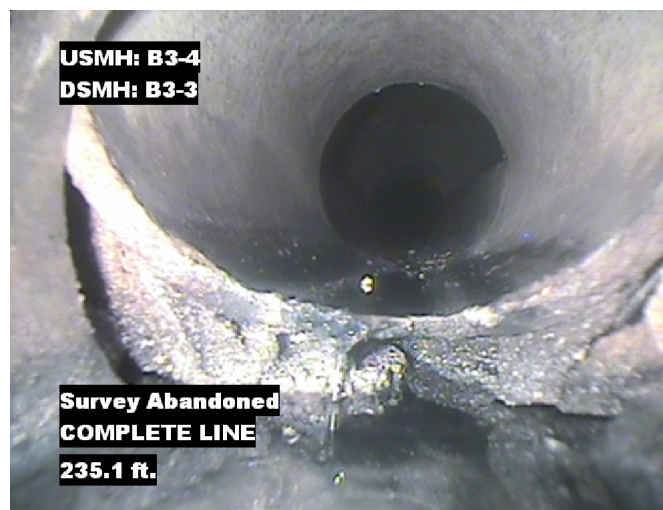
Distance: 235.1 ft. Grade: 0
Condition: Survey Abandoned
Remarks: COMPLETE LINE
