## Defect Listing

Pipe Segment Refere... <b>B3-5_B3-4</b>	City <b>Oliver Springs</b>	Street <b>Kentucky ST</b>	Material <b>Concrete Pipe (non-...</b>	Location C... <b>Light High...</b>	Sewer Use <b>Sanitary</b>
Upstream MH <b>B3-5</b>	Total Length <b>222.1</b>	Year Laid	Shape <b>Circular</b>	Location Details	
DS Manhole <b>B3-4</b>	Length surveyed <b>222.1</b>	Year Renewed	Height <b>8</b>	Width <b>8</b>	Pipe Joint... <b>4</b>

SPR <b>N/A</b>	MPR <b>N/A</b>	PO Number <b>4397-03</b>		Customer <b>GRW</b>	
SPRI <b>N/A</b>	MPRI <b>N/A</b>	Work Order <b>4397-02</b>		Purpose <b>Pre-Rehabilitation Survey</b>	
QSR <b>N/A</b>	QMR <b>N/A</b>				
OPR <b>N/A</b>	Surveyed By <b>Charlie Gordon</b>	Direction <b>Downstream</b>	Date <b>20150908</b>	Media label	
OPRI <b>N/A</b>	Certificate Number <b>U-615-07000491</b>	Pre-Cleaning <b>Jetting</b>	Time <b>12:15</b>	Weather <b>Dry</b>	
Date Cleaned <b>20150908</b>			End Time <b>12:30</b>	Additional Info

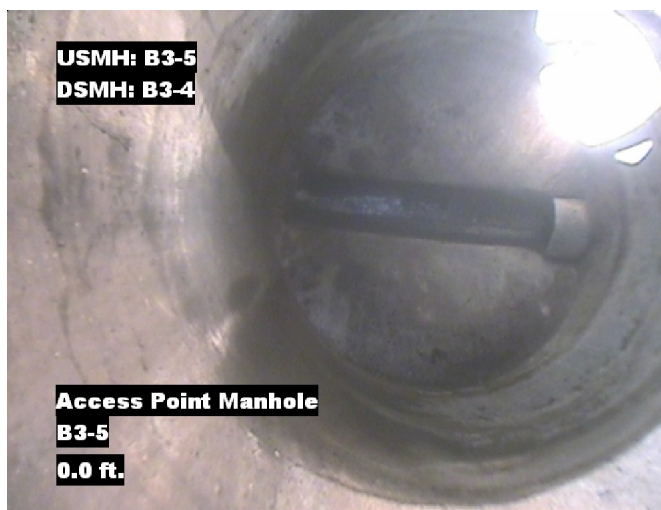
Distance: 0.0 ft. Grade: 0  
Condition: Access Point Manhole  
Remarks: B3-5

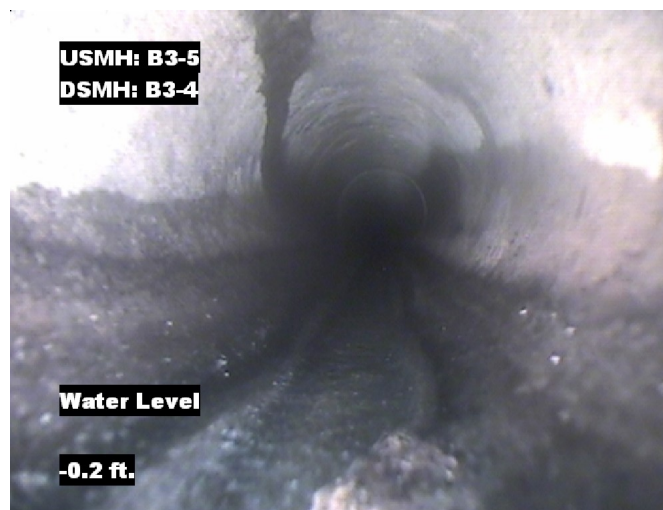
Distance: 0.0 ft. Grade: 0  
Condition: Water Level  
Remarks: N/A

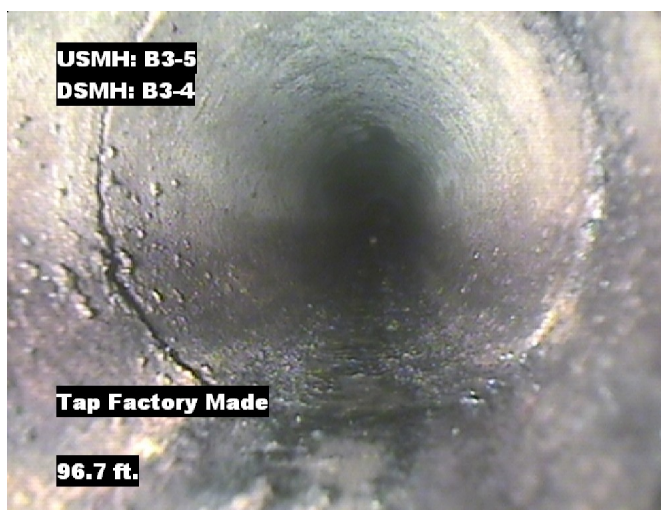
Distance: 96.7 ft. Grade: 0  
Condition: Tap Factory Made  
Remarks: N/A

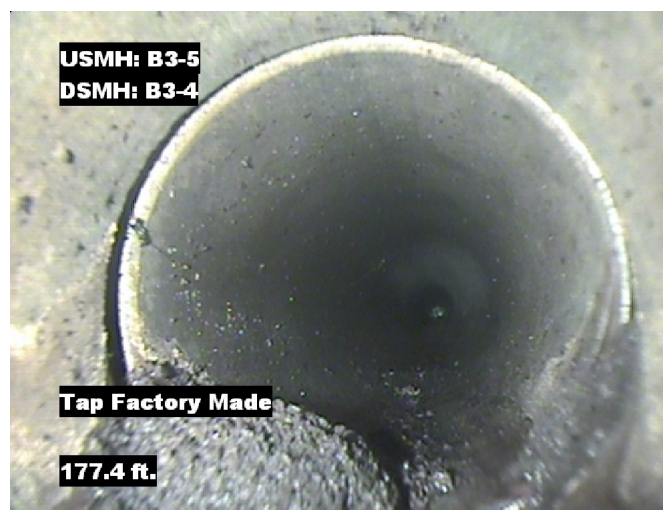
Distance: 177.4 ft. Grade: 0  
Condition: Tap Factory Made  
Remarks: N/A

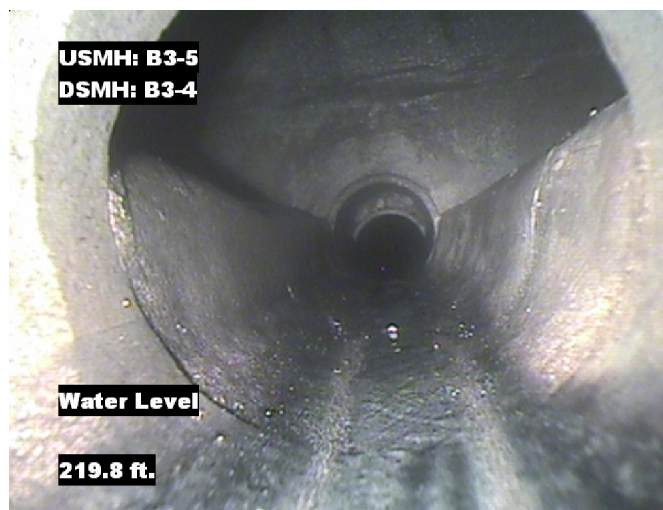
Distance: 219.8 ft.      Grade: 0  
Condition: Water Level  
Remarks: N/A

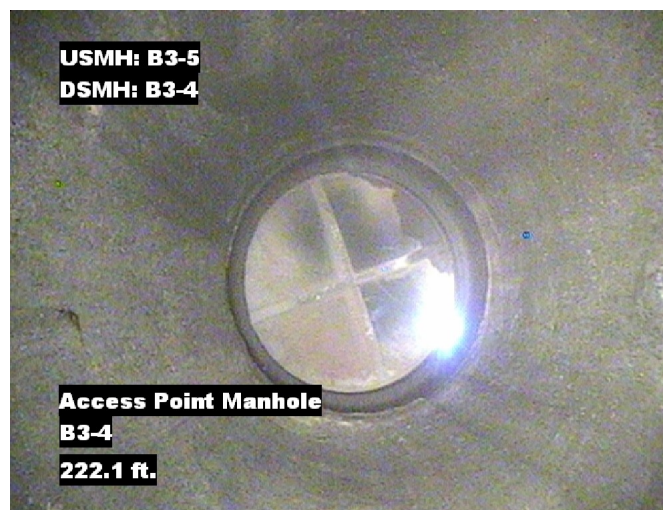
Distance: 222.1 ft.      Grade: 0  
Condition: Access Point Manhole  
Remarks: B3-4
