## Defect Listing

Pipe Segment Refere... <b>B3-6_B3-5</b>	City <b>Oliver Springs</b>	Street <b>kelly Rd</b>	Material <b>Concrete Pipe (non-...</b>	Location C... <b>Easement/R...</b>	Sewer Use <b>Sanitary</b>
Upstream MH <b>B3-6</b>	Total Length <b>174.5</b>	Year Laid	Shape <b>Circular</b>	Location Details	
DS Manhole <b>B3-5</b>	Length surveyed <b>174.5</b>	Year Renewed	Height <b>8</b>	Width <b>8</b>	Pipe Joint... <b>4</b>

SPR <b>N/A</b>	MPR <b>N/A</b>	PO Number <b>4397-03</b>	Customer <b>GRW</b>
SPRI <b>N/A</b>	MPRI <b>N/A</b>	Work Order <b>4397-02</b>	Purpose <b>Pre-Rehabilitation Survey</b>
QSR <b>N/A</b>	QMR <b>N/A</b>		
OPR <b>N/A</b>	Surveyed By <b>Charlie Gordon</b>	Direction <b>Downstream</b>	Date <b>20150908</b>
OPRI <b>N/A</b>	Certificate Number <b>U-615-07000491</b>	Pre-Cleaning <b>Jetting</b>	Time <b>10:30</b>
	Date Cleaned <b>20150908</b>	End Time <b>10:43</b>	Weather <b>Dry</b>
			Additional Info

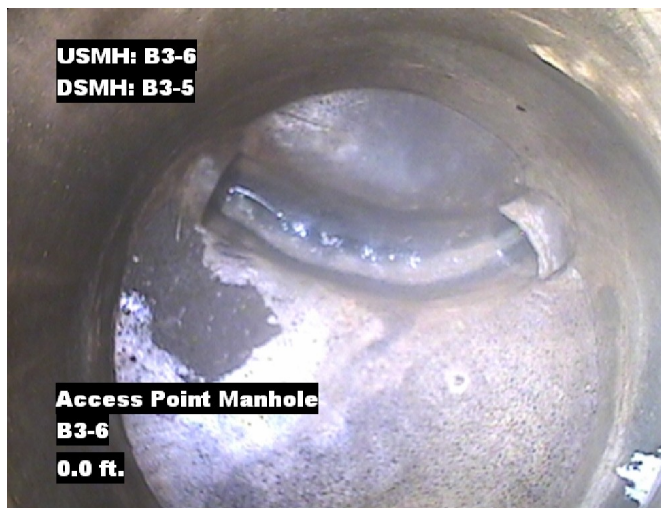
Distance: 0.0 ft. Grade: 0  
Condition: Access Point Manhole  
Remarks: B3-6

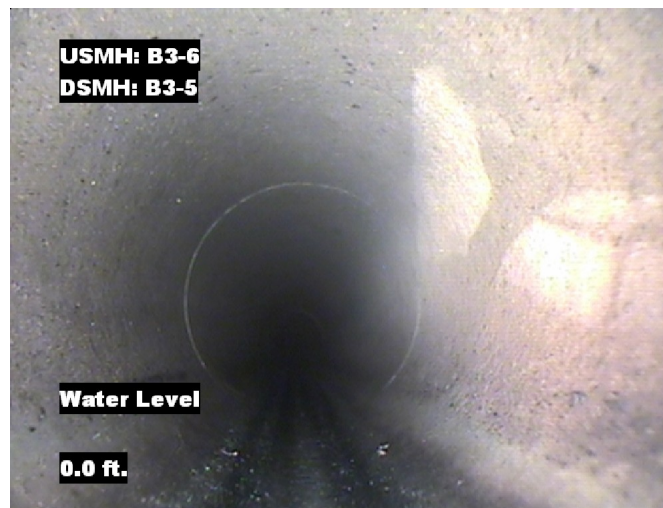
Distance: 0.0 ft. Grade: 0  
Condition: Water Level  
Remarks: N/A

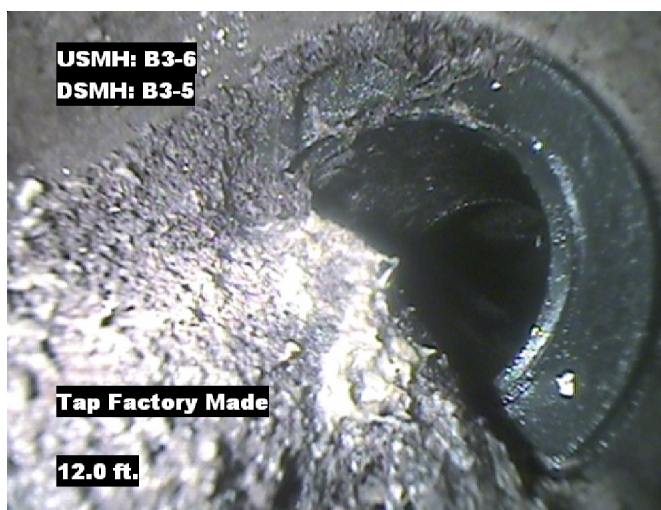
Distance: 12.0 ft. Grade: 0  
Condition: Tap Factory Made  
Remarks: N/A

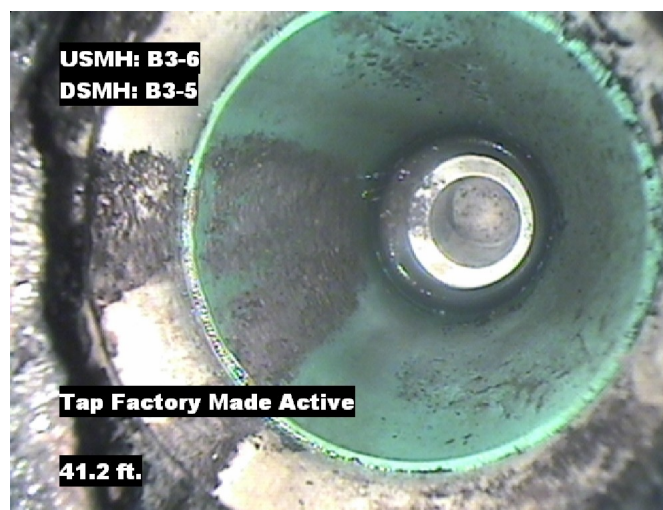
Distance: 41.2 ft. Grade: 0  
Condition: Tap Factory Made Active  
Remarks: N/A

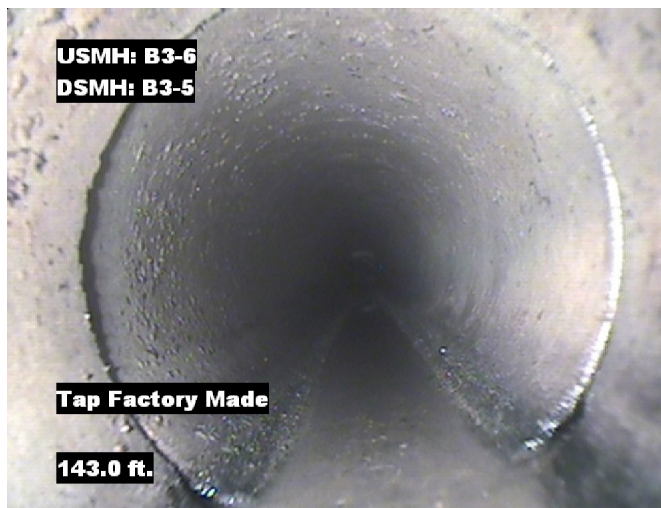
Distance: 143.0 ft. Grade: 0  
Condition: Tap Factory Made  
Remarks: N/A

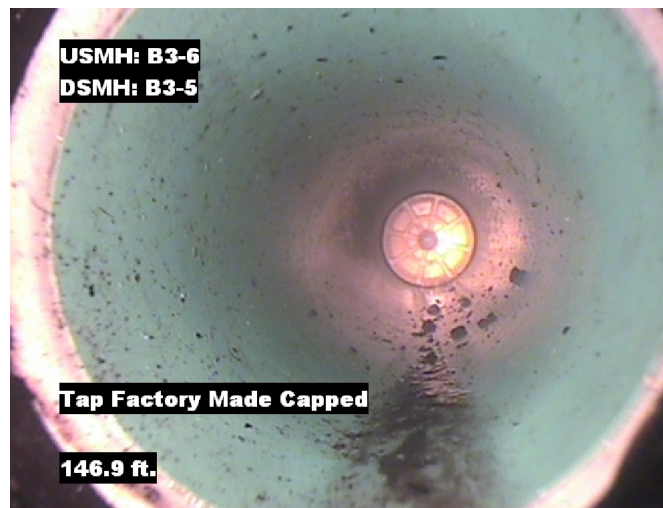
Distance: 146.9 ft. Grade: 0  
Condition: Tap Factory Made Capped  
Remarks: N/A

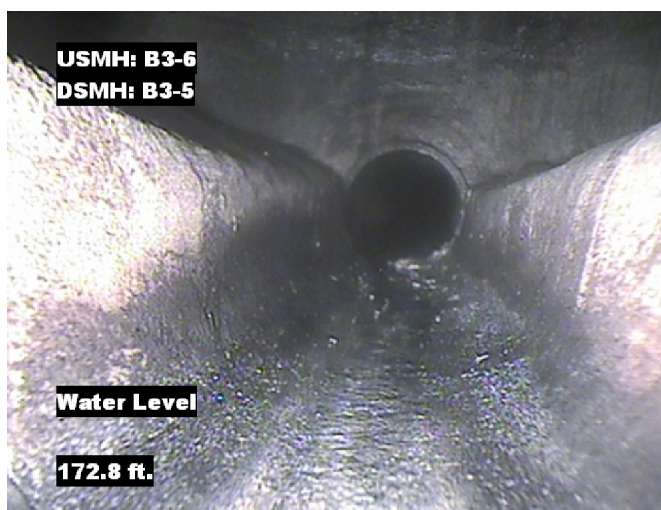
Distance: 172.8 ft. Grade: 0  
Condition: Water Level  
Remarks: N/A

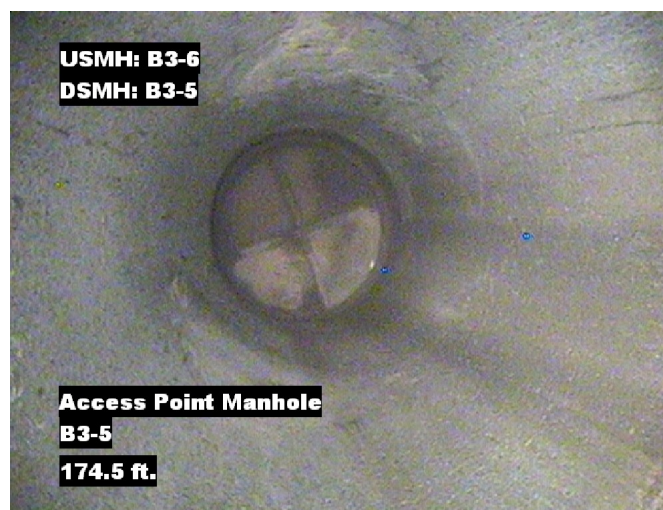
Distance: 174.5 ft. Grade: 0  
Condition: Access Point Manhole  
Remarks: B3-5
