Defect Listing

Pipe Segment Refere... B3-7_B3-7A	City Oliver Springs	Street Kelly Rd	Material Concrete Pipe (non-...	Location C... Light High...	Sewer Use Sanitary
Upstream MH B3-7	Total Length 164.6	Year Laid	Shape Circular	Location Details	
DS Manhole B3-7A	Length surveyed 164.6	Year Renewed	Height 8	Width 8	Pipe Joint... 4

Image Report 4/Page

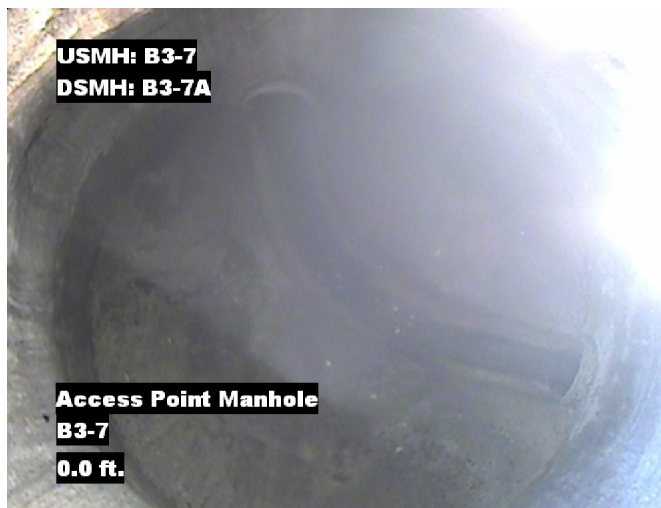
Distance: 0.0 ft. Grade: 0
Condition: Access Point Manhole
Remarks: B3-7

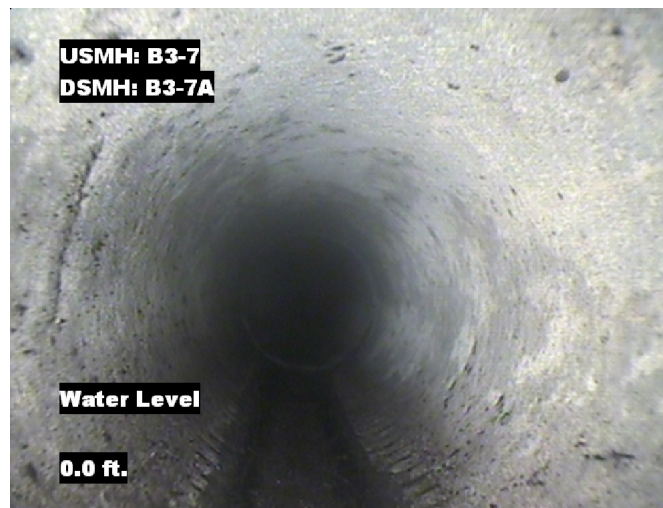
Distance: 0.0 ft. Grade: 0
Condition: Water Level
Remarks: N/A

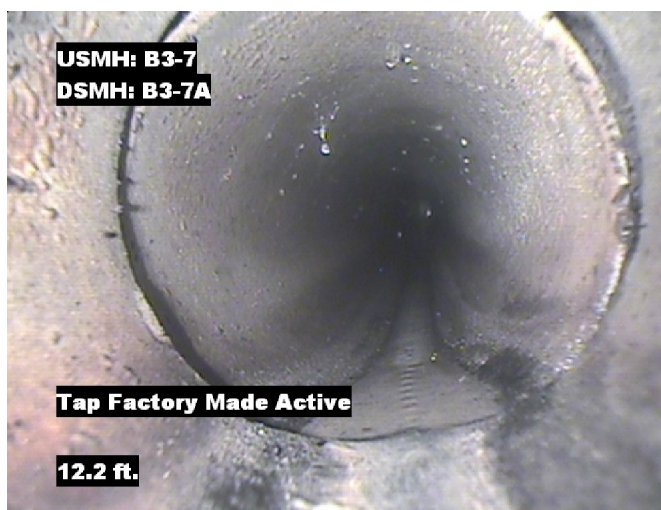
Distance: 12.2 ft. Grade: 0
Condition: Tap Factory Made Active
Remarks: N/A

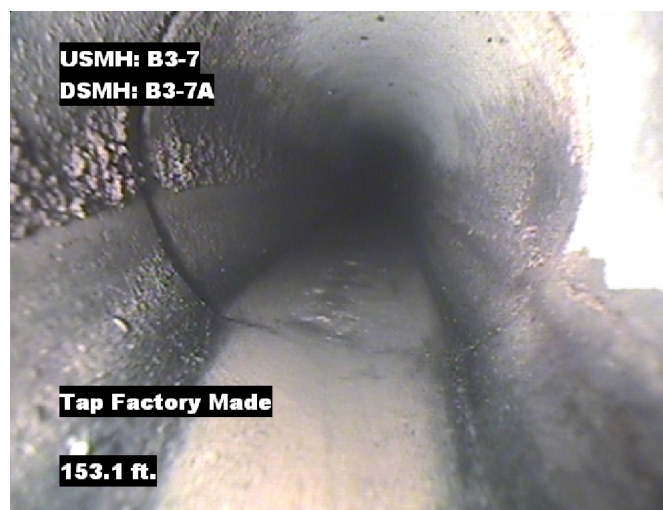
Distance: 153.1 ft. Grade: 0
Condition: Tap Factory Made
Remarks: N/A

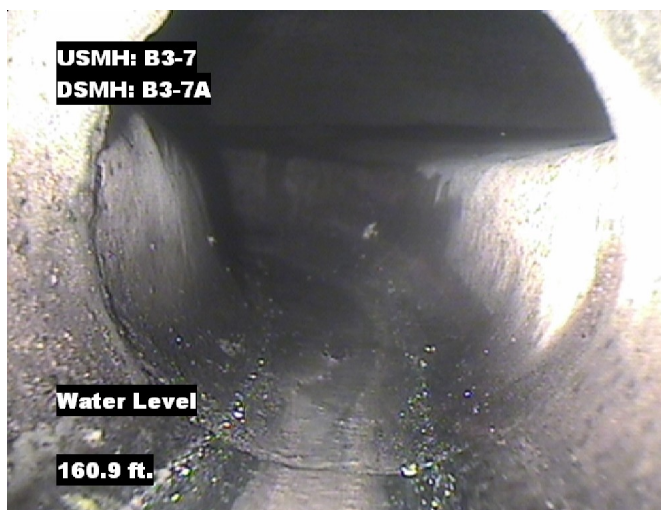
Distance: 160.9 ft. Grade: 0
Condition: Water Level
Remarks: N/A

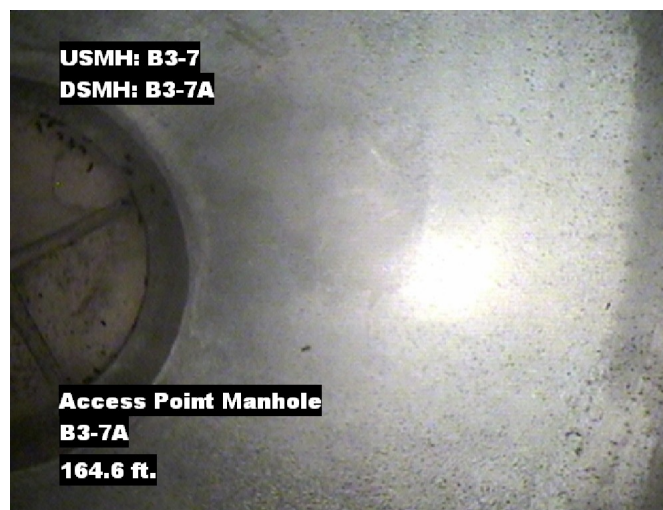
Distance: 164.6 ft. Grade: 0
Condition: Access Point Manhole
Remarks: B3-7A
