## Defect Listing

Pipe Segment Refere... <b>B3-7A_B3-6</b>	City <b>Oliver Springs</b>	Street <b>Kelly Rd</b>	Material <b>Concrete Pipe (non-...</b>	Location C... <b>Light High...</b>	Sewer Use <b>Sanitary</b>
Upstream MH <b>B3-7A</b>	Total Length <b>102</b>	Year Laid	Shape <b>Circular</b>	Location Details	
DS Manhole <b>B3-6</b>	Length surveyed <b>102</b>	Year Renewed	Height <b>8</b>	Width <b>8</b>	Pipe Joint... <b>4</b>

SPR <b>N/A</b>	MPR <b>N/A</b>	PO Number <b>4397-03</b>		Customer <b>GRW</b>	
SPRI <b>N/A</b>	MPRI <b>N/A</b>	Work Order <b>4397-02</b>		Purpose <b>Pre-Rehabilitation Survey</b>	
QSR <b>N/A</b>	QMR <b>N/A</b>				
OPR <b>N/A</b>	Surveyed By <b>Charlie Gordon</b>	Direction <b>Upstream</b>	Date <b>20150908</b>	Media label	
OPRI <b>N/A</b>	Certificate Number <b>U-615-07000491</b>	Pre-Cleaning <b>Jetting</b>	Time <b>10:18</b>	Weather <b>Dry</b>	
Date Cleaned <b>20150908</b>			End Time <b>10:26</b>	Additional Info

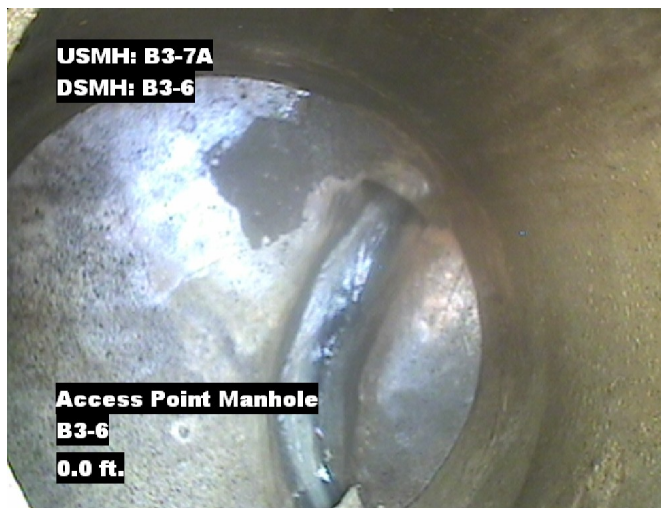
Distance: 0.0 ft. Grade: 0  
Condition: Access Point Manhole  
Remarks: B3-6

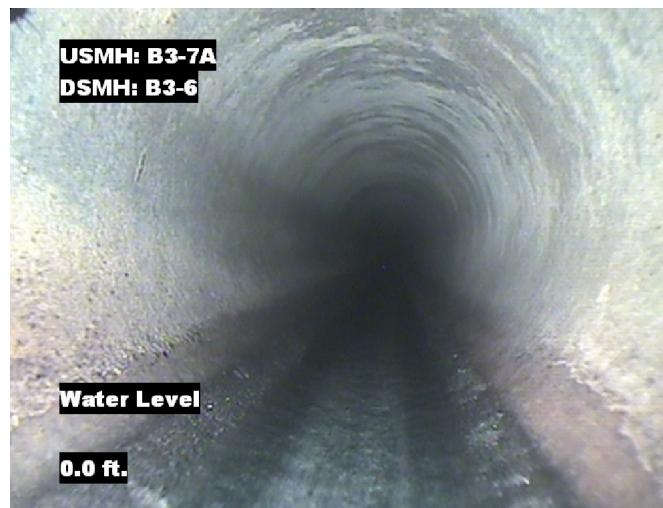
Distance: 0.0 ft. Grade: 0  
Condition: Water Level  
Remarks: N/A

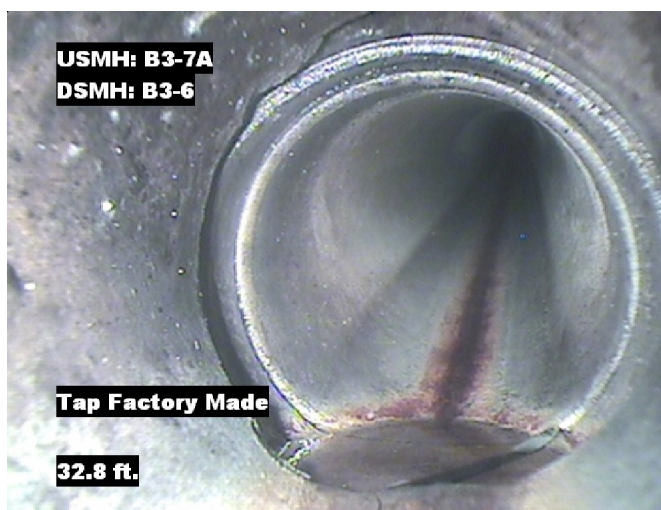
Distance: 32.8 ft. Grade: 0  
Condition: Tap Factory Made  
Remarks: N/A

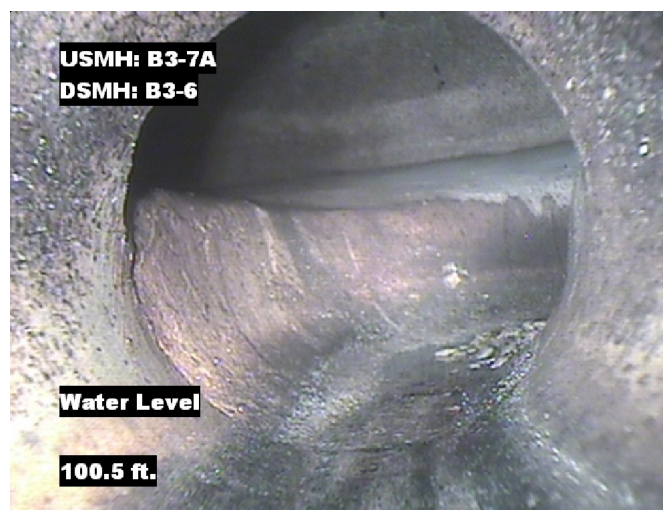
Distance: 100.5 ft. Grade: 0  
Condition: Water Level  
Remarks: N/A

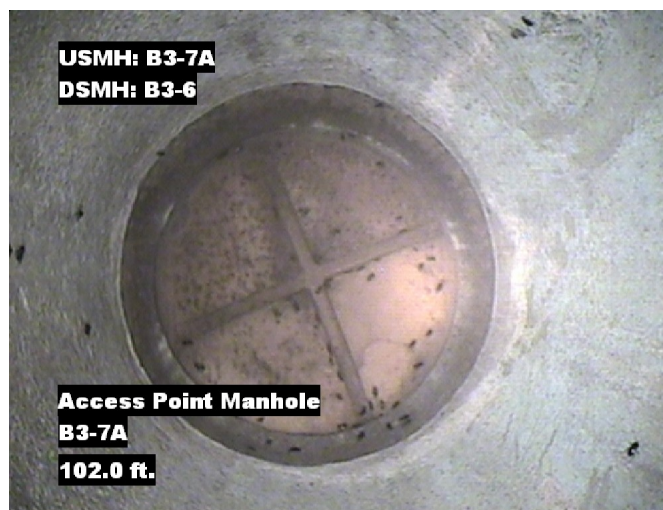
Distance: 102.0 ft.      Grade: 0  
Condition: Access Point Manhole  
Remarks: B3-7A
